Technical Service Bulletin

01 MIL on (DTC P0299 - turbo/super charger underboost)

01 15 16 2013060/7 March 12, 2015. Supersedes Technical Service Bulletin Group 01 number 08-05 dated December 22, 2008 for reasons listed below.

Model(s)	Year	VIN Range	Vehicle-Specific Equipment
A3, A4, A4 cabriolet	2005 - 2007	All	2.0 TFSI

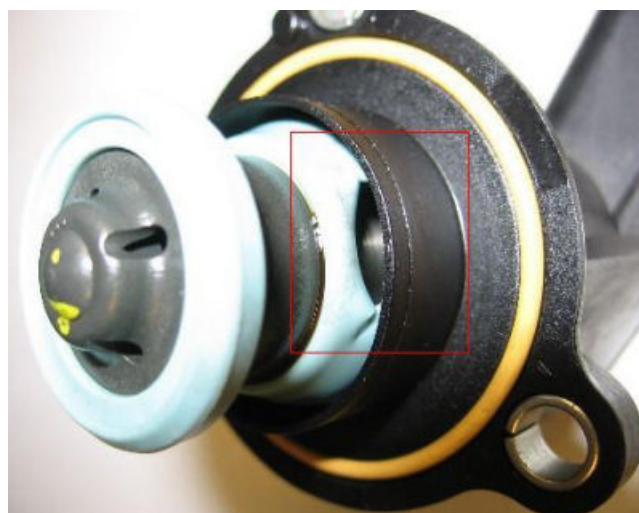
The condition may be the result of an abnormal turbocharger recirculation valve, N249.

Figure 1. A torn rubber membrane.

1. Remove the turbocharger recirculation valve, N249, from the turbocharger housing.
2. Visually inspect the rubber membrane. If the membrane is torn (Figure 1), replace the turbocharger recirculation valve, N249.
