Technical Service Bulletin

48 Creaking or squeaking noises from steering column (sealing boot)

48 15 65 2034351/4 March 23, 2015. Supersedes Technical Service Bulletin Group 48 number 14-57 dated January 29, 2014 for reasons listed below.

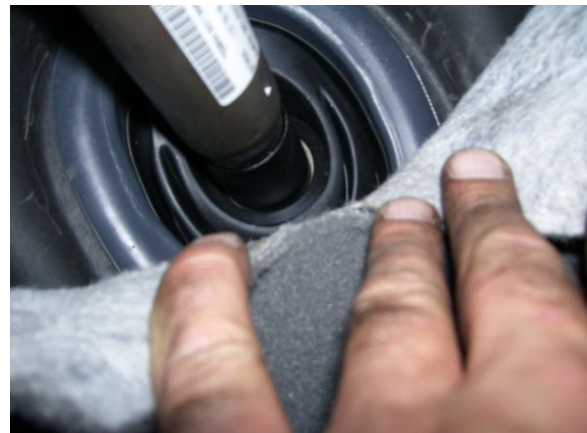
Insufficient lubrication of the intermediate steering shaft in the area of the sealing sleeve.

1. Check the correct fit of the sealing sleeve (Figure 1).

Figure 1. Sealing sleeve on the bulkhead.

2. Spray the intermediate steering shaft in the area of the bearing ring with special lubricant spray (**G 052172A2**). While spraying, turn the steering wheel side-to-side and adjust the steering column axially and vertically until the noise disappears.

! **Note:** Do not lubricate the u-joints of the steering shaft.

3. If the noise persists, replace the intermediate steering shaft.
