Technical Service Bulletin

57 Remote control key low battery voltage warning in DIS (DTC B147918)

57 15 08 2039814/2 March 6, 2015. Supersedes Technical Service Bulletin Group 57 number 15-07 dated February 13, 2015 for reasons listed below.

Model(s)	Year	VIN Range	Vehicle-Specific Equipment
A3	2015	All	Not Applicable

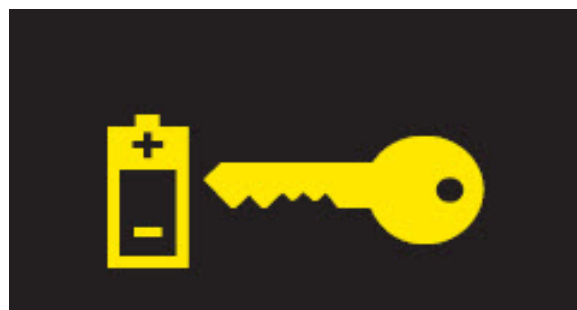
- A remote key low battery warning icon and the warning message "Please change key battery" appear in the instrument cluster (Figure 1).
- **DTC B147918** (Remote key 1 voltage too low) is logged in the vehicle electrical system control module (BCM1), J519 (address word 09).
- The remote key battery is correct.

Figure 1. Warning icon in instrument cluster for remote key low battery.

Incorrect diagnostics for determining low remote key battery voltage in the software of the vehicle electrical system control module (BCM1).

There is no need to replace the remote key battery if it tests greater than 3.0V.

1. Update the software and parameters of the vehicle electrical system control module (BCM1) using the instructions below. The parameter part number and version can only be seen after the SVM code completes.
2. After the software update is complete, test by unlocking and starting the vehicle multiple times to ensure that the low battery warning does not return.
