# Technical Service Bulletin

## 66 Wind noise from exterior rear view mirror

66 15 47 2039960/1 March 3, 2015.

Model(s)	Year	VIN Range	Vehicle-Specific Equipment
Q3	2015	All	Not Applicable

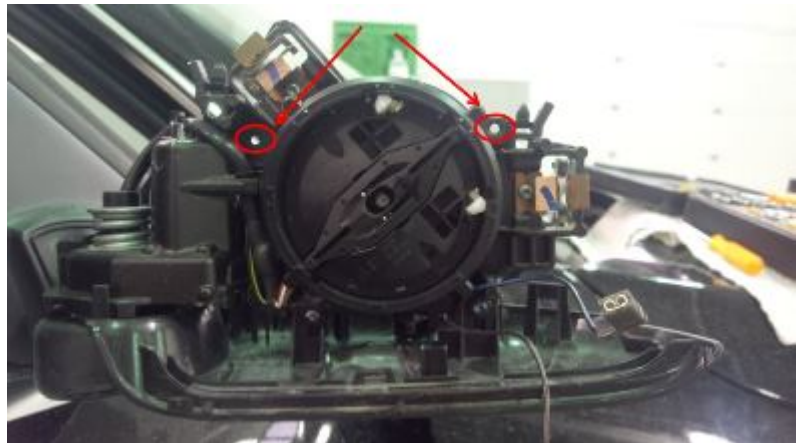
Possible sources of this wind noise are the seam surrounding the turn signal lamp and the seam surrounding the side assist lamp (if equipped). Because of the lack of two mounting screws from the mirror base to the mirror housing, the mirror housing can move when the vehicle is at speed, creating a large gap around the turn signal lamp. The modifications explained in the *Service* section of this bulletin will effectively mitigate the wind noise symptom should these seams be the root cause of the wind noise.

**Figure 1.** Mirror housing screw hole locations.

3. Inspect the holes shown in the illustration (Figure 1). If screws are already installed in these openings and the vehicle is not equipped with side assist, no further modification is necessary for the exterior mirror. If screws are not present, they will need to be installed. Proceed by removing the exterior rear view mirror cover. If screws are installed, they will need to be removed to complete this disassembly and to access the side assist lamp.

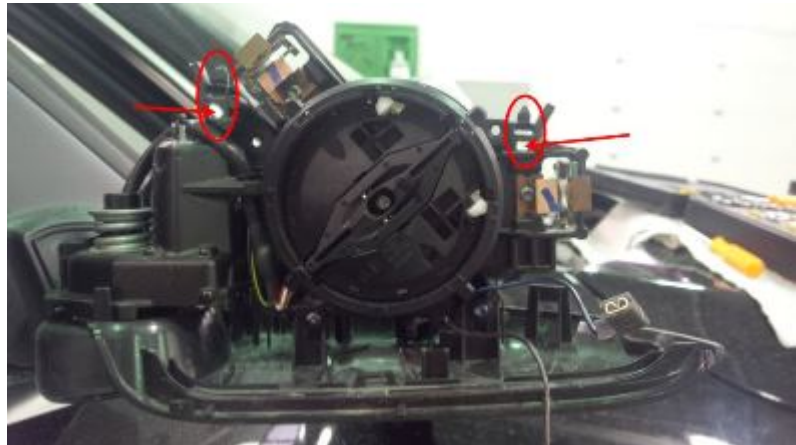
**Figure 2.** Exterior rear view mirror glass and housing removed. Retaining clip engagement locations are shown.

4. With the screws removed, carefully pull the lower rim of the cover away from the mirror base. Release the two retaining clips for the cover inside the mirror base and pull upwards. The retaining clip engagement is shown in the illustration (Figure 2).

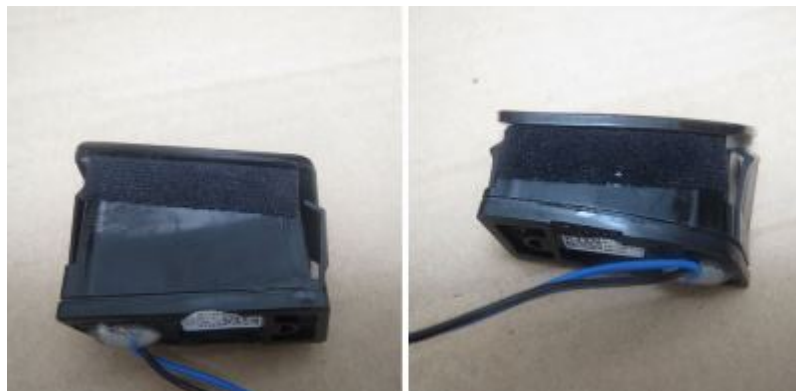
**Figure 3.** Adhesive tape D 373125A2 applied to the side assist lamp.

5. If the vehicle is equipped with side assist, unclip the lamp away from the housing. If not already present, apply a section of adhesive tape D 373125A2 to either side of the lamp body as shown in the illustration (Figure 3).

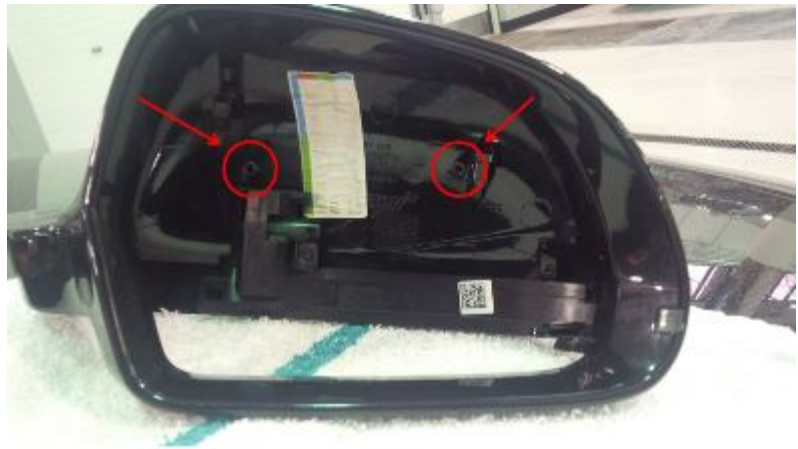
**Figure 4.** Mirror housing boss locations.

6. If the screws were not initially installed, the bosses in the exterior mirror housing will need to be drilled out to accommodate the screws (Figure 4).

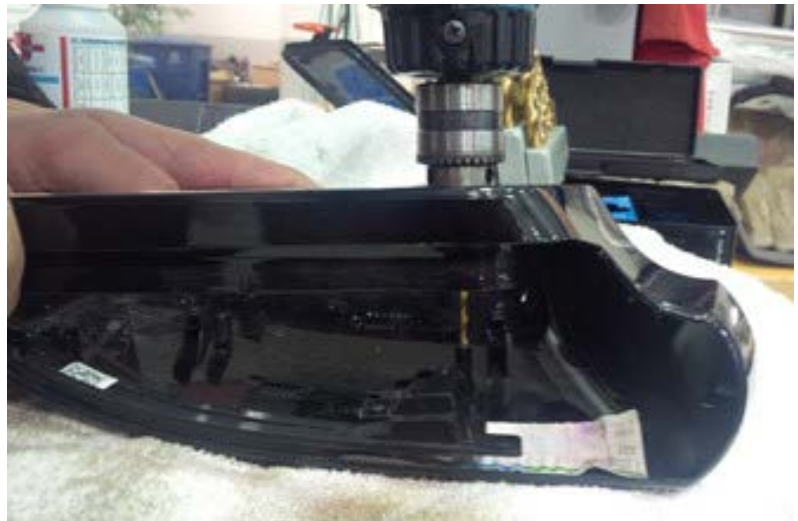
**Figure 5.** Drilling out the boss opening to 3mm.

7. Using a 3mm drill bit, carefully drill out the boss. Use extreme care to not drill into the mirror housing and damage it (Figure 5). The opening being drilled out is only to allow easier screw installation.
