Technical Service Bulletin

91 MMI3G+ Audi Connect only reaches 2G service - Telephone module replacement instructions for A4,A5,A5 cab,Q5,Q7,A8

91 15 76 2039476/1 March 3, 2015.

Model(s)	Year	VIN Range	Vehicle-Specific Equipment
A4, A5, A5 cabriolet, Q5	2013	All	Audi Connect
A8, Q7	2012 - 2013	All	Audi Connect

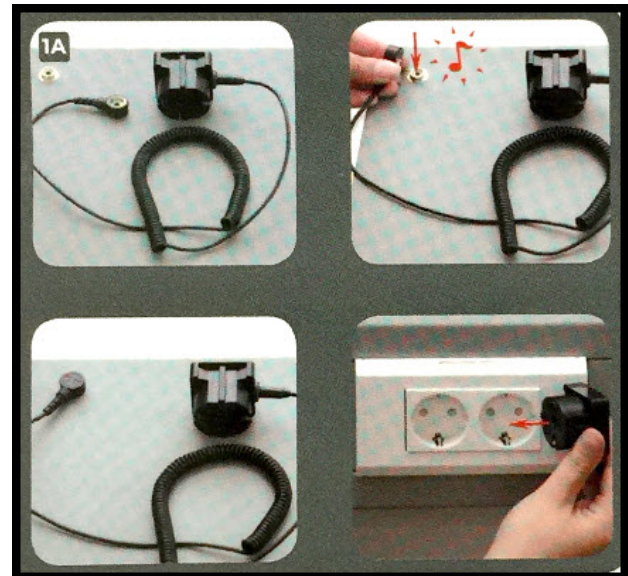
Figure 2. VAS6613 ESD work surface grounding plug.

4. Ground the ESD mat by plugging the 110V grounding strap into a wall socket or power strip (Figure 2). If a power strip is used, it must be plugged into a grounded wall outlet. (See attached user instructions for VAS6613 titled "VAS6613 ESD Workspace Guide.pdf".)

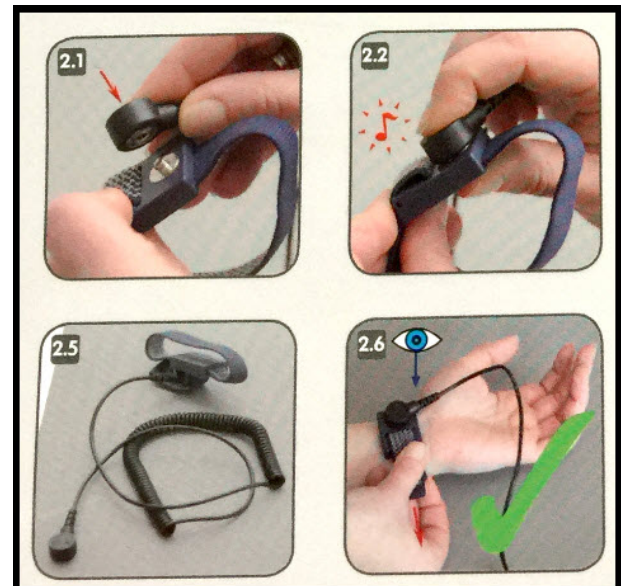
Figure 3. VAS6613 ESD work surface grounding wrist strap.

5. Ground yourself by placing the elastic strap around your wrist. Make sure it is securely touching your skin. It cannot be not loose-fitting or over your shirt cuff (Figure 3).

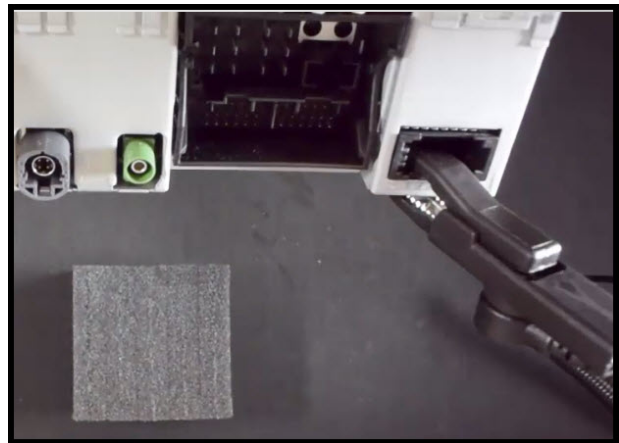
Figure 4. VAS6613 ESD work surface grounding device clip.

6. Ground the MMI main unit by placing an alligator clip on the back, ensuring that it makes contact with the metal housing of the main unit. The most secure location is at the MOST connector (Figure 4).

A foam block can be used as a spacer under the main unit to keep the grounding strap connected.

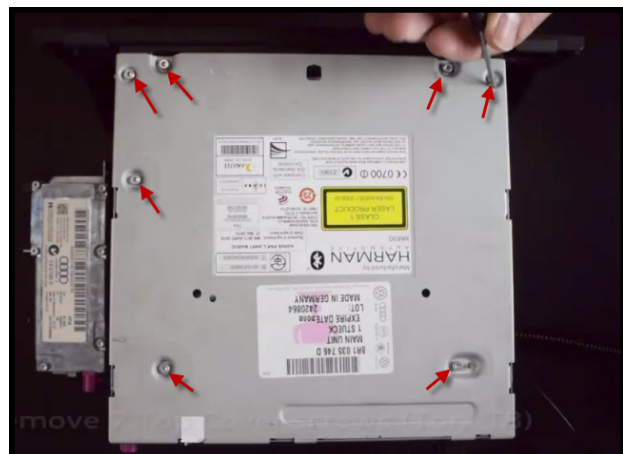
Figure 5. MMI main unit with screw locations for top cover indicated by the red arrows.

7. Remove the seven screws that are holding the MMI top cover in place (Figure 5).

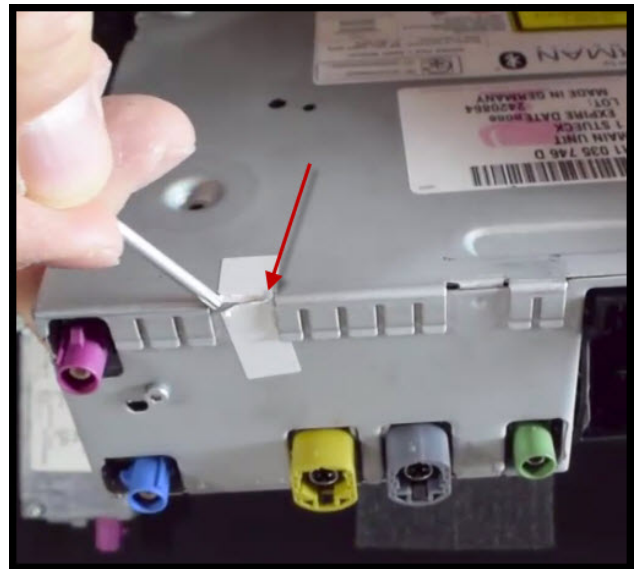
Figure 6. Break white warranty seal.

8. Break the white warranty seal on the back of the main unit (Figure 6).

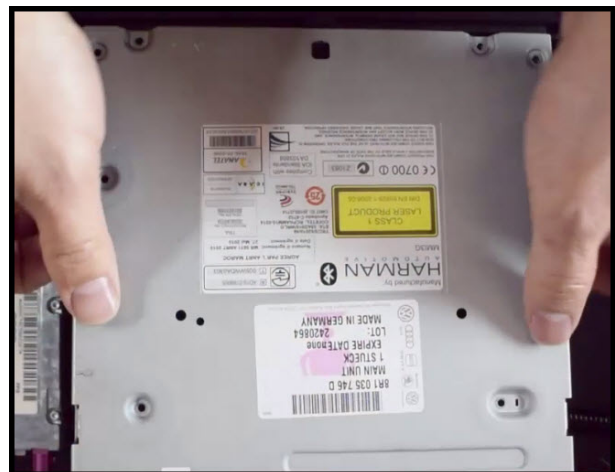
Figure 7. Pry top cover off with fingers.

9. Using a flat head screw driver, your fingers or a plastic wedge trim tool, remove the top cover by prying it from the back of the cover at the location seen in Figure 8. If a flat head screw driver is used then touch the tool to the ESD mat to discharge the tool prior to touching the main unit.

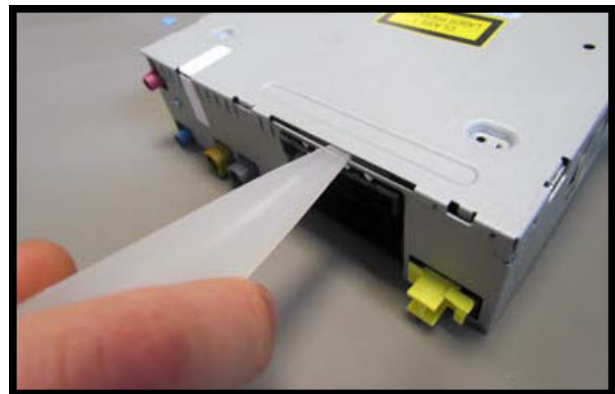
Figure 8. Pry top cover off using plastic trim wedge

tool.

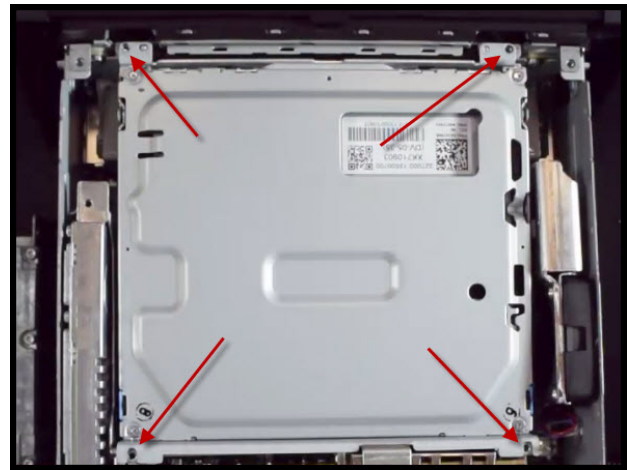
Do not flip the main unit over at this point. The CD drive, which was held in place by the top cover screws, is no longer secured. If it moves significantly, the ribbon cable can detach from the circuit board and disable the CD drive's functionality (Figure 9).

Figure 9. CD drive mounting points are free to move.

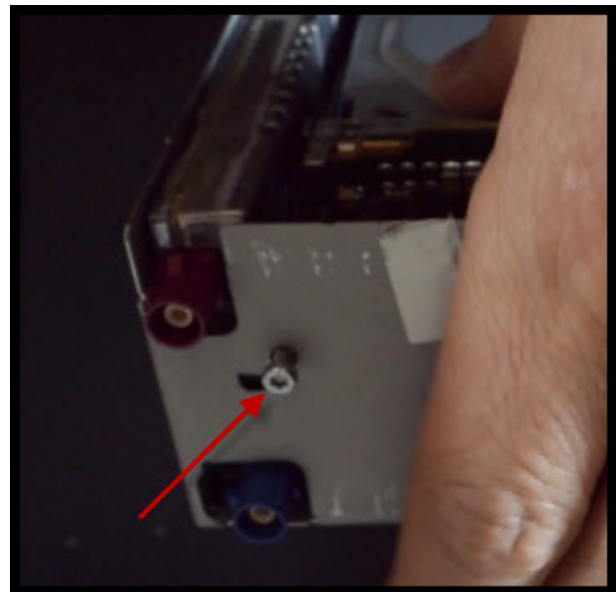
Figure 10. Telephone module retaining screw indicated by the red arrow.

10. On the back of the main unit, remove the retaining screw that holds the telephone module in place (Figure 10).

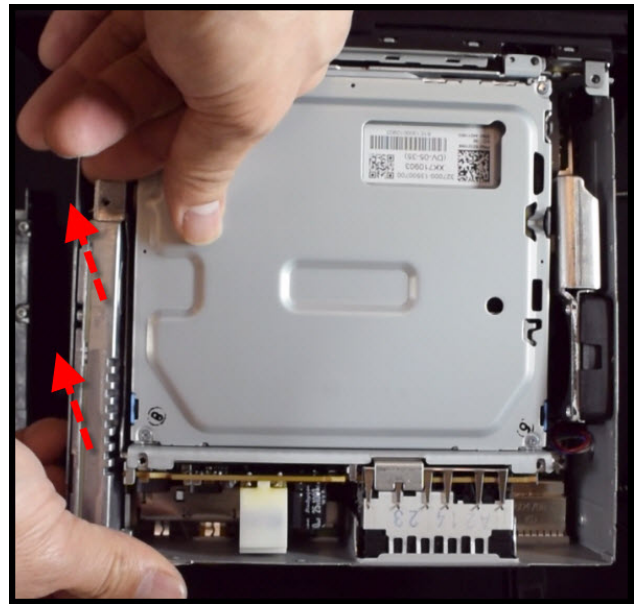
Figure 11. Lift up on both ends of the telephone module as indicated by the red arrows.

- Carefully lift up the telephone module, using both ends as points of contact when pulling up (Figure 11). The module is held in place with a computer socket-type attachment and will release when enough force is used.

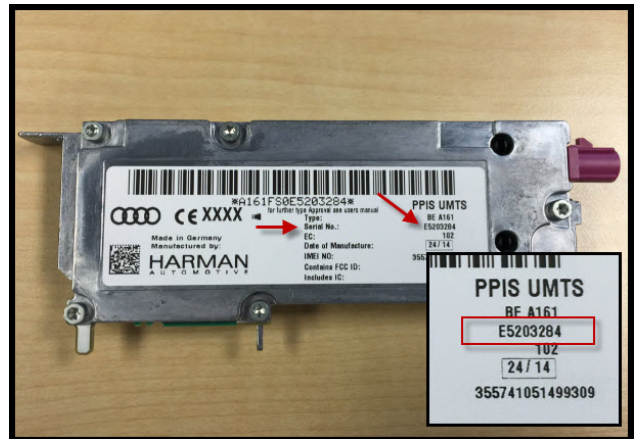
Figure 12. Serial number of the PPIS UMTS telephone module indicated by the red arrows and red box.

- Before proceeding, write the serial number of the new replacement UMTS telephone module on the rework label (Figure 12).

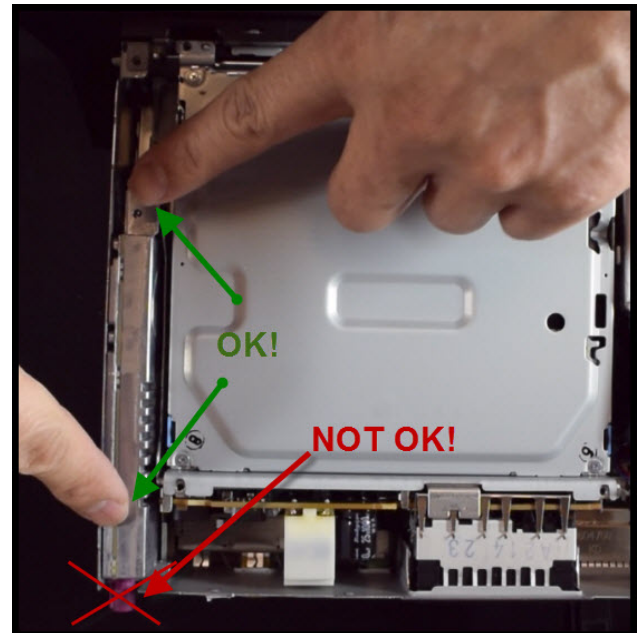
Figure 13. Do not press down using the purple FAKRA connector.

13. Place the new UMTS telephone module into the socket, making sure it is level before snapping it into place. Do not use the purple FAKRA connector for leverage. Press down only on the metal housing of the telephone module to prevent damage to the telephone module connector (Figure 13).

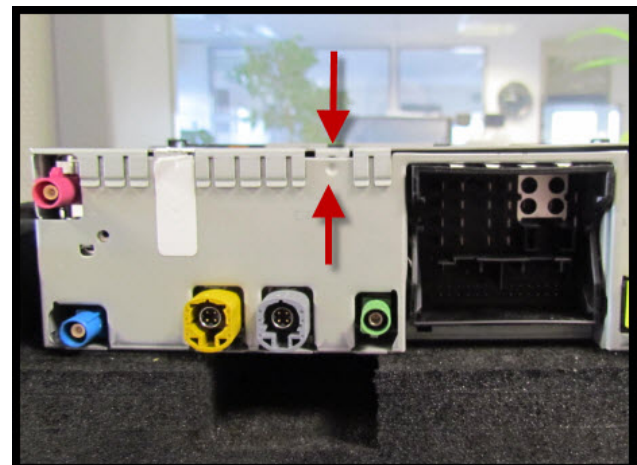
Figure 14. Place the new warranty seal over the location indicated by the red arrows.

14. Re-secure the telephone module retaining screw into the back of the MMI main unit.
15. Place the main unit top cover back into the MMI main unit housing.
16. Re-secure all seven top cover screws.
17. Place the new warranty seal from the retrofit kit next to the original warranty seal (Figure 14).

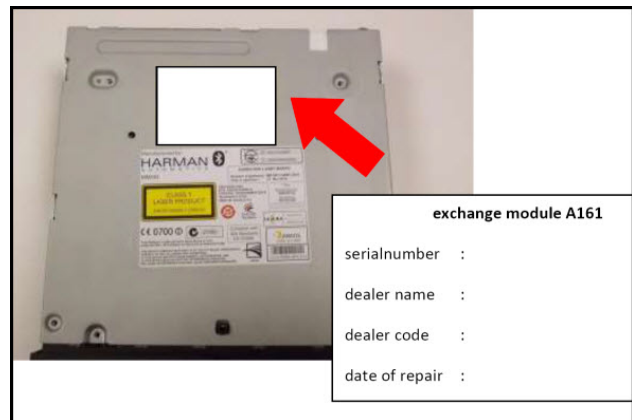
Figure 15. The white area indicates the “suggested” location for the repair label on the top cover of the main unit. Do not cover any existing part number labels.

- Place the rework label on the top of the main unit cover. Do not cover any part number labels (Figure 15). Fill out all fields on the repair label.

Do not cover the yellow laser warning label. The repair label may need to be placed on sideways due to space limitations.
