Technical Service Bulletin

96 Audi side assist "sensors blocked" warning in information panel (DTC C1114F3 and C1115F5)

96 15 94 2035047/4 March 27, 2015. Supersedes Technical Service Bulletin Group 96 number 13-79 dated December 5, 2013 for reasons listed below.

Model(s)	Year	VIN Range	Vehicle-Specific Equipment
A4, A5, A5 Cabriolet, Q5	2013 - 2014	All	Not Applicable

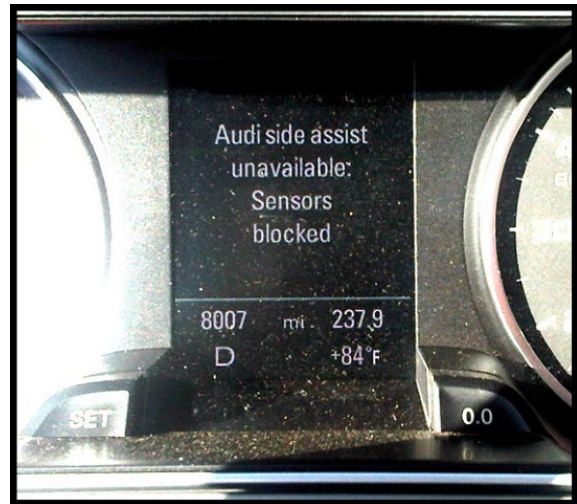
- Audi side assist deactivates or is sporadically inoperative when the vehicle is driven in slow-moving stop-and-go traffic, especially on roads with multiple lanes.
- The message “Audi side assist unavailable: Sensors blocked” appears in the driver information panel (Figure 1).

Figure 1. Audi side assist warning in information panel.

The software parameter update below will optimize the appearance of the “sensors blocked” message when the vehicle is driven in heavy stop-and-go traffic at low speeds. The updated parameter set will not remove the condition completely, as it is considered normal. Explain the *Technical Background* to the customer to prevent unnecessary repairs in the future.

- Follow all instructions in 2011732: *00 Software Version Management (SVM), operating instructions*.
- Update the lane change assistance control module, J769 (address word 3C), using the SVM code as listed in the table below if necessary. Note that the allroad is the only vehicle that can receive a software update; all other models receive an updated parameter set only.

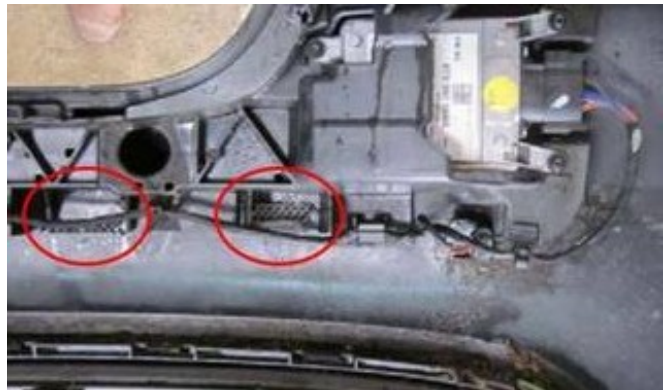
- The control module mounting brackets are securely fastened to the lower rear bumper, and no damage is found on the inside or on the outside rear bumper area (Figure 2).

Figure 2. Control module mounting bracket.

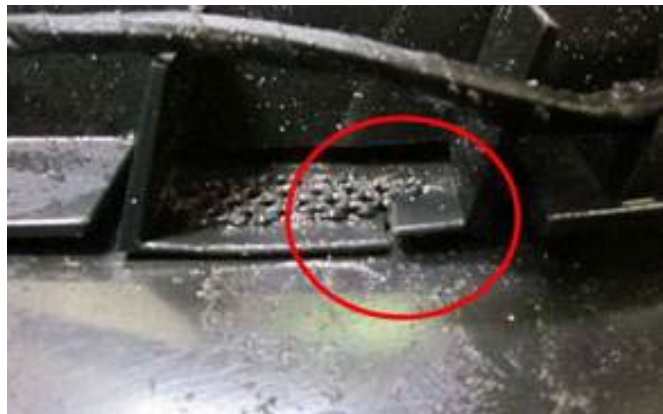
- The control module mounting brackets are not broken or loose (Figure 3 and Figure 4).

Figure 3. Broken mounting bracket.

Tip: If a loose bracket is found, repair as necessary using the Elsa Repair Manual. This TSB does not cover this repair.

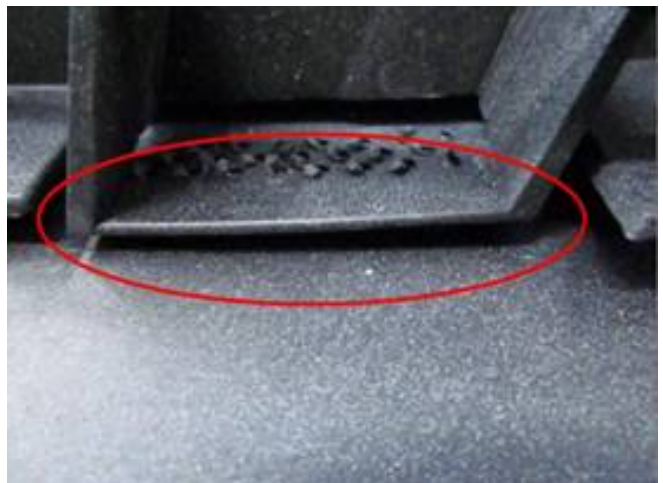
Figure 4. Loose mounting bracket.
