Technical Service Bulletin

01 MIL on (DTC P2440(00) and/or P2442(00))

01 15 19 2040403/1 April 15, 2015.

Model(s)	Year	VIN Range	Vehicle-Specific Equipment
S4, S5, S5 Cabriolet, A6, A7, Q5, and Q7	2011 - 2014	All	3.0 FSI engine

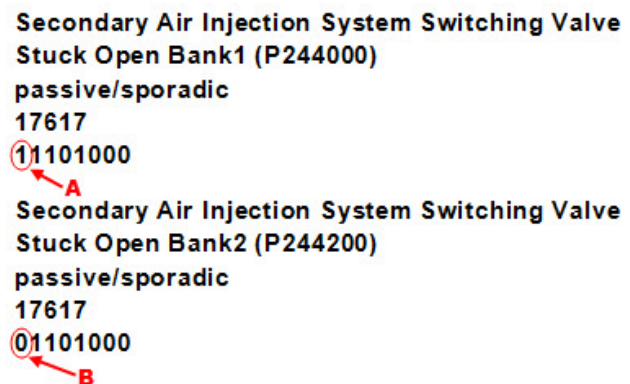
Scenario A is the cause if:

- One or both of the DTCs listed in the *Condition* is stored.
- The bit for MIL on shows “1” for one DTC only (Figure 1).

Figure 1. In this example, both DTCs are stored. The bit for MIL on with DTC P244000 (A) shows “1”, which means this DTC caused the MIL to illuminate. The bit for MIL on with DTC P244200 (B) shows “0”, which means it did not cause the MIL to illuminate.

- Replace the combi valve of the bank with the DTC that caused the MIL to illuminate.

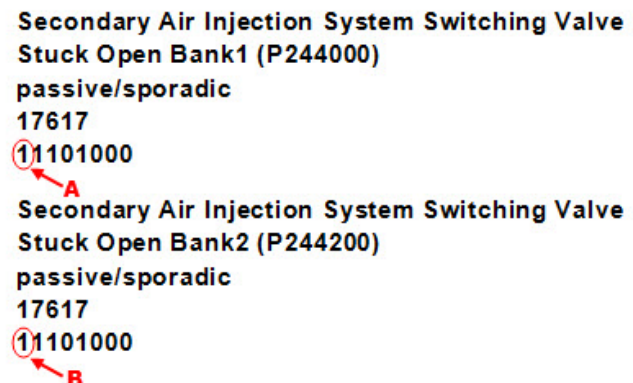
Scenario B is the cause if:

- Both of the DTCs listed in the *Condition* are stored.
- The DTCs were stored at the same time.
- The bit for MIL on shows “1” for both DTCs.

Figure 2. In this example, both DTCs are stored. The bit for MIL on shows “1” for both DTCs (A and B).

- Replace the vacuum solenoid valve that controls both of the combi valves.
