# Technical Service Bulletin

## 66 Wind noise from exterior rear view mirror

66 15 50 2035673/4 April 10, 2015. Supersedes Technical Service Bulletin Group 66 number 13-39 dated December 9, 2013 for reasons listed below.

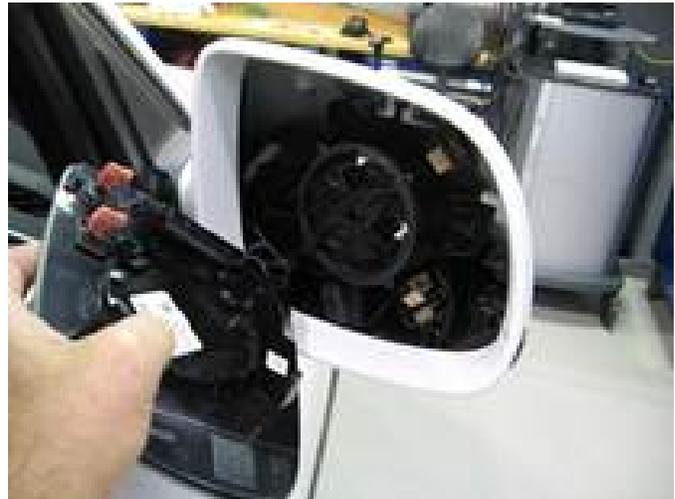
*Figure 1. Exterior rear view mirror glass removed.*

1. Begin by removing the exterior rear view mirror glass (Figure 1). Disconnect the electrical connectors carefully and set the glass aside.

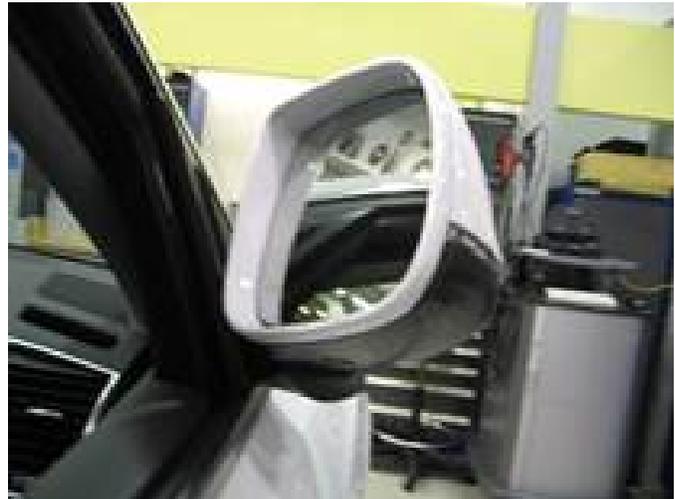
*Figure 2. Exterior rear view mirror manually folded.*

2. Remove the exterior rear view mirror cover. Manually folding the mirror body up will aid in the removal process (Figure 2).

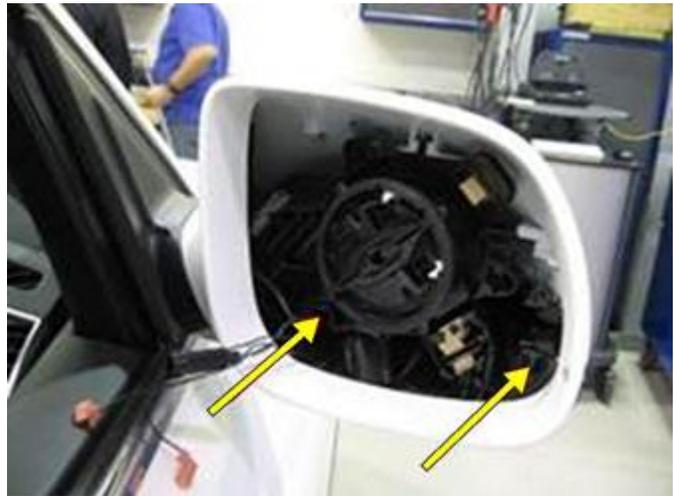
*Figure 3. Location of the retaining clips.*

- Carefully pull the lower rim of the cover away from the mirror base. Release the two retaining clips for the cover inside the mirror base (Figure 3).

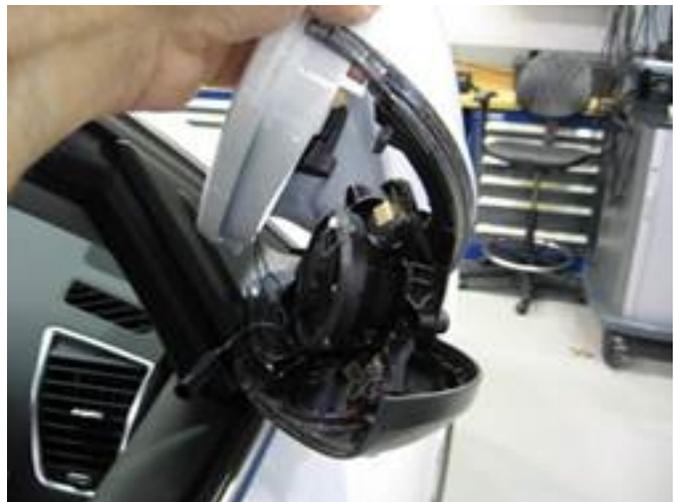
*Figure 4. Removing the mirror cover.*

- Unsnap the cover and set it aside (Figure 4).

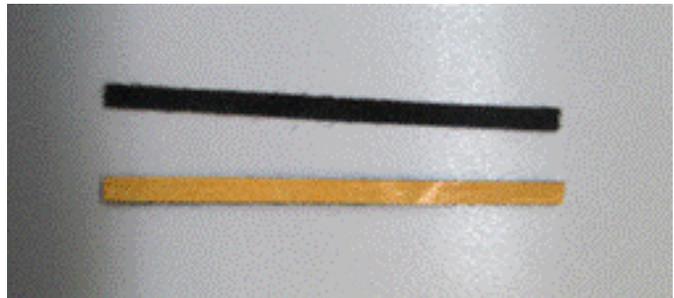
*Figure 5. Strips cut from felt tape.*

- Cut two 60mm x 3mm strips of felt tape (part number: **533863288A**) (Figure 5).

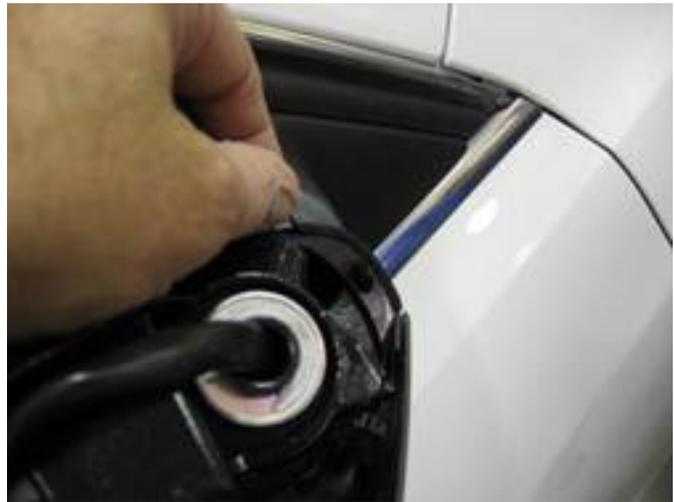
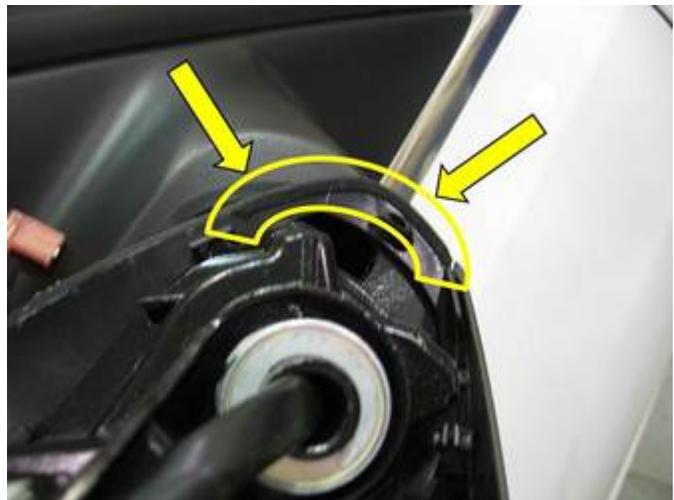
*Figure 6. Application of felt tape.*

*Figure 7. Felt tape applied.*

6. Apply the felt tape strips to the exposed area of the mirror base, as shown at right (Figure 6 and Figure 7).

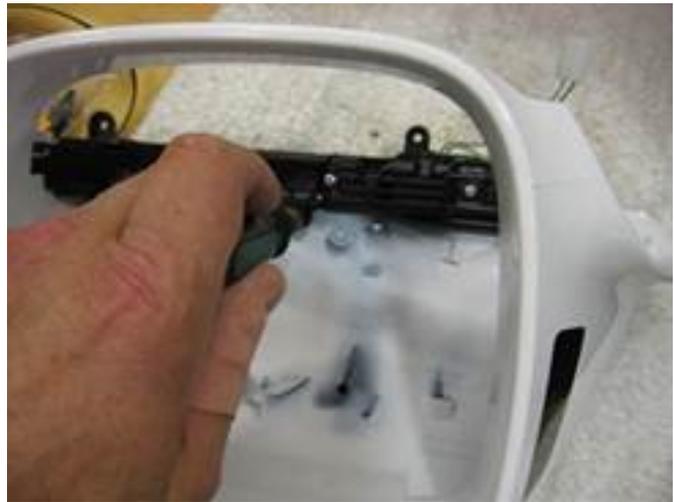
*Figure 8. Removing the turn signal lamp.*

7. Remove the turn signal lamp from the mirror cover (Figure 8).

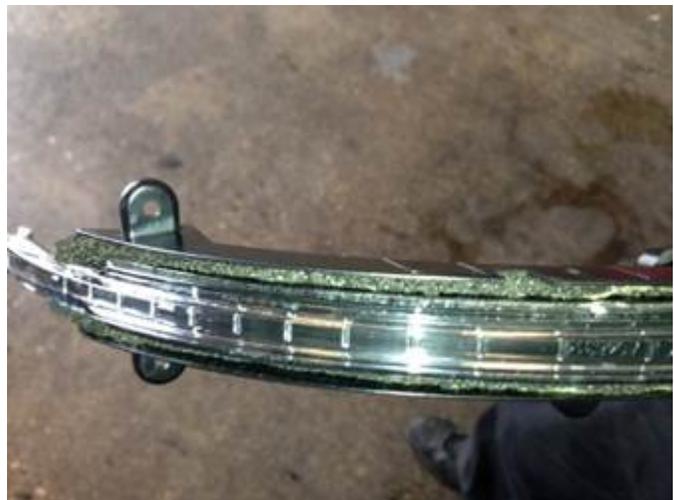
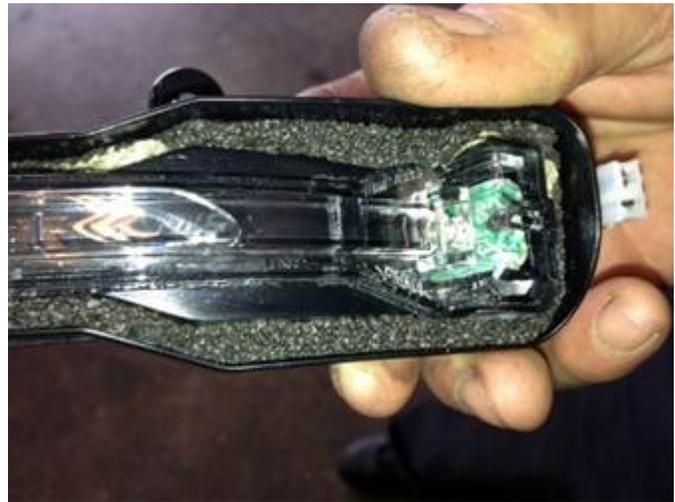
*Figure 9. Turn signal lamp with sealing foam tape installed.*

**Figure 10.** Turn signal lamp with sealing foam tape installed.

8. Apply strips of foam material (part number **8F0857869**) into the entire channel that surrounds the turn signal lamp, as shown at right (Figure 9 and Figure 10).

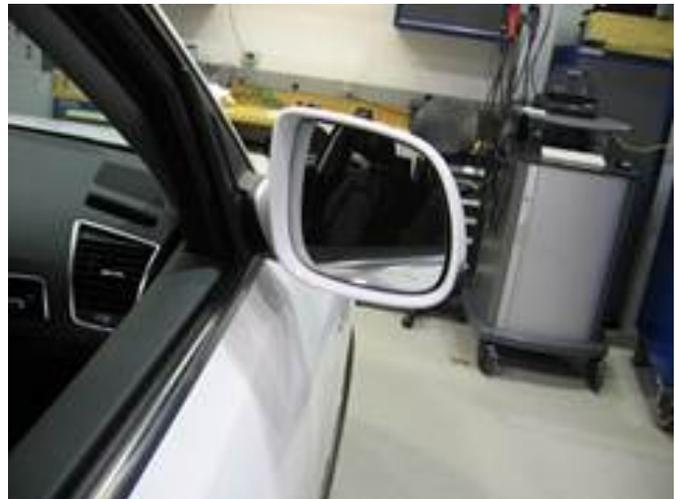
**Figure 11.** Mirror reassembled.

9. Reinstall the turn signal lamp into the mirror cover. Reinstall the mirror cover onto the mirror base (Figure 11).

**Tip:** Exercise care in the reassembly process. Incorrect or incomplete reassembly will cause recurrence or additional wind noise from the mirror assembly.
