Technical Service Bulletin

70 Noises from the upper-center dashboard area

70 15 45 2029280/5 April 15, 2015. Supersedes Technical Service Bulletin Group 70 number 14-37 dated April 24, 2014 for reasons listed below.

Model(s)	Year	VIN Range	Vehicle-Specific Equipment
A6, A7	2012 - 2014	All	Not Applicable
A6, A7	2015	000001 -005332	Not Applicable

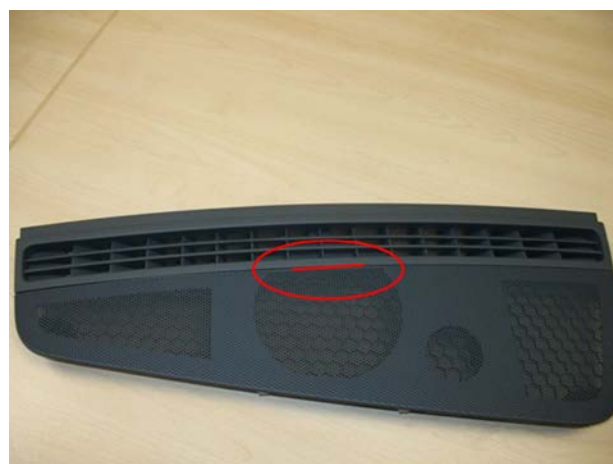
The noise can be caused by unfavorable tolerances between the instrument panel speaker and the center speaker trim. A speaker that has been incorrectly installed can make the condition worse.

Because there is no attachment to the trim carrier in the speaker cut-out, this area is the likely source of the vibration (Figure 1).

Figure 1. The affected area of the speaker grille, circled in red.

Replace the center defroster vent and the speaker trim. Review the steps below before proceeding:
