Technical Service Bulletin

87 Air conditioning does not cool and / or compressor is noisy

87 15 61 2038023/3 April 23, 2015. Supersedes Technical Service Bulletin Group 87 number 15-60 dated March 20, 2015 for reasons listed below.

Model(s)	Year	VIN Range	Vehicle-Specific Equipment
A3, A3 Cabriolet	2015	000001 - 106816	Not Applicable

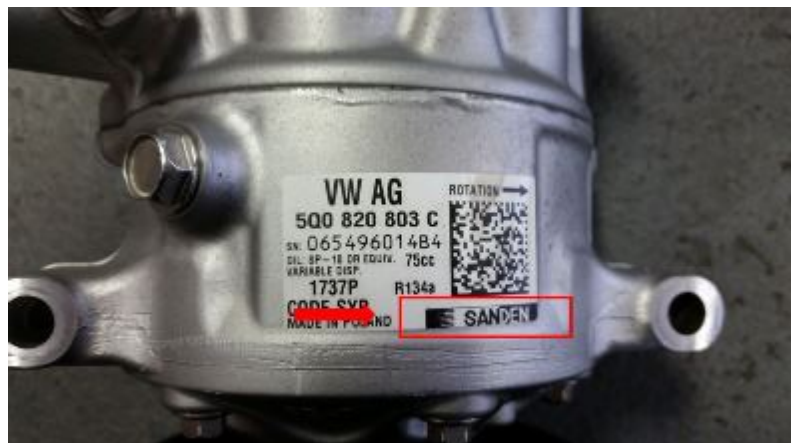
The originally installed compressor on the MY 2015 A3 is manufactured by Sanden (Figure 1). The replacement compressor is manufactured by Denso (Figure 2).

Figure 1: Sanden compressor identification tag.

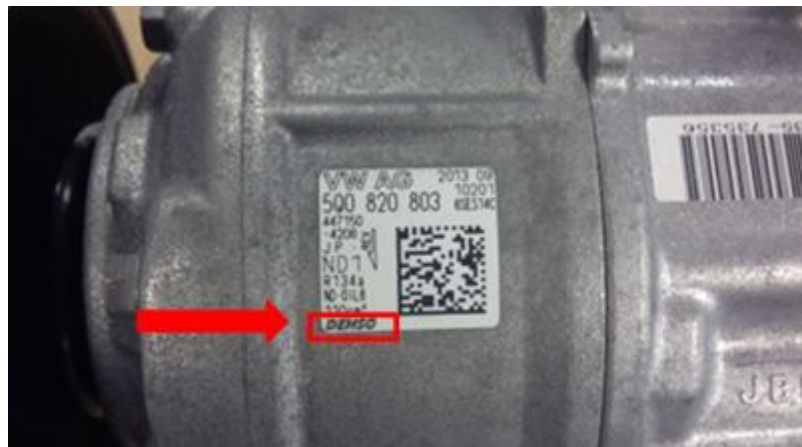
Figure 2: Denso compressor identification tag.

When replacing the original Sanden compressor with a Denso compressor, be aware that while the refrigerant volume is the same regardless of the compressor installed, the PAG oil type and volume is not. Sanden and Denso compressors have specific PAG oils that must be used. The original PAG oil that will be in the refrigerant circuit must be flushed out completely with the air conditioning service station with flushing equipment, as specified in the Elsa Repair Manual.

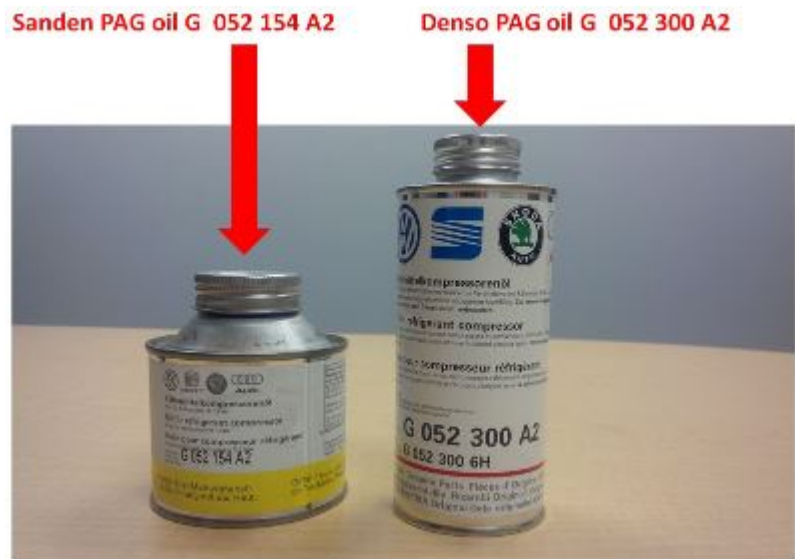
Figure 3: Compressor manufacturer specific PAG oils.

The replacement compressor will come with the specified type of PAG oil for the compressor (Figure 3). The amount of PAG oil supplied with the replacement compressor may not be the exact amount required to replenish the refrigerant circuit. Drain and measure the PAG oil in the replacement compressor to determine the required amount. If the amount needs to be adjusted, do so using the correct type of PAG oil specified in ETKA. Refer to Elsa for the correct oil capacity for the compressor being installed.
