Technical Service Bulletin

91 Rear/Top/Corner view camera image quality complaints (distorted image)

91 15 82 2029903/2 April 24, 2015. Supersedes Technical Service Bulletin Group 91 number 12-42 dated June 20, 2012 for reasons listed below.

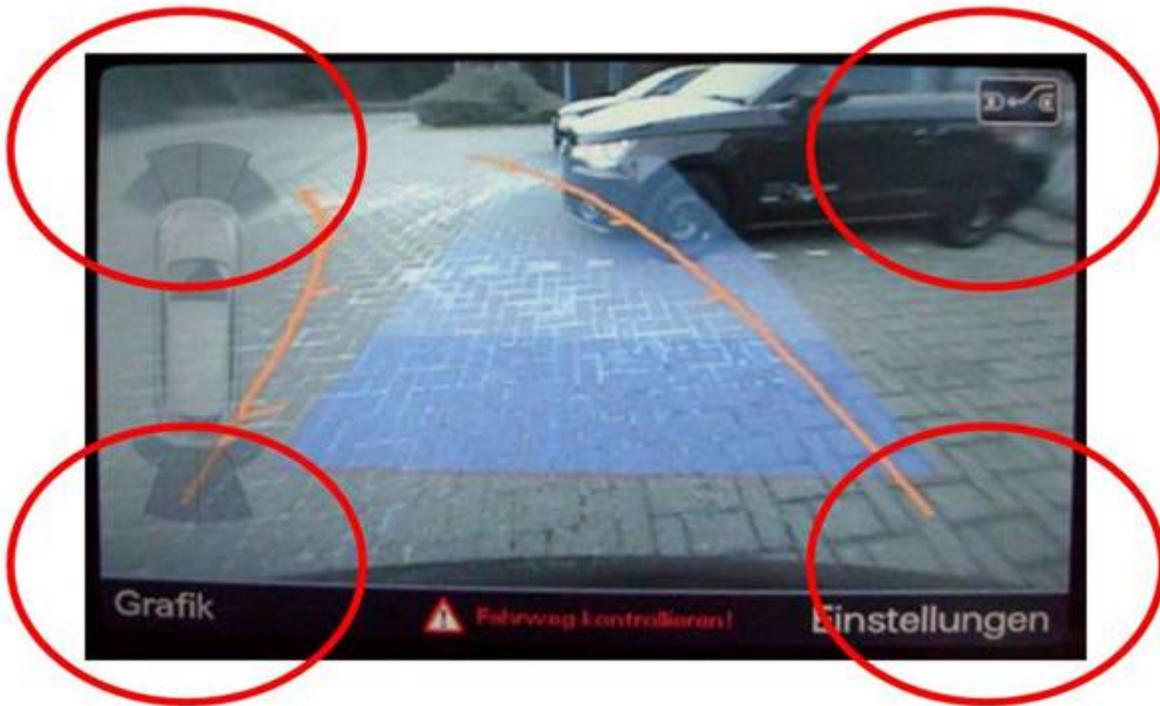
Explanation: The wide angle backup camera lens provides a 140° curved, “fish-eye” image. The MMI software straightens this image to fit the rectangular screen. As a result, the corners of the image look less sharp than the center of the image (Figure 1). The condition is more noticeable on larger MMI screens because the image is expanded.

Figure 1. Distorted or fuzzy corners of backup camera image in MMI.

These are normal conditions and no repair or replacement is necessary.

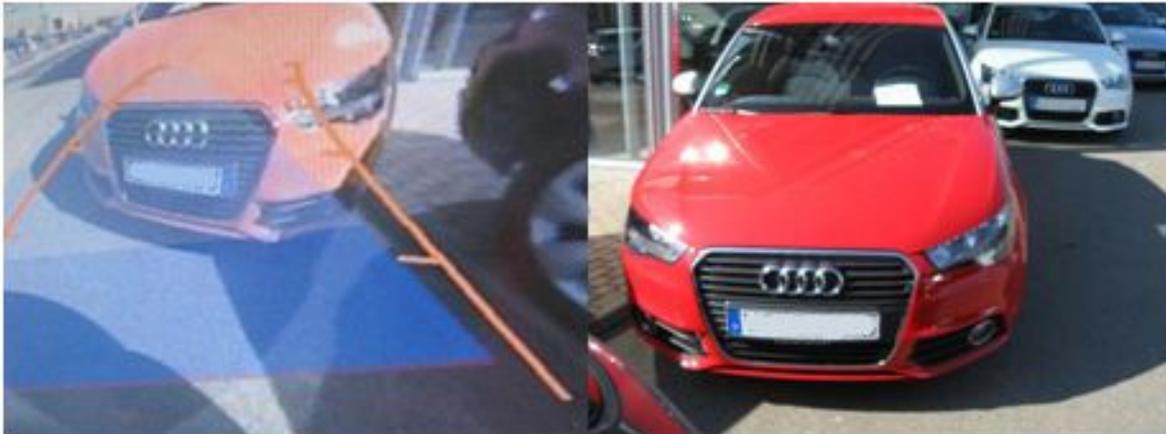
Explanation: In order to display the optimal representation of brightness, contrast, and color, the backup camera dynamically adjusts the image in the MMI screen in response to ambient light. As a result, the colors in the image appear to be different than the actual colors (Figure 2). Colors in the image are also affected during nighttime viewing because the camera is not equipped with an infrared filter.

Figure 2: Camera image in MMI screen (left) and actual color of objects (right).

The brightness of the image can be adjusted in the MMI menu (which will affect the whole screen for all MMI menus), but color and contrast cannot be changed.

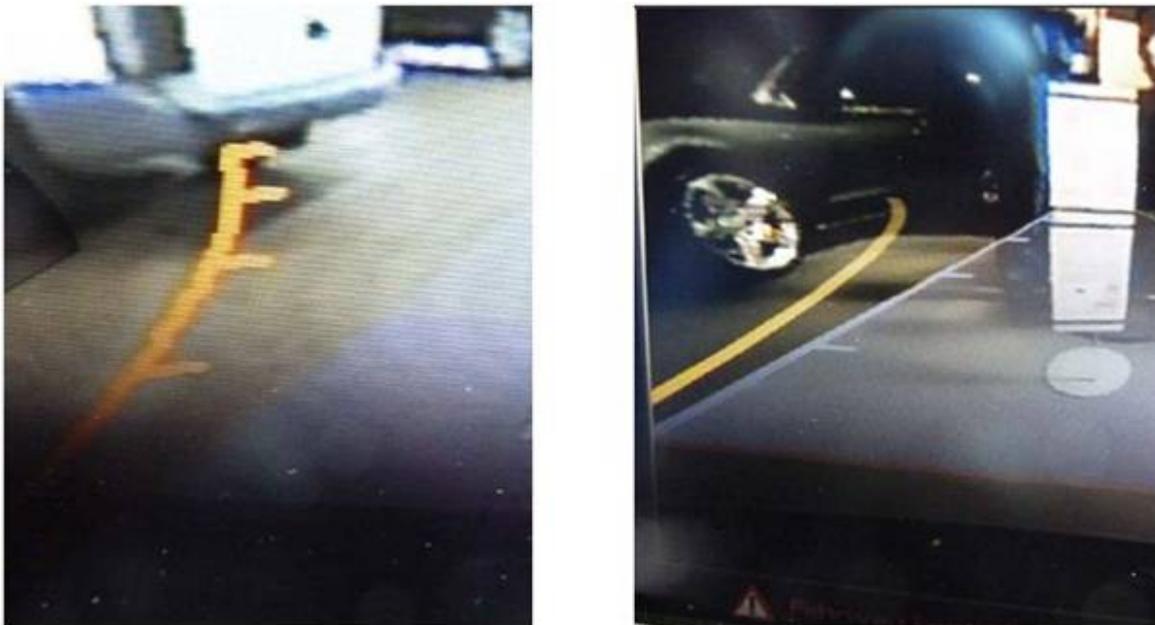
Explanation: In vehicles *without* the Peripheral View Camera (No Top View and No Corner View), the displayed guidelines are static images that are overlaid on the camera image in the MMI at different steering angles. On larger MMI screens, the lines appear pixelated because the image is expanded (Figure 3).

In vehicles *with* Peripheral View Camera (with Top View and Corner View), the lines are dynamically generated vector graphics, which are scaled and appear sharper (Figure 3).

Figure 3. Guide lines of a vehicle without Peripheral View Camera (left) and guide lines of a vehicle with Peripheral View Camera (right).
