# Technical Service Bulletin

## 96 Parking aid continuous tone comes on too early

96 15 96 2040471/1 April 23, 2015.

Model(s)	Year	VIN Range	Vehicle-Specific Equipment
A6	2015	000001 - 080777	S line and S6 models only

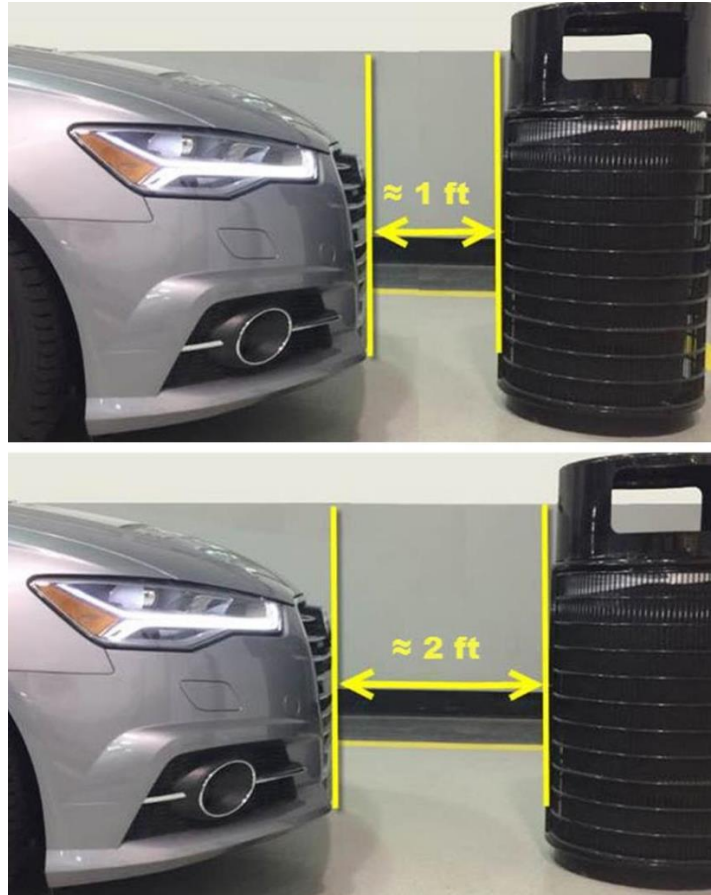
1. Confirm that the continuous parking aid warning tone begins too soon by first enabling the parking aid (or by driving in reverse so that the parking aid turns on automatically), then slowly driving the vehicle toward an object. Be sure to check with the vehicle moving both forward and in reverse.
2. Once the parking aid warning tone is continuous, park the vehicle and measure the distance to the object (Figure 1):
  - If the distance is approximately one foot, the system is working correctly and no repair is needed.
  - If the distance is approximately two feet, perform the SVM update below.

**Figure 1.** Vehicle parked at a distance of one foot (top) and at a distance of two feet (bottom).

1. Follow all instructions in the TSB 2011732: *00 Software Version Management (SVM), operating instructions*.
2. Update the vehicle electrical system control module, J519 (address word 09) using the SVM action code as listed in the table below if necessary.
