Technical Service Bulletin

97 Rear wiper motor inoperative

97 15 46 2040221/1 April 2, 2015.

Model(s)	Year	VIN Range	Vehicle-Specific Equipment
Q5	2010 - 2015	All	Not Applicable

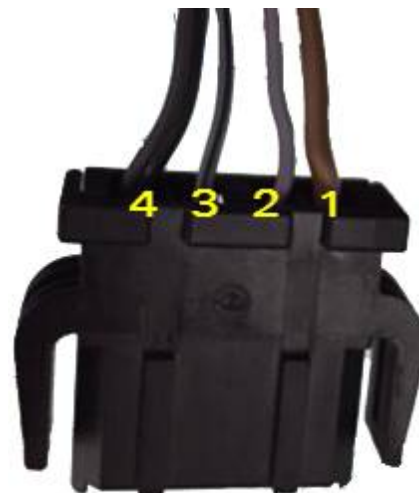
Figure 3. Rear wiper motor connector.

The voltage reading should show battery voltage (approximately 12.4V). If battery voltage is not found, continue diagnosis outside this TSB.

2. With key on, check voltage at pin 1 and pin 4 of the rear wiper motor connector (Figure 3 and Figure 4).

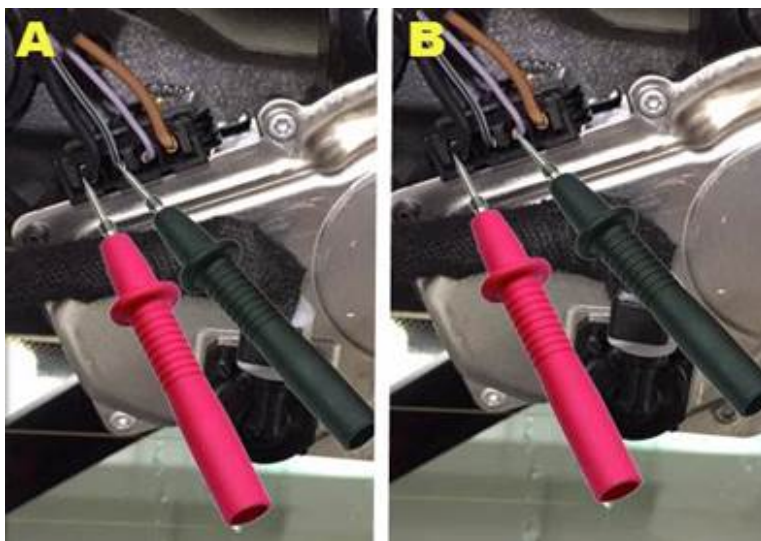
Figure 6. Compare voltage readings between pin 4 and pin 3 (A) and between pin 4 and pin 2 (B).

4. Compare the voltage readings between pin 4 and pin 3 with the voltage readings between pin 4 and pin 2 (Figure 6).
 - If the voltage reading between pin 4 and pin 3 is more than .5V DC when compared to pin 4 and pin 2, continue to the next step.
 - If the voltage readings are identical, continue diagnosis outside of this bulletin.

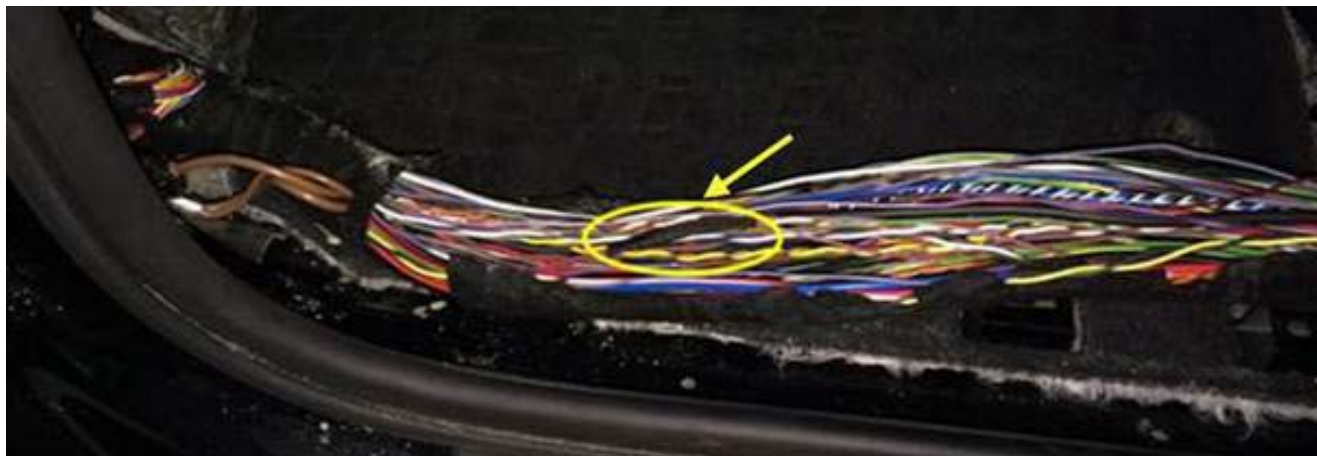
Figure 9. Access splice B538.

Corrosion at the B538 splice of the rear wiper motor control circuit can cause an excessive voltage drop, resulting in an out of range control signal

6. Open the wiring harness (Figure 8) to access splice B538 (Figure 9).

8. Use wiring harness repair kit VAS 1978B to repair the splice, then reassemble the wiring harness.

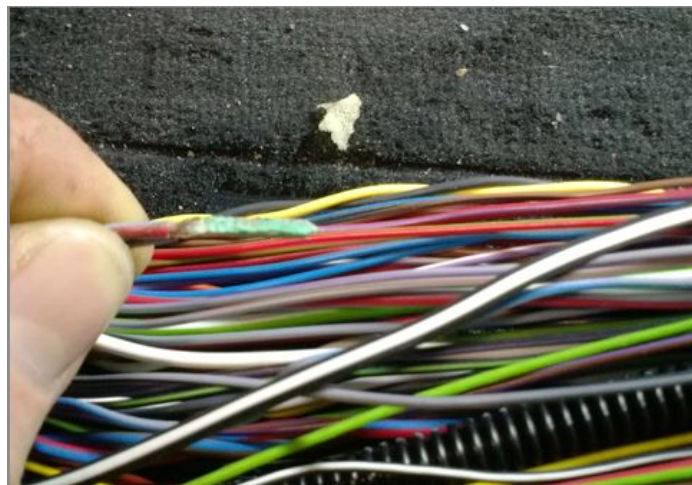
Figure 10. Example of corroded wire.

Tip: Utilize the proper connectors from the repair kit as the heat shrink will seal out future corrosion. The adhesive-lined inner layer will keep moisture out.
