Technical Service Bulletin

20 MIL on (DTC P045600 - EVAP system leak detected NVLD (very small leak))

20 15 45 2035073/8 May 6, 2015. Supersedes Technical Service Bulletin Group 20 number 14-43 dated December 19, 2014 for reasons listed below.

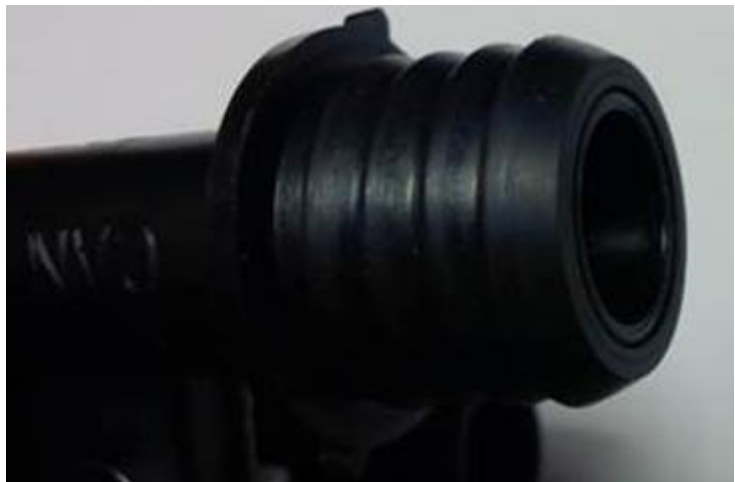
Figure 2. Align grommet and sensor outer edges.

- Align grommet and sensor outer edges (Figure 2).

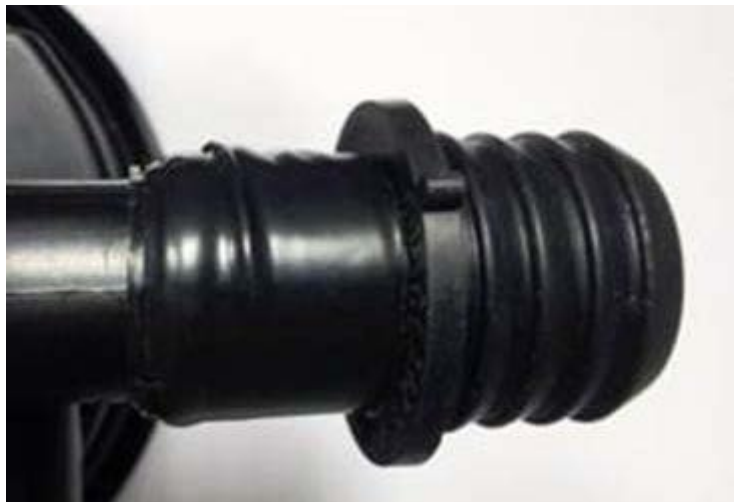
Figure 4. Vinyl layer supporting grommet.

- To aid installation, wrap several (~10) layers of vinyl tape behind the grommet to ensure that it does not slip during installation (Figure 3 and Figure 4).

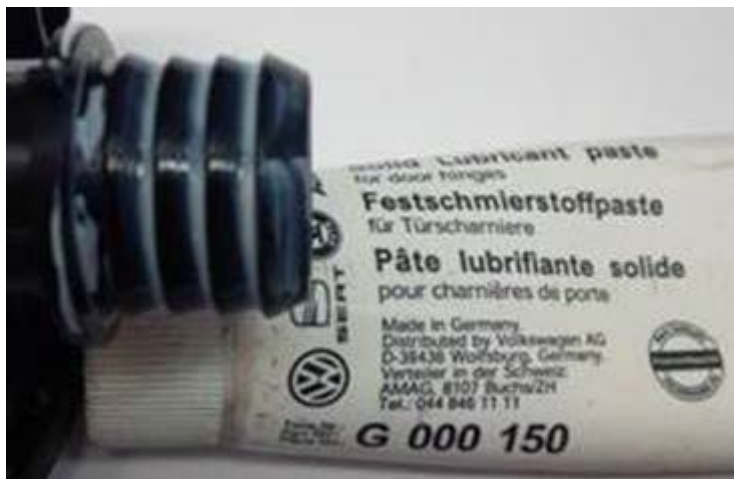
Figure 5. Grease film on outer surface of grommet.

- Apply a small amount of grease to create a film on the outer surface of the grommet before installing the sensor (Figure 5).

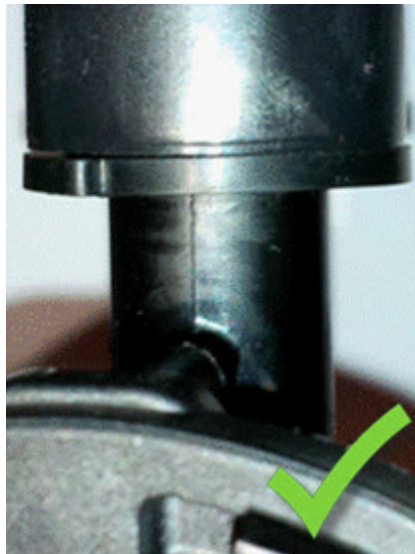
Figure 6. Correctly-installed sensor and grommet.

- When the sensor and grommet have been correctly installed, the grommet and canister will be flush (Figure 6). At this point, the vinyl tape can be removed (or it can be left in place).

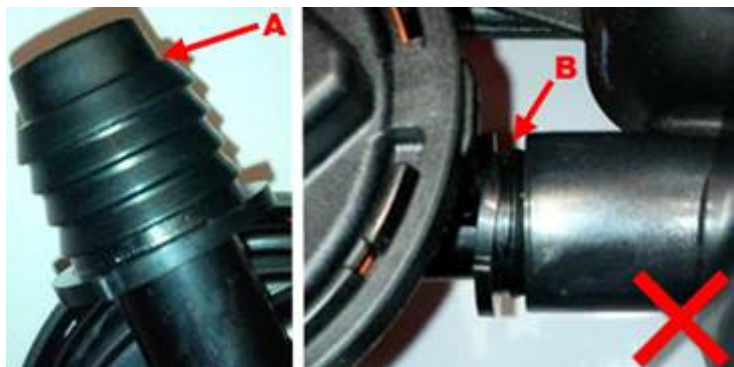
- An incorrectly-installed sensor and grommet (Figure 7) can cause an EVAP leak and repeat failures. Issues can occur when the NVLD switch is pressed too far into the canister, then pulled back out in an attempt to align the NVLD switch with the mounting holes. Do not apply any lubricant between the sensor and the grommet.

Figure 7. Plastic port extending past the grommet (A) causing installation issues (B).
