Technical Service Bulletin

20 MIL on (DTC P045600 - EVAP system leak detected NVLD (very small leak))

20 15 46 2035073/9 May 15, 2015. Supersedes Technical Service Bulletin Group 20 number 15-45 dated May 6, 2015 for reasons listed below.

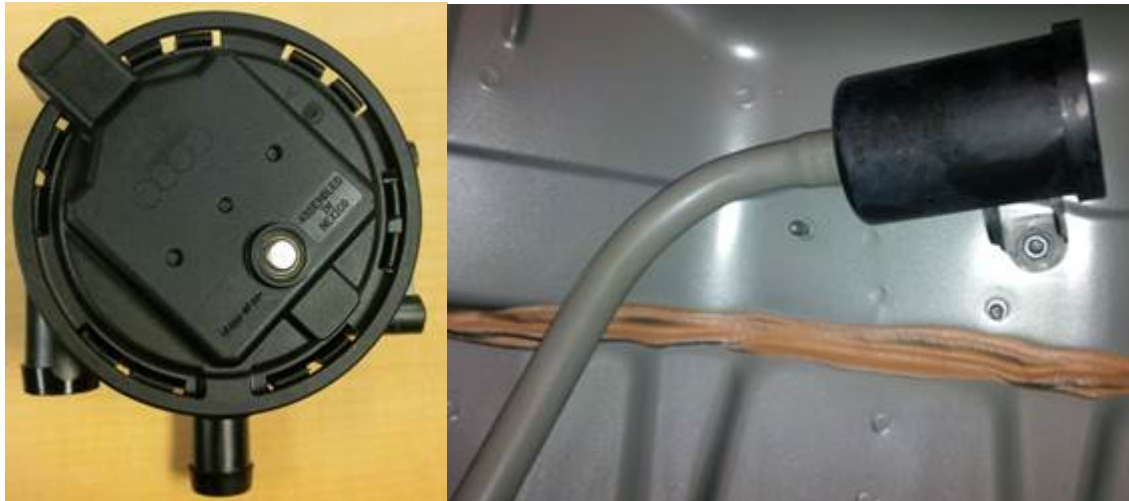
The NVLD pressure switch may erroneously detect a very small leak.

Figure 1. NVLD pressure sensor (left) and NVLD filter (right).

1. Ensure that **DTC P045600** (EVAP System Leak Detected NVLD (very small leak)) is stored in the engine control module (ECM), J623 (address word 01). If DTC P045600 is not present, this bulletin does not apply.
2. Replace the NVLD pressure sensor G400 and the NVLD filter with the latest part number available (Figure 1).

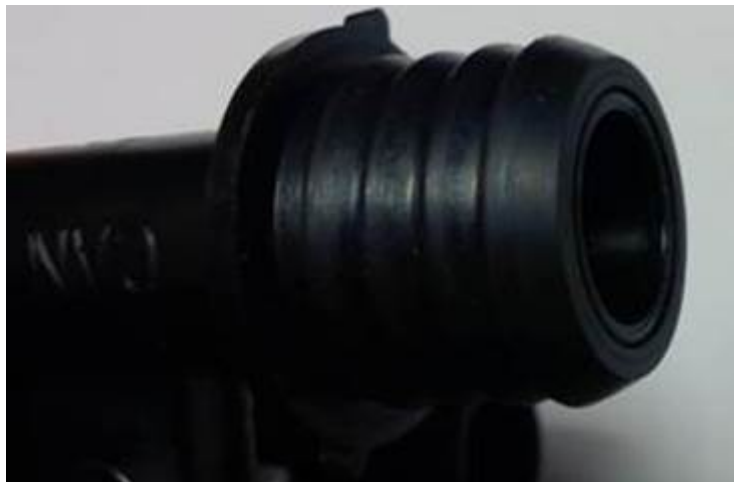
Figure 2. Align grommet and sensor outer edges.

- Align grommet and sensor outer edges (Figure 2).

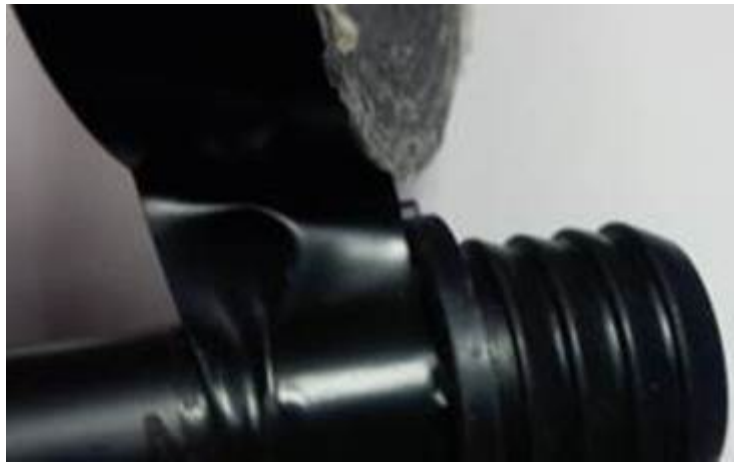
Figure 3. Wrapping vinyl tape behind the grommet.

- To aid installation, wrap several (~10) layers of vinyl tape behind the grommet to ensure that it does not slip during installation (Figure 3 and Figure 4).

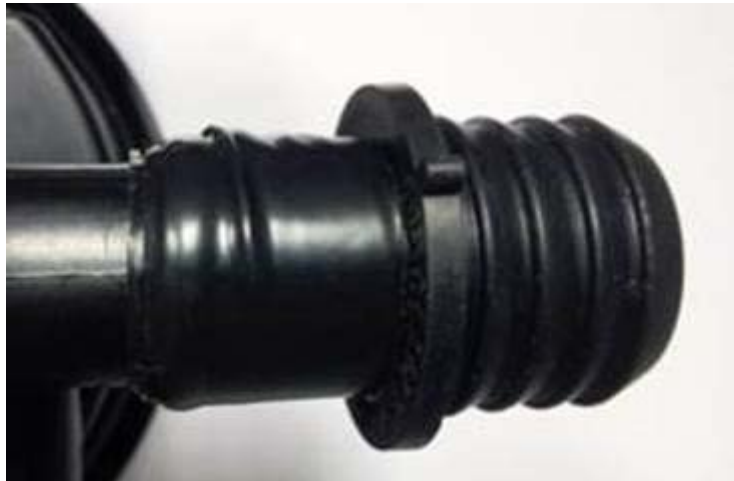
Figure 4. Vinyl layer supporting grommet.

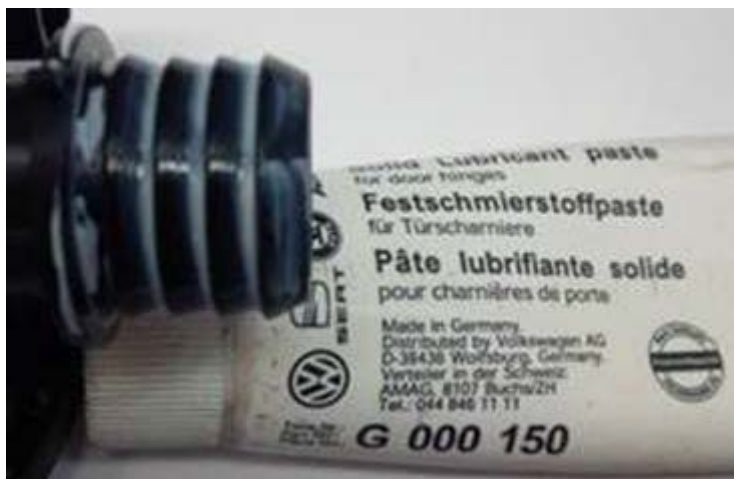
Figure 5. Grease film on outer surface of grommet.

- Apply a small amount of grease to create a film on the outer surface of the grommet before installing the sensor (Figure 5).

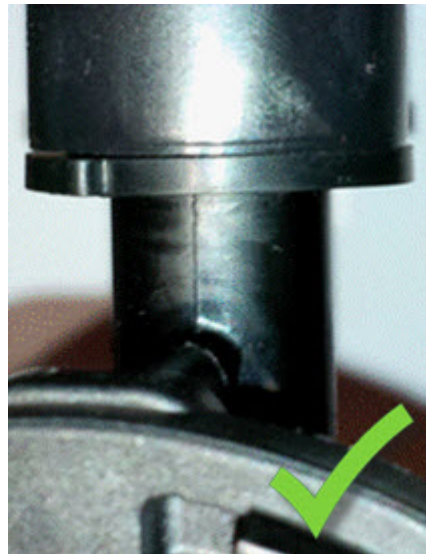
Figure 6. Correctly-installed sensor and grommet.

- When the sensor and grommet have been correctly installed, the grommet and canister will be flush (Figure 6). At this point, the vinyl tape can be removed (or it can be left in place).

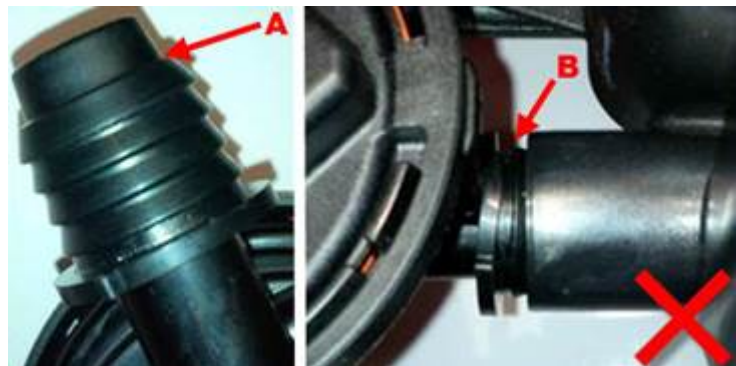
- An incorrectly-installed sensor and grommet (Figure 7) can cause an EVAP leak and repeat failures. Issues can occur when the NVLD switch is pressed too far into the canister, then pulled back out in an attempt to align the NVLD switch with the mounting holes. Do not apply any lubricant between the sensor and the grommet.

Figure 7. Plastic port extending past the grommet (A) causing installation issues (B).
