Technical Service Bulletin

90 Sporadically the ignition cannot be switched on

90 15 54 2040593/1 May 11, 2015.

Model(s)	Year	VIN Range	Vehicle-Specific Equipment
A6	2005 - 2011	All	Not Applicable
Q7	2007 - 2015	All	Not Applicable

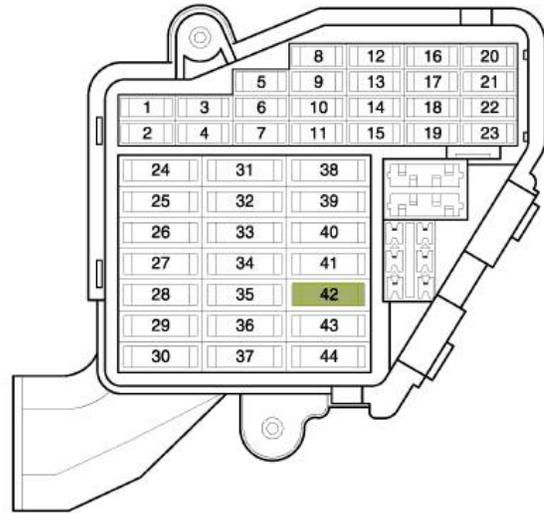
Figure 1. SB42 fuse location in A6 vehicles.

1. Reset the access/start authorization control module, J518 (address word 05), by removing and reinstalling the 30 power fuse for the control module:

- **For A6:** Remove green 30A fuse SB42 from fuse box instrument panel left (Figure 1). Reinstall the fuse after 30 seconds.
- **For Q7:** Remove green 30A fuse SB10 from fuse box instrument panel left (Figure 2). Reinstall the fuse after 30 seconds.

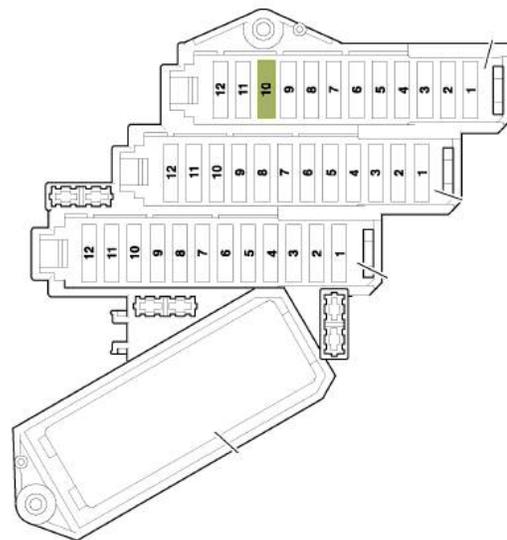
Figure 2. SB10 fuse location in Q7 vehicles.

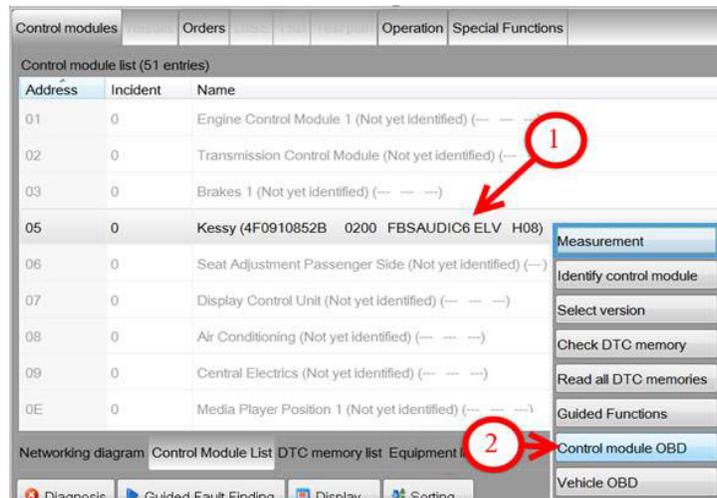
Figure 3. Right-click **Address 05** (1), then click **Control module OBD** (2).

2. Before proceeding, use ODIS to determine the hardware part number of the access/start authorization control module, J518 (address word 05):

- First, right-click **Address 05**, then click **Control module OBD** from the pop-up menu (Figure 3).
- Next, in the OBD functions menu, select **Identification**, then click **Perform** (Figure 4).
- Scroll to the bottom of the lower results window to see the software version and hardware part number (Figure 5).

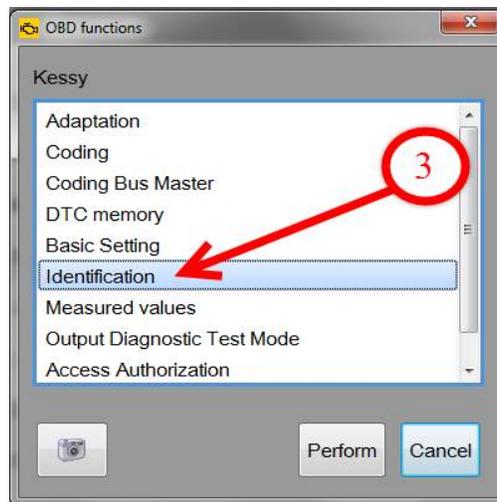
Figure 4. In the OBD functions menu, select **Identification** (3), then click **Perform**.

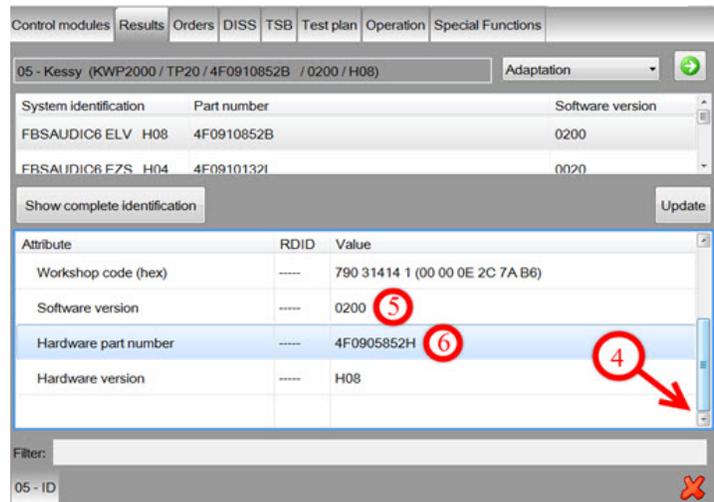
Figure 5. Bottom of lower results window (4) showing software version (5) and hardware part number (6).

3.
 - **For model year 2009 - model year 2014 vehicles:**
Perform SVM update with code 05A005, following the instructions below.
 - **For model year 2005 - model year 2008 vehicles:**
 - If the hardware part number is 4F0905852D, 4F0905852E, 4F0905852F, or 4F0905852H, perform SVM update with code 05A005, following the instructions below.
 - If the hardware part number is not listed above, do not perform the SVM update. Proceed to step 4.
