Technical Service Bulletin

91 MMI 3G+ Various technical Issues (K0814 ZUG update; supersedes K0715 update)

91 15 83 2030465/7 May 8, 2015. Supersedes Technical Service Bulletin Group 91 number 13-07 dated September 12, 2013 for reasons listed below.

Model(s)	Year	VIN Range	Vehicle-Specific Equipment
All	2011 - 2015	All	MMI3G+

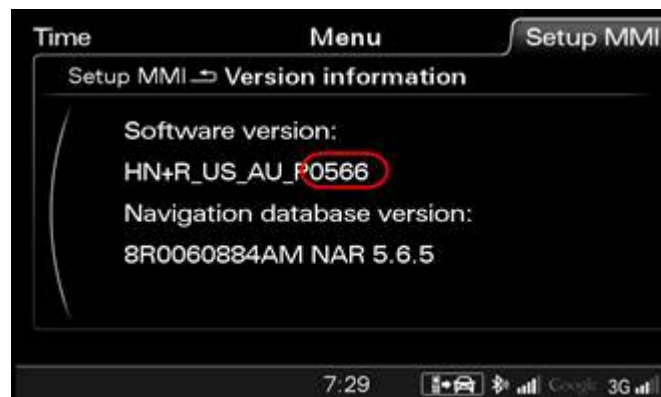
Tip: The MMI software version can be found under *Menu >> Setup MMI >> Version Information* (Figure 1).

Figure 1. MMI software version (566).

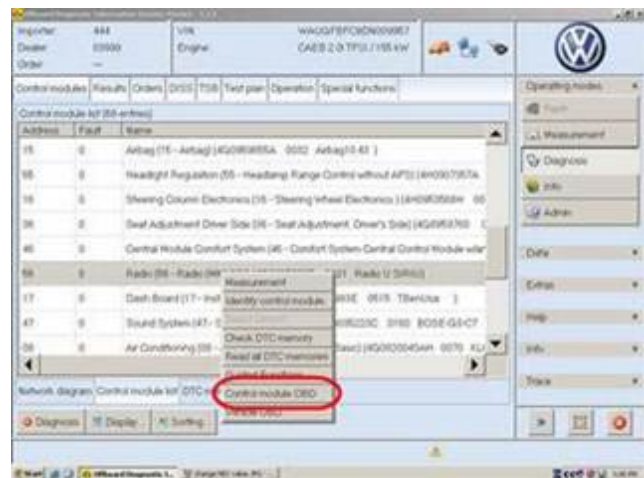
Figure 2. Radio self-diagnosis.

1. Verify the HD radio is enabled in the MMI by navigating to *Radio >> Settings*.
 - If the HD radio options are present in the MMI menu, proceed directly to Step 6.
 - If the HD radio options are not present in the MMI menu, continue with Step 2.
2. Using ODIS, right-click on 56 – *Radio* in the Control module list, and select *Control Module OBD* (Figure 2).

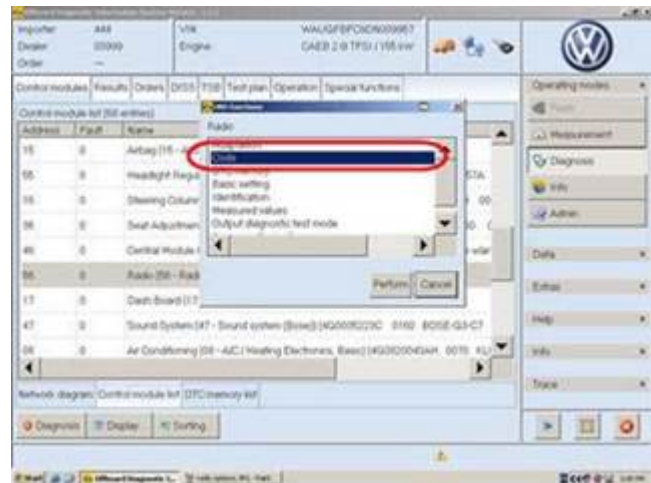
Figure 3. Code radio option.

3. Select *Code* (Figure 3).

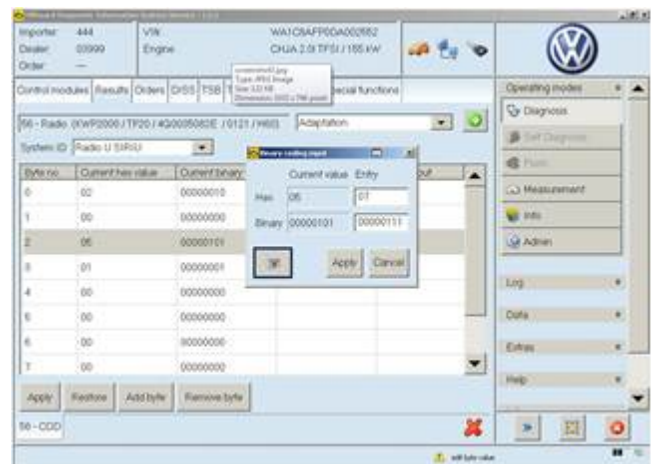
Figure 4. Changed radio coding.

4. Verify the coding in byte 2 is HEX 07.

- If it is not HEX 07, change the coding to HEX 07. Apply changes (Figure 4).

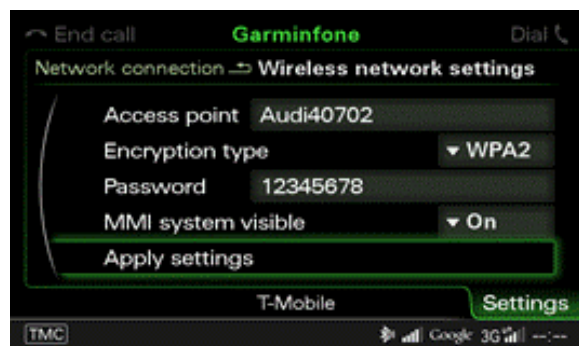
Figure 5. Wireless network settings.

6. As part of the update, wireless settings and paired devices will be deleted. All devices will need to be re-paired after the update, and all wireless settings restored to the customer's settings. To access the Wireless network settings on the MMI (Figure 5), press *TEL >> Settings >> Wireless network connection >> Wireless network settings*. Record all settings so they can be re-entered at the end of the update.

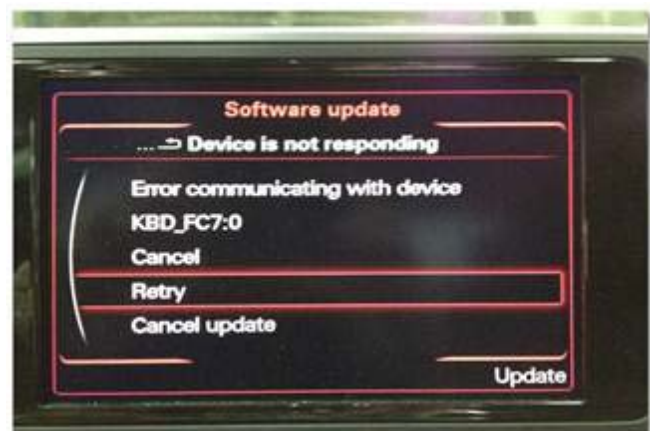
Figure 6. A device requiring a 'Cancel' selection.

Some earlier model year 2012 vehicles, or vehicles equipped with Bose® sound systems may experience certain modules that will not update properly during Step 16 of TSB 2028141. If this should occur, either choose 'Cancel' (Figure 6), or 'Skip device' (Figure 7), depending on the type of error. Do *not* choose 'Cancel update', as this may cause the software update to fail entirely. After the update is finished and the summary page is shown, select 'Retry' at the bottom of the list if it is available to attempt to update the modules again. If 'Retry' is greyed out, then the software update was successful. Select 'Continue' to proceed. In some cases 'Retry' may have to be repeated two or three times to get all modules to update successfully.

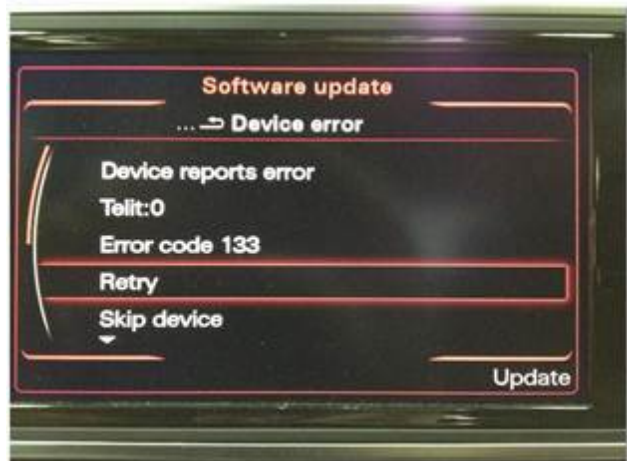
Figure 7. A device requiring a 'Skip device' selection.

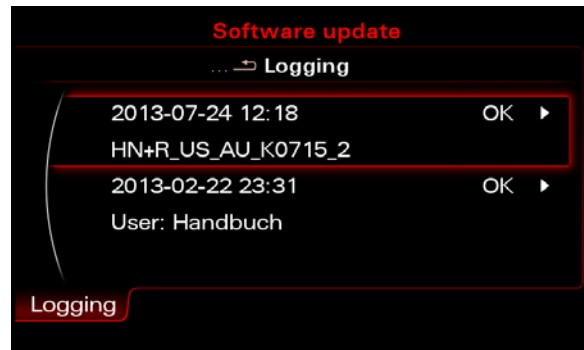
Figure 8. Software update log showing a successful software installation.

- Verify that the software update has been completed successfully by accessing the logging page (Figure 8). To access this screen, proceed to step 8 in TSB 2028141 and press the lower left softkey. A successful update will show the date the update was performed and the software that was installed (HN+R_US_AU_K0715_X), with 'OK' listed on the right. The 'X' may be one of several different numbers. If K0715_X does not have any rows with 'OK', the update must be retried until it is successful.

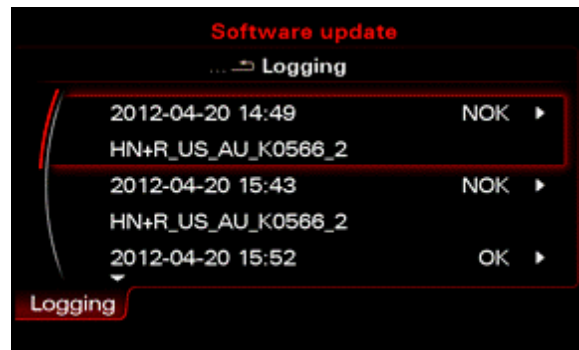
Figure 9. Software update log showing 2 failed attempts before a successful installation.

Tip: If the update must be performed two or more times due to modules not updating correctly, a screenshot of the software update log is required (Figure 9). This should be kept on-hand for warranty auditing purposes. To take a screenshot, insert an SD Card into slot 1. For A6/A7/A8/Q7, press and hold the left and right arrow keys at the same time. For A4/A5/Q5, press and hold the bottom two softkeys at the same time. All 4 softkeys will flash when the screenshot is taken. A screenshot should be taken of each page in the logging display.
