Technical Service Bulletin

91 MMI3G+ Audi Connect only reaches 2G service - Telephone module replacement instructions for A6 & A7

91 15 85 2039515/2 May 15, 2015. Supersedes Technical Service Bulletin Group 91 number 15-75 dated March 3, 2015 for reasons listed below.

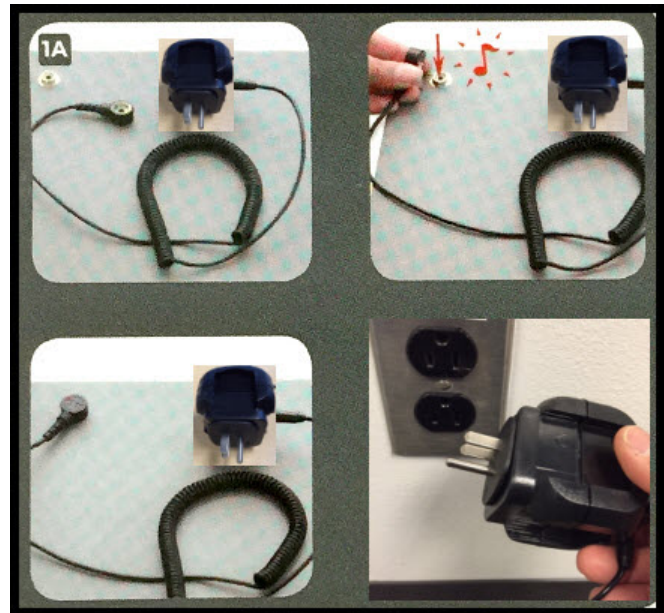
Figure 2. VAS6613 ESD work surface grounding plug.

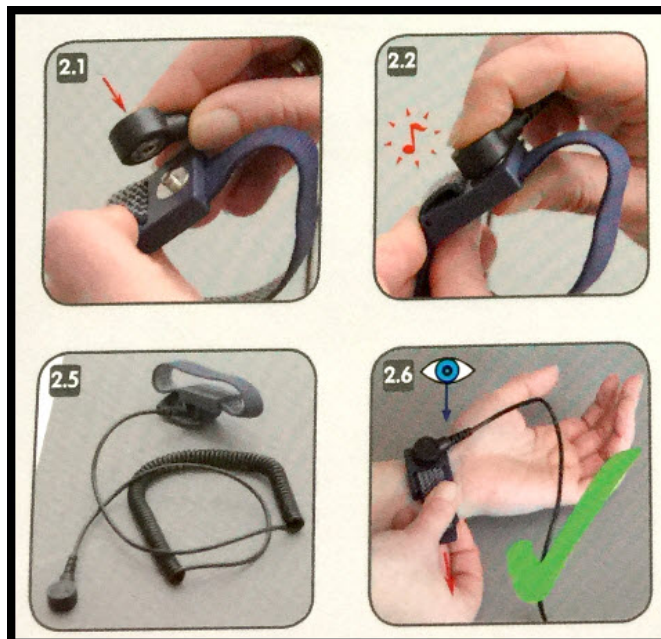
Figure 3. VAS6613 ESD work surface grounding wrist strap.

5. Ground yourself by placing the elastic strap around your wrist. Make sure it is securely touching your skin. It cannot be loose-fitting or over your shirt cuff (Figure 3).

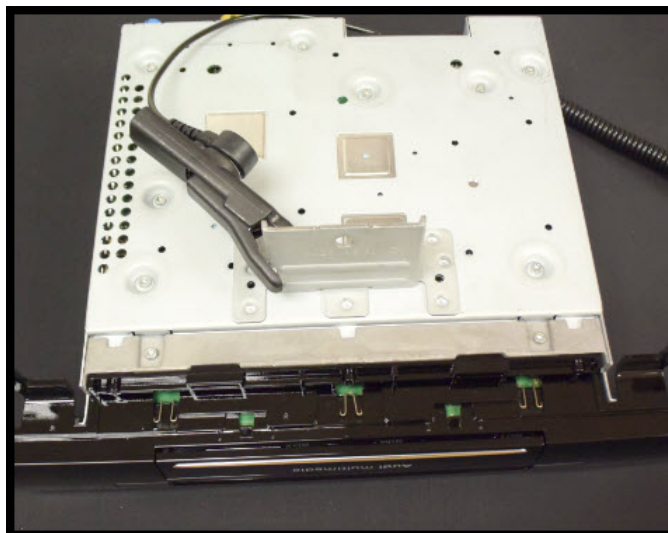
Figure 4. VAS6613 ESD work surface grounding device clip.

6. Ground the MMI main unit by placing an alligator clip on the back, ensuring that it makes contact with the metal housing of the main unit. The most secure location is at the bottom of the metal bracket (Figure 4).

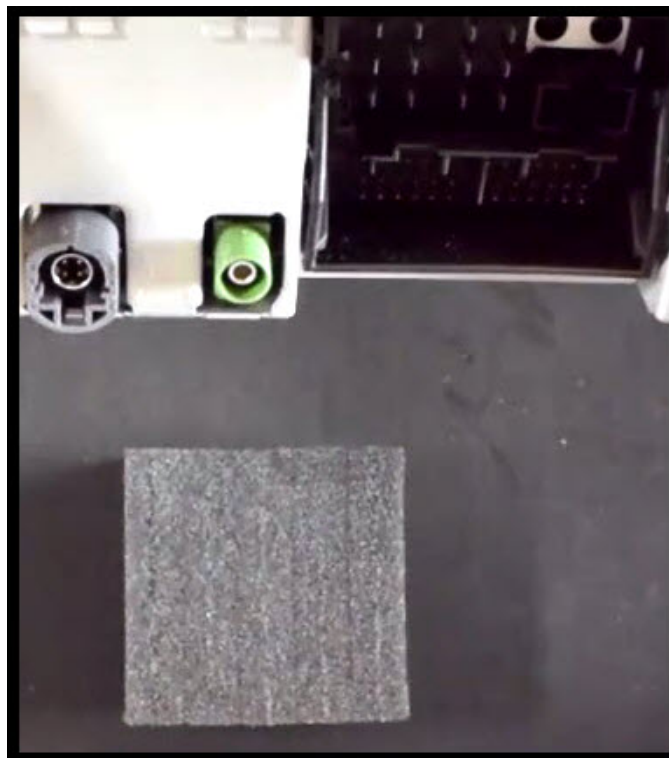
Figure 5. Foam block used as a spacer under the main unit.

A foam block can be used as a spacer under the main unit to keep the grounding strap connected (Figure 5).

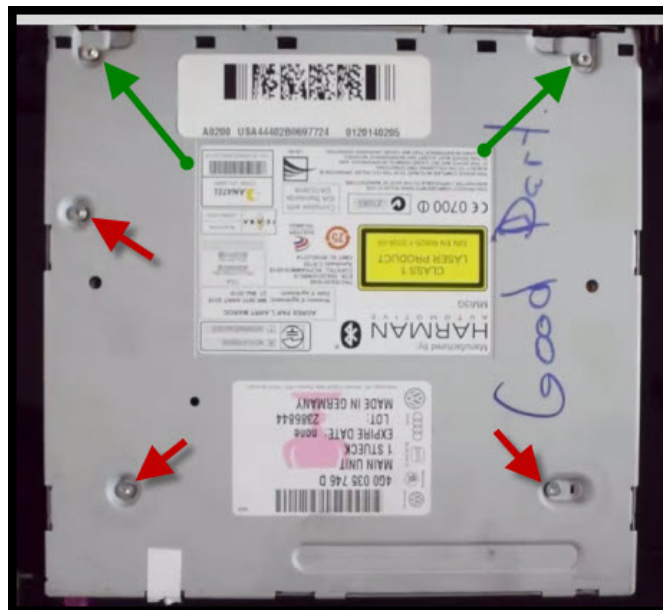
Figure 6. MMI main unit with screw locations for top cover.

7. Start by touching the screw driver to the ESD mat to discharge any static that may be built up in the tool. Next, remove the five screws that are holding the MMI top cover in place. The two screws near the faceplate (Figure 6, green arrows) are longer than the others, have thread lock on them, and may require extra effort to remove. Keep these screws separated from the others at all times.

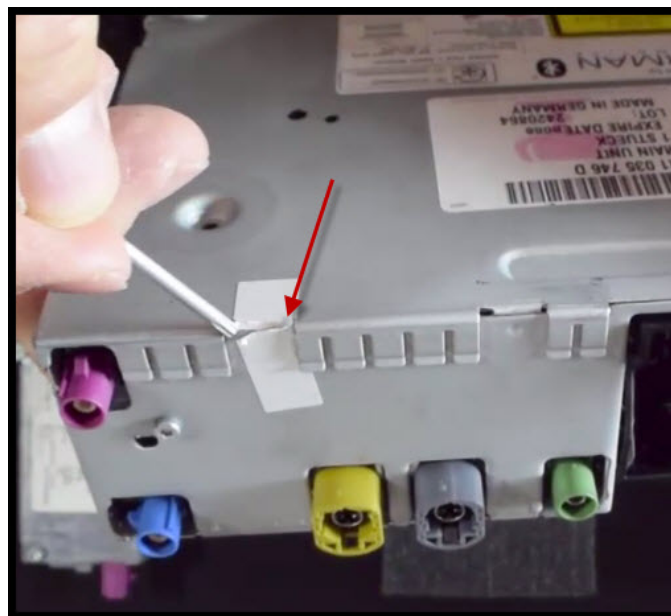
Figure 7. Break the white warranty seal.

8. Break the white warranty seal on the back of the main unit (Figure 7).

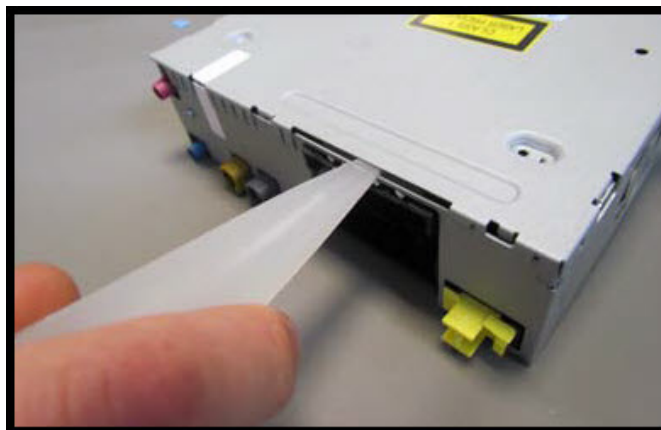
Figure 8. Pry to cover off using plastic trim wedge tool.

9. Using a flat head screw driver, your fingers or a plastic wedge trim tool, remove the top cover by prying it from the back of the cover at the location seen in Figure 8. If a flat head screw driver is used then touch the tool to the ESD mat to discharge the tool prior to touching the main unit.

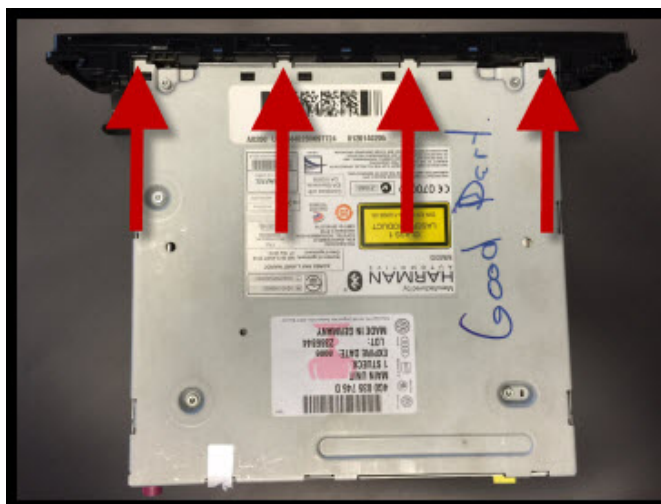
Figure 9. Top cover metal tabs indicated by the red arrows.

The top cover of the main unit has four metal tabs that are slotted into the plastic front face plate (Figure 9). Slightly lift on the rear of the cover and pull back on the cover until the metal tabs are released. Lift up on the cover and pull it away from the face plate at the same time to prevent bending the top cover's metal tabs (Figure 10). If the metal tabs bend during this process, straighten them with a pair of pliers.

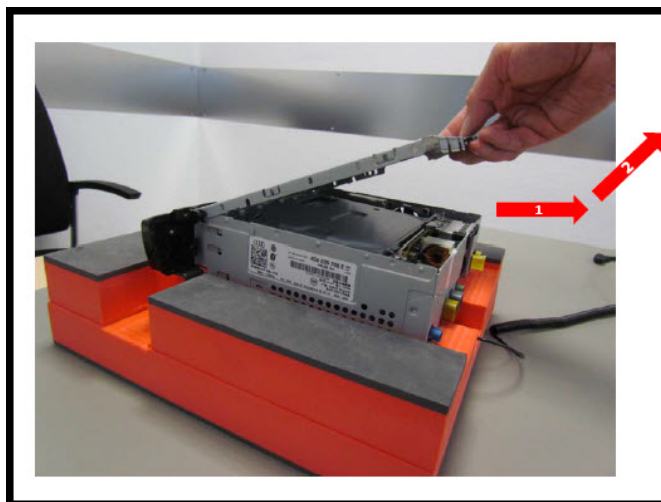
Figure 10. Pull up and back to prevent damaging the faceplate slots (Note: the orange/black holder is not required).

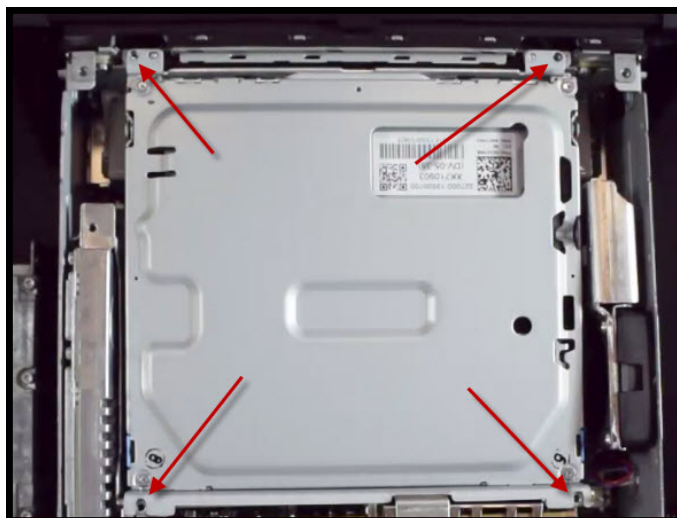
Figure 11. CD drive mounting points are now free.

Do not flip the main unit over at this point. The CD drive, which was held in place by the top cover screws, is no longer secured. If it moves significantly, the ribbon cable can detach from the circuit board and disable the CD drive's functionality (Figure 11).

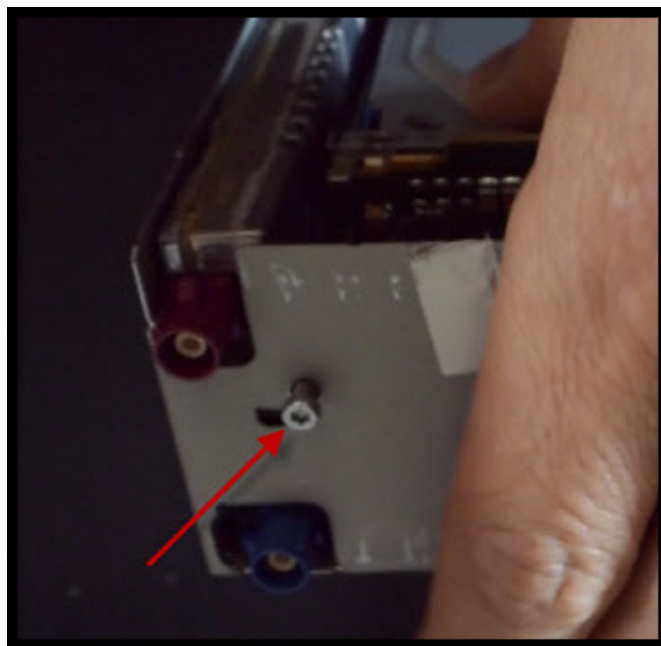
Figure 12. Telephone module retaining screw indicated by the red arrow.

10. On the back of the main unit, remove the retaining screw that holds the telephone module in place (Figure 12).

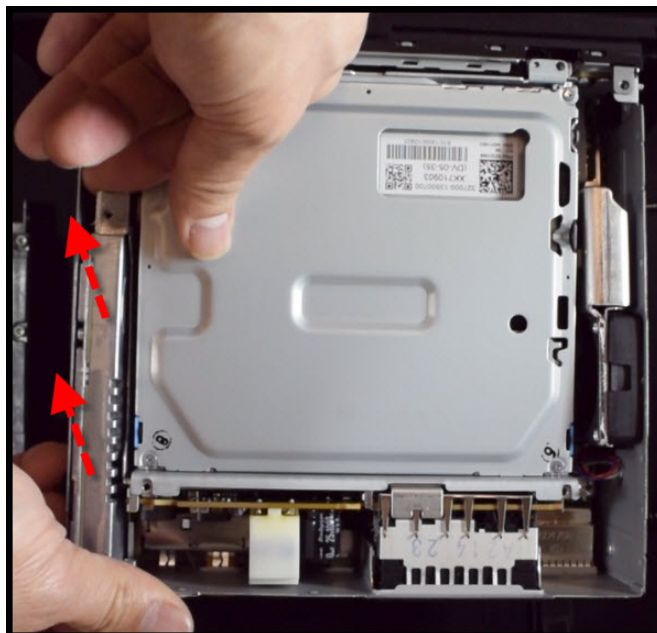
Figure 13. Lift up on both ends of the telephone module as indicated by the red arrows.

11. Carefully lift up the telephone module, using both ends as points of contact when pulling up (Figure 13). The module is held in place with a computer socket-type attachment and will release when enough force is used.

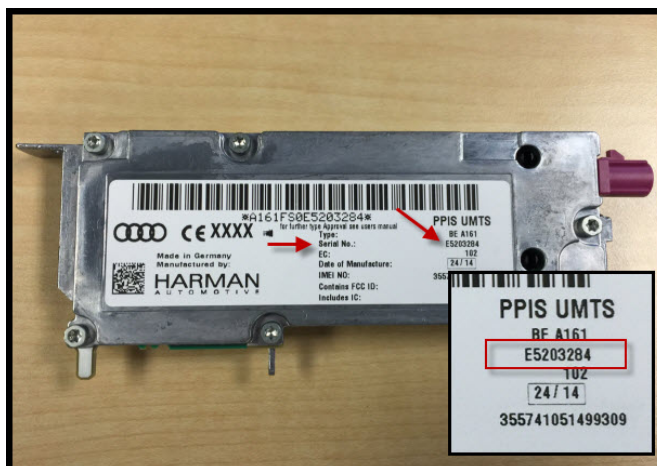
Figure 14. Serial number of the PPIS UMTS telephone module indicated by the red arrows and red box.

12. Before proceeding, write down the serial number of the new replacement UMTS telephone module (Figure 14).

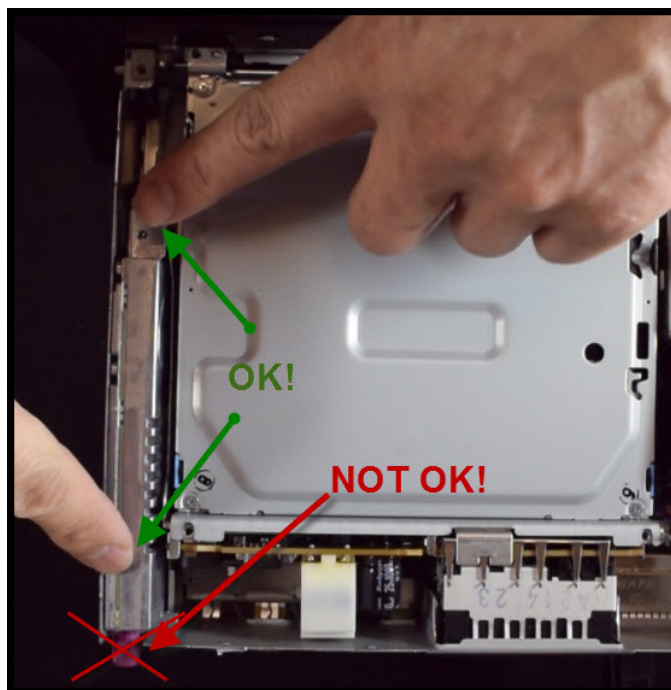
Figure 15. Do not press down using the purple FAKRA connector.

13. Place the new UMTS telephone module into the socket, making sure it is level before snapping it into place. Use both ends of the telephone module when pressing it into place. Do not press down using the purple FAKRA connector (Figure 15).

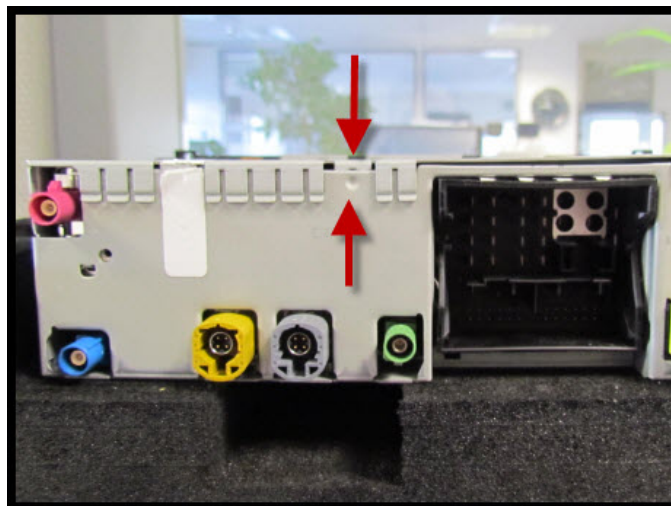
Figure 14. Place the new warranty seal over the location indicated by the red arrows.

17. Place the new warranty seal from the retrofit kit next to the original warranty seal (Figure 14).

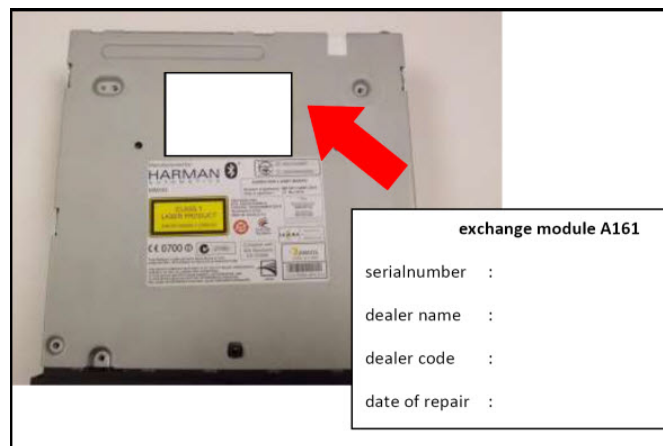
Figure 15. The white area indicates the suggested location for the repair label on the top cover of the main unit. Do not cover any existing part number labels or the laser warning.

18. Place the repair label on the top of the main unit cover. Do not cover any part number label with the repair label and do not cover the yellow laser warning (Figure 15). Fill out all fields on the repair label.
