Technical Service Bulletin

91 MMI3G+ Audi Connect only reaches 2G service - Telephone module replacement instructions for A4,A5,A5 cab,Q5,Q7,A8

91 15 86 2039476/2 May 15, 2015. Supersedes Technical Service Bulletin Group 91 number 15-76 dated March 3, 2015 for reasons listed below.

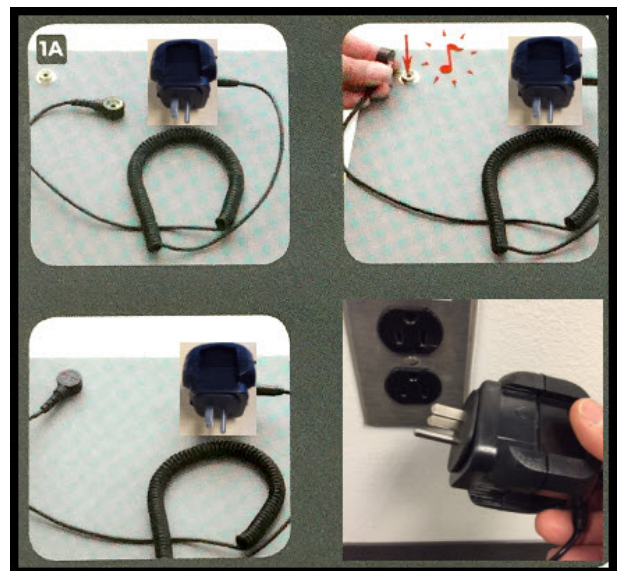
Figure 2. VAS6613 ESD work surface grounding plug.

3. Place the ESD anti-static mat onto the surface. Ensure that all three grounding straps are securely strapped to the ESD mat.
4. Ground the ESD mat by plugging the 110V grounding strap into a wall socket or power strip (Figure 2). If a power strip is used, it must be plugged into a grounded wall outlet. (See attached user instructions for VAS6613 titled "VAS6613 ESD Workspace Guide.pdf".)

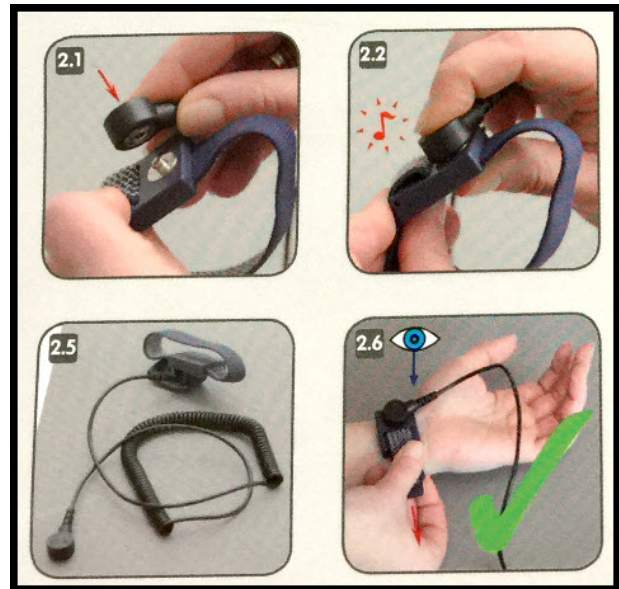
Figure 3. VAS6613 ESD work surface grounding wrist strap.

5. Ground yourself by placing the elastic strap around your wrist. Make sure it is securely touching your skin. It cannot be loose-fitting or over your shirt cuff (Figure 3).

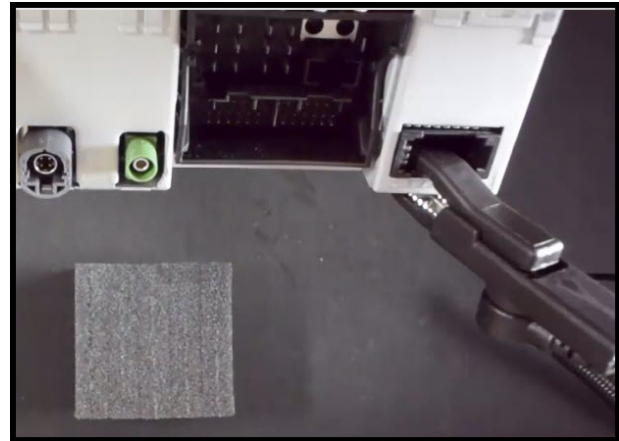
Figure 4. VAS6613 ESD work surface grounding device clip.

6. Ground the MMI main unit by placing an alligator clip on the back, ensuring that it makes contact with the metal housing of the main unit. The most secure location is at the MOST connector (Figure 4).

A foam block can be used as a spacer under the main unit to keep the grounding strap connected.

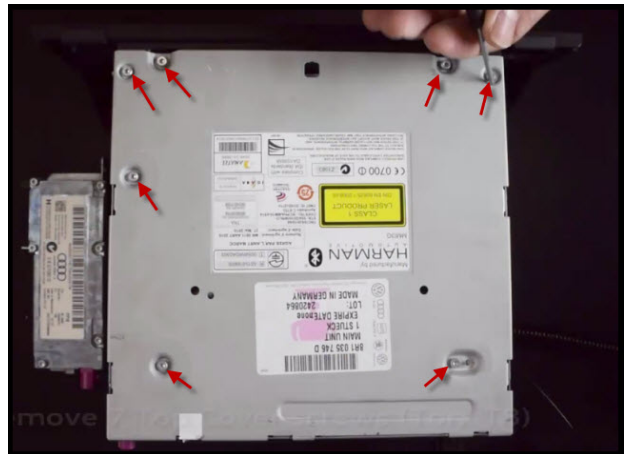
Figure 5. MMI main unit with screw locations for top cover indicated by the red arrows.

7. Remove the seven screws that are holding the MMI top cover in place (Figure 5).

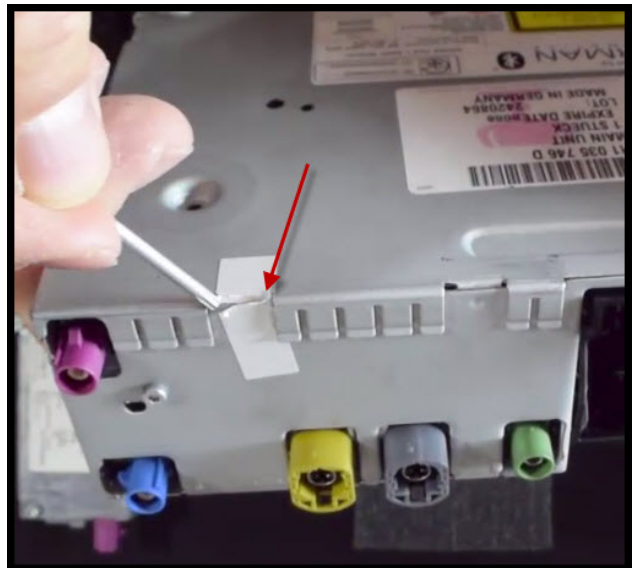
Figure 6. Break white warranty seal.

8. Break the white warranty seal on the back of the main unit (Figure 6).

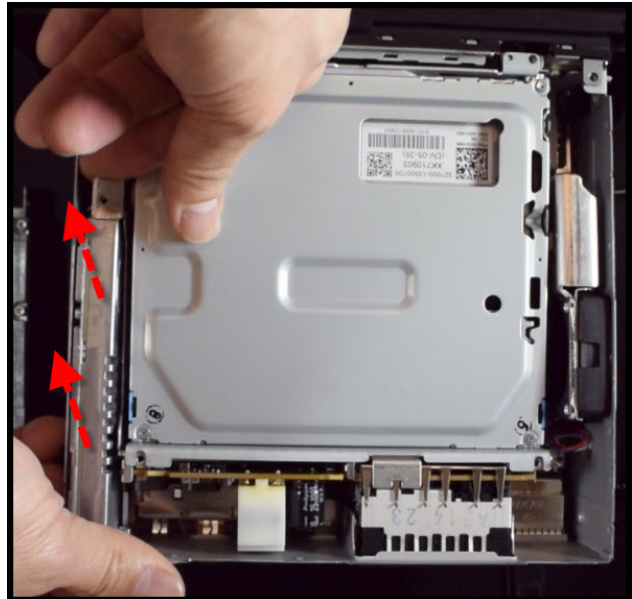
Figure 11. Lift up on both ends of the telephone module as indicated by the red arrows.

11. Carefully lift up the telephone module, using both ends as points of contact when pulling up (Figure 11). The module is held in place with a computer socket-type attachment and will release when enough force is used.

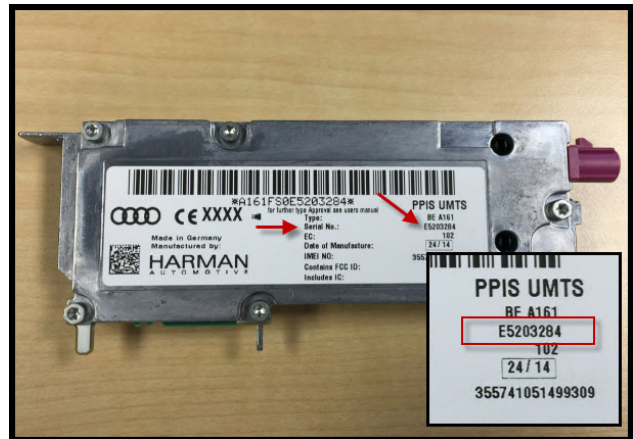
Figure 12. Serial number of the PPIS UMTS telephone module indicated by the red arrows and red box.

12. Before proceeding, write the serial number of the new replacement UMTS telephone module on the rework label (Figure 12).

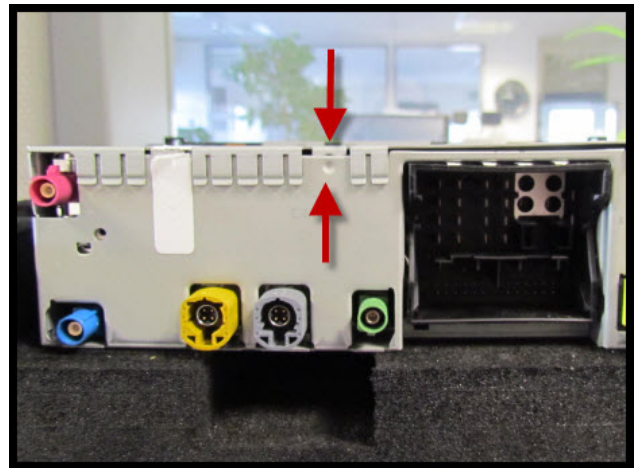
Figure 14. Place the new warranty seal over the location indicated by the red arrows.

17. Place the new warranty seal from the retrofit kit next to the original warranty seal (Figure 14).

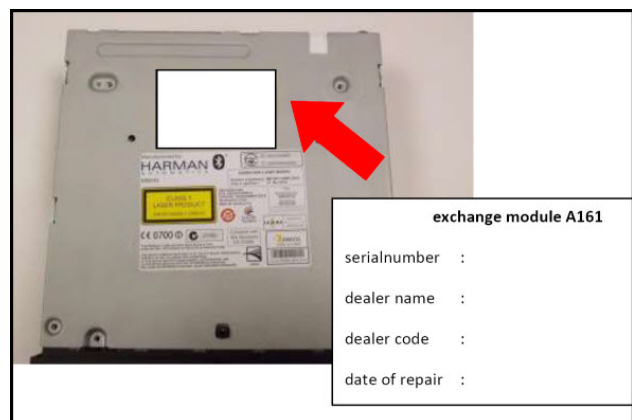
Figure 15. The white area indicates the “suggested” location for the repair label on the top cover of the main unit. Do not cover any existing part number labels.

18. Place the rework label on the top of the main unit cover. Do not cover any part number labels (Figure 15). Fill out all fields on the repair label.

Do not cover the yellow laser warning label. The repair label may need to be placed on sideways due to space limitations.
