Technical Service Bulletin

91 MMI3G+ GPS navigation location inaccurate or navigation takes a very long time to acquire location

91 15 87 2040406/1 May 18, 2015.

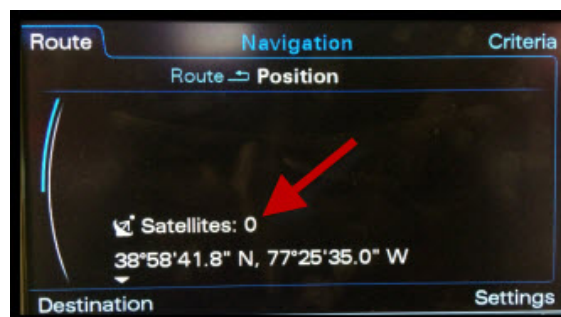
- When the vehicle is started, the GPS location or vehicle direction indicated on the MMI navigation map does not match the vehicle's actual location or direction of travel for a long period of time (often as long as 10 minutes):
 - The issue occurs in open sky, with no large buildings obstructing the sky view.
 - The issue is intermittent, but it can occur for long periods of time during a single day.
 - The issue typically happens on very warm days when the HVAC system blower is at a medium to high setting (auto or manual), with air being directed out of the panel vents.
 - When the issue occurs, the GPS navigation system satellite reception shows 0 satellites. Due to the infrequency of the issue, this might not be verifiable. (To view the number of satellites being received, go to *Nav >> Route >> Select Current Position* (first item in list) and scroll up (Figure 1)).

Figure 1. No satellite reception.

A potential failure in the internal hardware of the MMI main unit can cause the GPS signal to be blocked, even if good reception is available. The failure can happen at start-up or while the vehicle is being driven. The issue typically starts when the vehicle is driven on curvy or circular roads, driven in circles (such as when driven around a parking lot), or driven on or off an expressway.

1. Replace the MMI main unit (infotainment control unit 1), J794 (address word 5F).
2. Update the MMI software using ZUG K0814 (see TSB 2030465: *91 MMI 3G+ Various technical Issues (K0814 ZUG update; supersedes K0715 update)*).
3. Perform the required SVM feedback according to the instructions in TSB 2030465. The required SVM code is included in the ZUG K0814 update medium.
4. Using Guided Fault Finding, perform the replacement test plan for the MMI main unit (infotainment control unit 1), J794 (address word 5F).
