Technical Service Bulletin

97 Multiple warning lights illuminated; communication error DTCs

97 15 47 2034945/3 May 6, 2015. Supersedes Technical Service Bulletin Group 97 number 13-40 dated November 26, 2013 for reasons listed below.

Model(s)	Year	VIN Range	Vehicle-Specific Equipment
Q7	2010 - 2015	All	Not Applicable

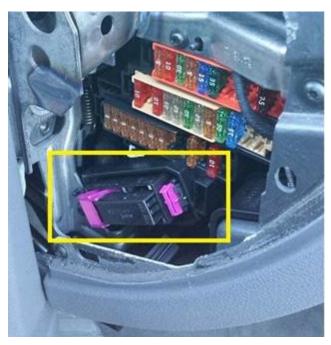
There is sporadic data disruption on the CAN bus wiring behind the dashboard, between the left (T46a) and right (T46b) 46-pin CAN disconnect plugs.

Figure 1. T46a CAN disconnect plug, left dashboard.

- 1. Upload GFF paperless log showing communication DTCs as described in the complaint.
- 2. Overlay new CAN twisted pair wiring behind the dashboard, between the two 46-pin CAN disconnect plugs (T46a/1H <-> T46b/1H and T46a/1L <-> T46b/1L) (Figure 1 and Figure 2).

3. Replace the terminals with the VAS1978B repair kit.

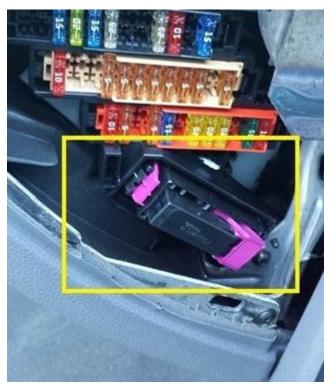
Figure 2. T46b CAN disconnect plug, right dashboard.
