Service Action Campaign – U.S. ONLY

Code: 20U3

**Subject: 2010-2012 Model Year Audi A3 with TDI® Clean Diesel Engine
Install Misfueling Guard**

May 29, 2015

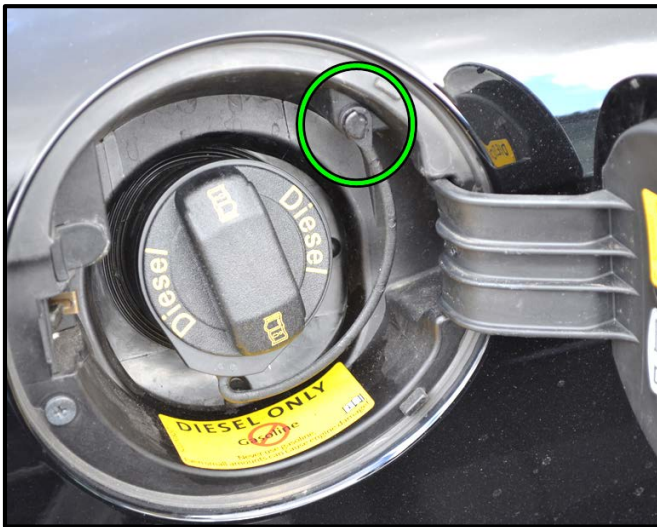
⇐ Insert the retaining ring into the filler neck <arrow>.

- The ring will lock into place at both the 9 o'clock and the 3 o'clock positions when fully seated against the lockout mechanism.
