ROADSTER 2013 Special Repair Needed at PDI - 40182

A very limited quantity of vehicles may have been produced with incorrectly routed electrical wires and brake lines.

Re: Model Year 2013 Can-Am™ Spyder - Special Repair Needed at PDI

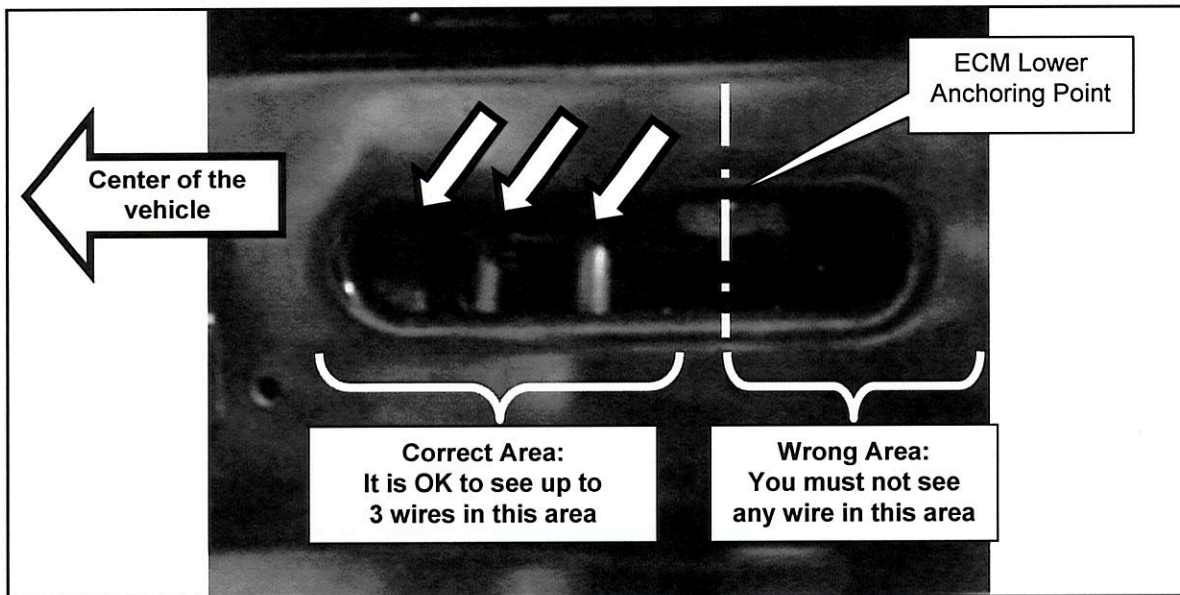
You may see up to 3 wires between the ECM lower anchoring point and the center of the vehicle.

- Red positive cable with corrugated over it
- Regulator/rectifier wires (2) protected by harness tape
- Large black ground cable

Correct Routing	Wrong Routing
<ul style="list-style-type: none"> • Up to 3 wires are visible in the correct area • Each visible wire can be moved slightly with fingers (side-to-side) 	<ul style="list-style-type: none"> • One or more wire is visible in the Wrong Area • One or more wire can not be moved slightly from side-to-side with fingers (must not feel pinched)
<p>No correction needed: reassemble fuse box</p>	<p>Solution: Reroute wire(s), or replace damaged/pinched wire(s).</p>
