Technical Service Bulletin

19 Coolant warning light on, coolant level close to or below minimum

19 15 56 2039777/2 February 26, 2015. Supersedes Technical Service Bulletin Group 19 number 15-54 dated February 13, 2015 for reasons listed below.

Model(s)	Year	VIN Range	Vehicle-Specific Equipment
A3	2015	All	Not Applicable

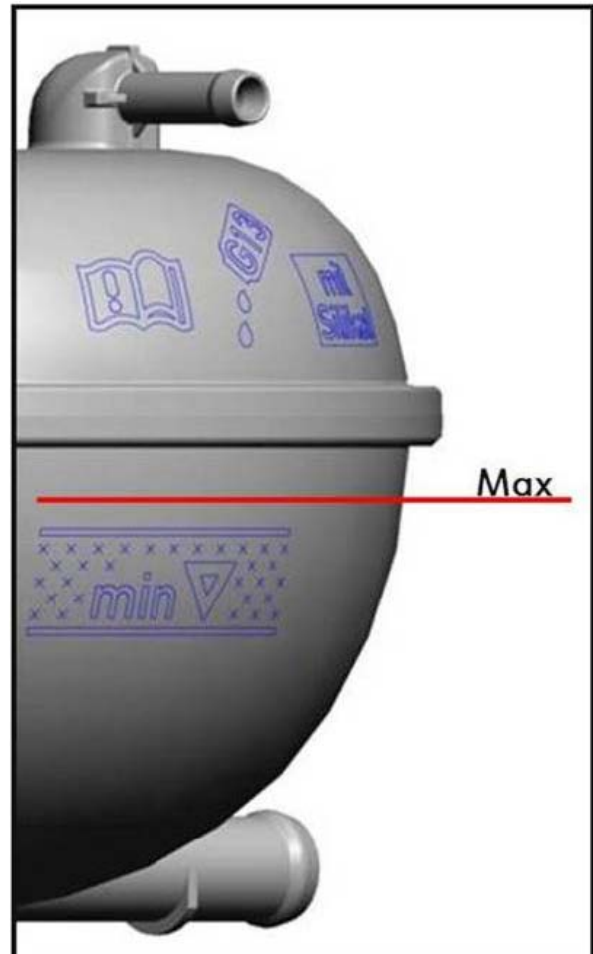
- The coolant temperature warning light is on.
- The coolant level in the coolant expansion tank is close to or below minimum.
- The customer had to top off the coolant several times.

Air gets into the cooling system during production or when refilled during previous repairs. As this air escapes, the coolant level in the coolant expansion tank can drop below the minimum. A drop of the coolant level because of air in the system is possible even after the vehicle has exceeded 15,000 miles. Because of the remaining air, the coolant level can drop a few times.

Figure 1. Coolant fill level.

1. Double-check the cooling system to ensure that there are no leaks causing the condition. Use the instructions in the Elsa repair manual:
 - If no leak is found, top off the coolant level to the mark (Figure 1). No repair is necessary. Explain the *Technical Background* to the customer.
 - If a leak is found, repair the cooling system according to the repair manual.
