Technical Service Bulletin

94 Xenon headlights are adjusted too low

94 15 62 2032852/3 February 19, 2015. Supersedes Technical Service Bulletin Group 94 number 13-09 dated February 26, 2013 for reasons listed below.

Model(s)	Year	VIN Range	Vehicle-Specific Equipment
A4	2013 - 2016	All	Not Applicable

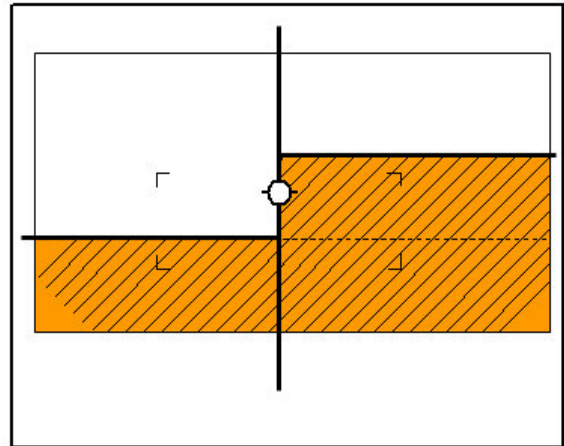
Distinct cut-off beam pattern: The light distribution of the headlights on model year 2009 - 2012 A4 vehicles has a very sharp cut-off beam pattern (Figure 1). This is most noticeable when the vehicle is driven through long dips in the road (such as when coming to the bottom of a large hill).

Figure 1. Model year 2009 - 2012 A4 xenon headlight beam pattern.

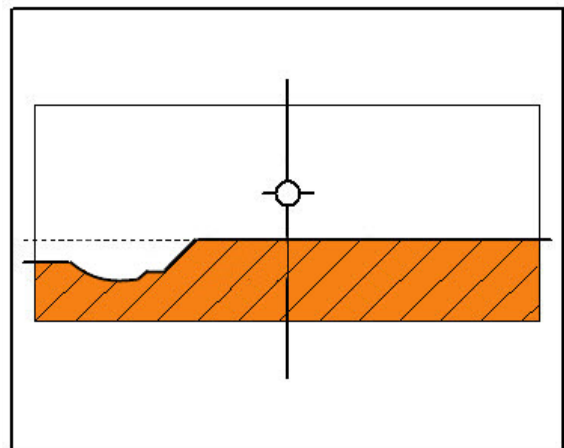
Modified light distribution for A4 product improvement vehicles (starting in model year 2013): The illumination of the headlight has been changed for these vehicles to help further reduce the amount of light seen by oncoming traffic (Figure 2).

Figure 2. Model year 2013 and newer A4 xenon headlight beam pattern.

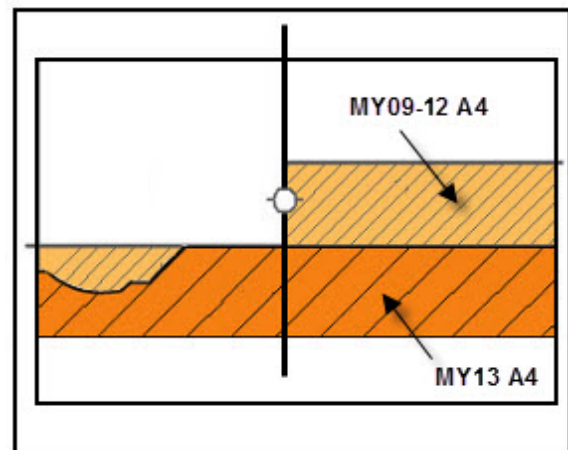
Figure 3. Comparison of new and previous generation headlight beam pattern

Explain to the customer the changes in the beam for A4 product improvement vehicles (Figure 3). Explain the risks of adjusting the beam too high, which may cause an unsafe condition for oncoming traffic.
