94 Taillight lens delamination or cracks on lower edge

94 15 63 2039906/1 February 23, 2015.

Model(s)	Year	VIN Range	Vehicle-Specific Equipment
TT	2013	000001 - 010539	Not Applicable
TT	2014 - 2015	All	Not Applicable

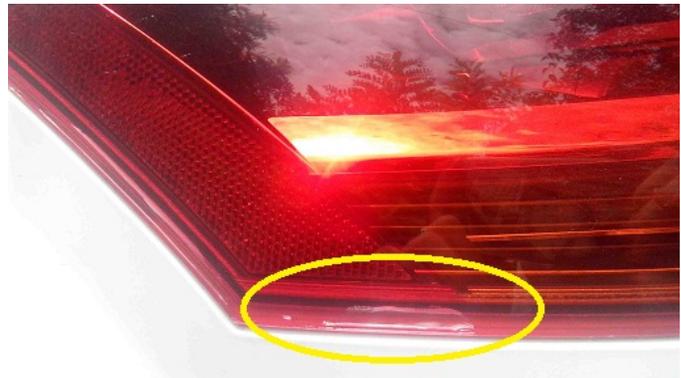
- The customer states that the taillight lens is cracked or broken in the lower edge of the lens (Figure 1). This is a visual defect complaint.
- There is delamination along, or isolated to, the edge area of the taillight lens. The delamination cannot always be felt.
- On the affected side, the taillight lens is touching the body (bumper/side panel). There may be visible contact or interference marks caused by the rubbing of the tail light lens to the body (Figure 2).

Figure 1. Visible cracking at the lower edge of the taillight lens.

The taillight lens consists of two layers of material: a red component and a clear component. Delamination of the taillight lens occurs when force is applied while the lens is in contact with the body, causing the clear component to detach.

1. Replace the affected taillight only if the damage is on one of the outer edges of the taillight. When installing the new taillight, ensure that the lens is not in contact with the body, otherwise a repeat repair can be expected.
2. Road test the vehicle and ensure there are no fitment issues after installation.

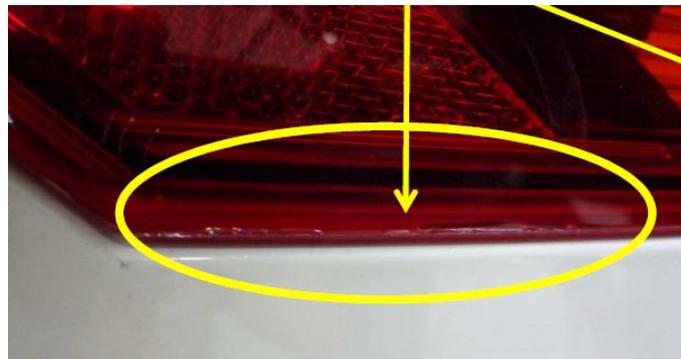
Figure 2. The contact point of the tail lens to the body panel.
