Technical Service Bulletin

19 Coolant pipe seepage on turbocharger

19 15 60 2036167/2 June 24, 2015. Supersedes Technical Service Bulletin Group 19 number 14-47 dated January 31, 2014 for reasons listed below.

Model(s)	Year	VIN Range	Vehicle-Specific Equipment
S6	2013	000001 - 127113	4.0T
S7	2013	000001 - 127864	4.0T
S8	2013	000001 - 027858	4.0T
A8 4.0T	2013	000001 - 027858	4.0T

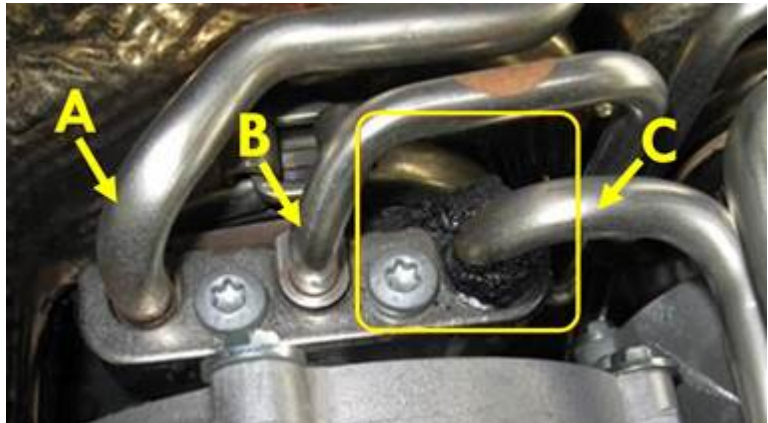
- The low coolant level light is illuminated.
- The coolant level is too low.
- A black crust is visible on the turbocharger coolant lines.

There may be slow coolant loss from the connections of the coolant feed pipe and coolant return pipe. High temperatures cause the coolant to become encrusted on the connection flange of the turbocharger (Figure 1).

Figure 1. Black, encrusted coolant residue (outlined area), coolant feed pipe (A), oil feed pipe (B), and coolant return pipe (C).

1. Drain the cooling system.
2. Replace the coolant feed pipes and coolant return pipes for both cylinder banks.
3. Replace the oil feed pipe o-rings.
4. Tighten the coolant line and oil line hold-down bolts to 9nm.
5. Fill and bleed the cooling system.
