# Technical Service Bulletin

## 23 MIL on, rough running, no start (DTCs P0087, P0088, and/or P0191) (TDI only)

23 15 35 2036668/3 June 30, 2015. Supersedes Technical Service Bulletin Group 01 number 14-75 dated March 20, 2014 for reasons listed below.

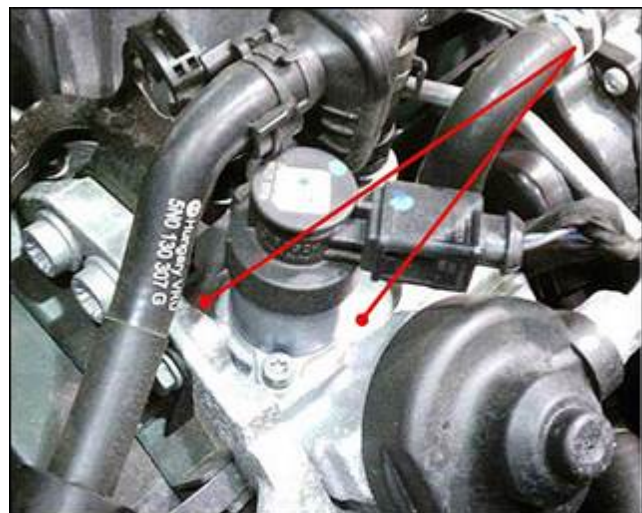
Before the N290 fuel metering valve is removed, the area surrounding the valve (Figure 1) must be sprayed with a cleaner and dried with compressed air to ensure that all debris is removed from the area.

Figure 1. Area surrounding the valve.

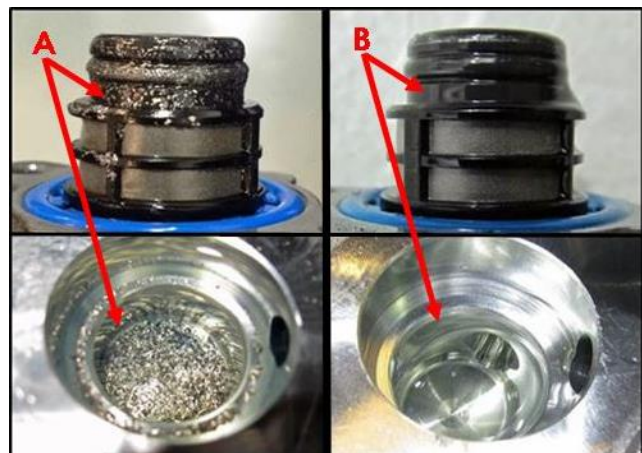
1. Remove the N290 fuel metering valve and inspect the valve and valve bore for the presence of metallic particles (Figure 2). Proceed with the appropriate section below.

Figure 2. Fuel metering valve and valve bore with metallic particles (A), and without metallic particles (B).

1. Contact the Audi Technical Assistance Center (TAC) and open a TAC ticket before continuing with the repair. Before contacting TAC, attach the following to the TAC ticket:
  - GFF diagnostic log
  - Clear pictures showing the metallic particles in the N290 fuel metering valve and bore (Figure 3 and Figure 4).

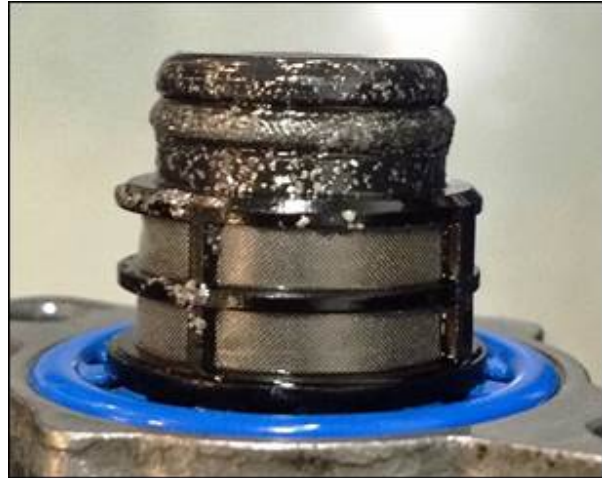
**Figure 3.** Example of a clear picture showing the metallic particles in the N290 fuel metering valve.

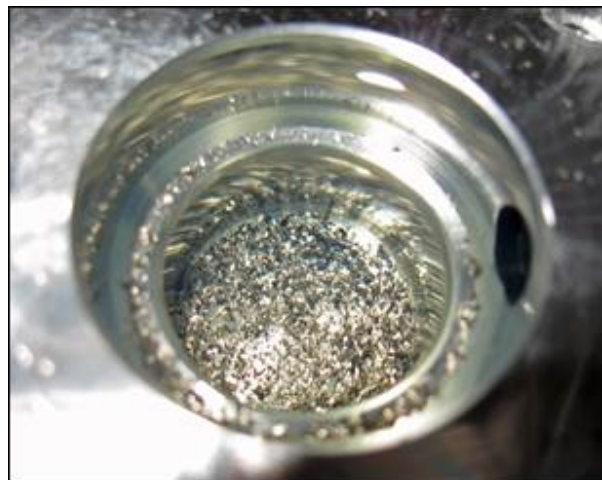
**Figure 4.** Example of a clear picture showing the metallic particles in the valve bore.

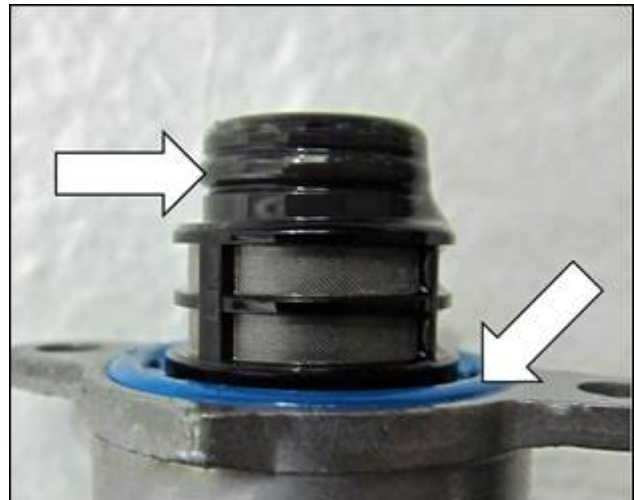
Additionally, ensure that neither O-ring (Figure 5) is damaged. If either O-ring is damaged, replace the high fuel pressure pump.

**Figure 5.** N290 fuel metering valve O-rings.

To prevent damaging the O-rings when reinstalling the N290 fuel metering valve, lubricate them with diesel fuel.

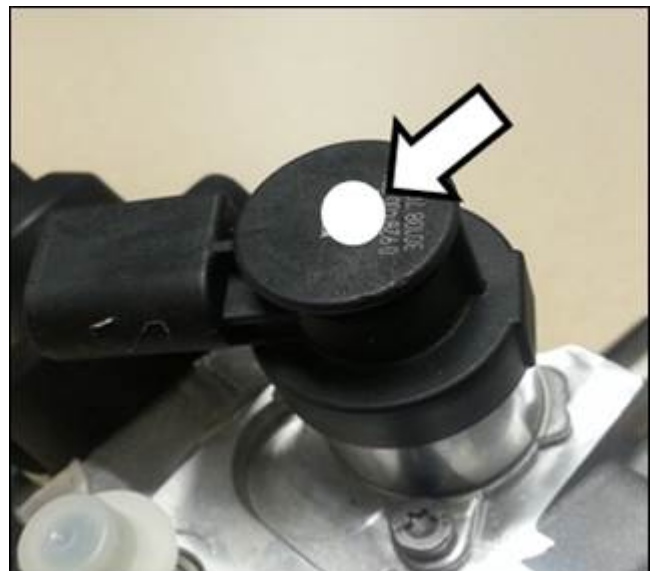
**Figure 6.** White dot on N290 fuel metering valve.

2. Use light pressure to reinstall the N290 fuel metering valve into the valve bore.
3. Install and hand tighten both M5 fasteners, ensuring that the threads are clean and dry. Pre-tighten to 2 Nm, then to 6.5 – 7 Nm.
4. Use a paint marker or equivalent to mark the top of the N290 fuel metering valve with a white dot (Figure 6).
