Technical Service Bulletin

46 Q5 Hybrid squealing from front brakes (PR-1LJ)

46 15 13 2040942/1 June 29, 2015.

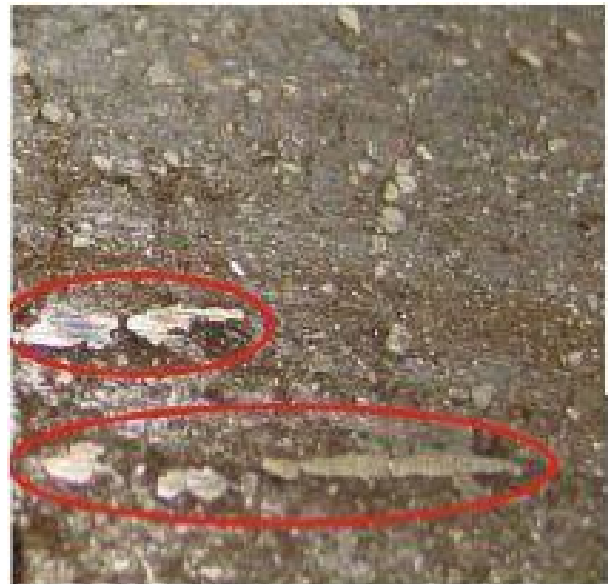
1. Front brake discs or brake pads are close to their wear limit (disc wear limit: 28 mm and pads wear limit with backing plate and dampening plate: 10 mm).
2. Foreign objects between brake disc and brake pad, such as small stones, grit, rust build-up, or sand.
3. Un-ground or corroded friction materials.
4. Metallic deposits from disc material in brake pad (Figure 1).

Figure 1. Metallic deposits.

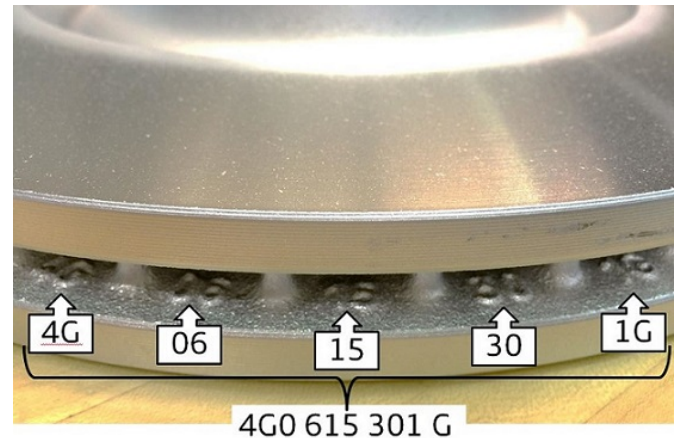
Figure 2. Front brake disc part number location.

1. Check the part number on the front discs. If part number is not 4G0615301G, then install 4G0615301G front discs (Figure 2).

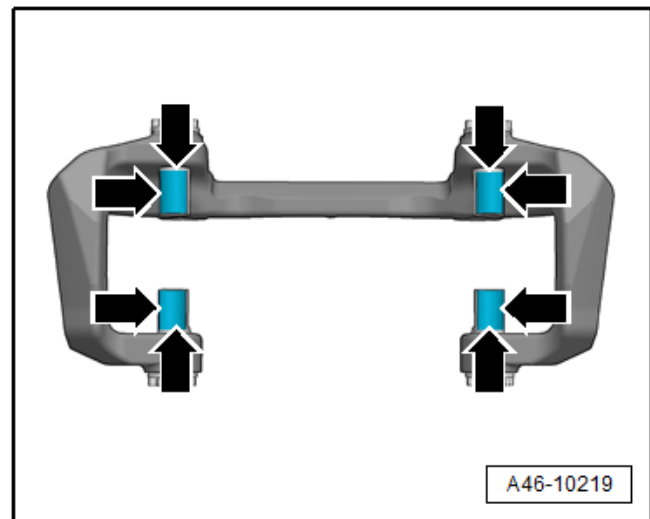
Figure 3. Caliper carrier guide pins with anti-seize (G 052560A2) lubricant applied where the pads make contact.

2. Apply a thin coat of anti-seize (G 052560A2) lubricant to the guide pins of the front caliper carriers (Figure 3).
