## 70 Media interface access door does not open or close

70 15 46 2041119/1 June 29, 2015.

Model(s)	Year	VIN Range	Vehicle-Specific Equipment
R8	2012 - 2015	All	Not Applicable

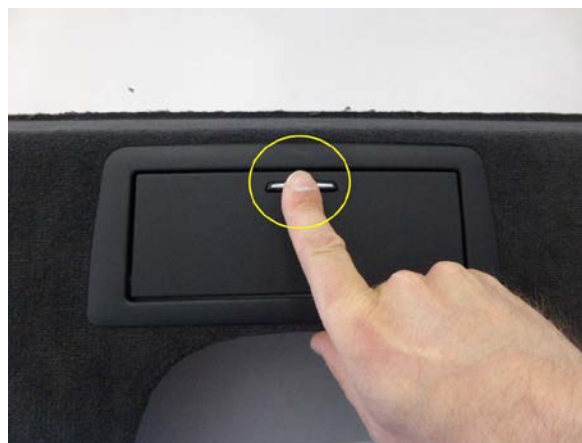
**Figure 1.** Pressing the center of the release button allows the access door to open more easily.

- The access door opens more easily if the release button is pressed in a central location (Figure 1).
- The access door will close more easily and consistently if the force applied is also more centrally located. If the door is closed on one side or the other, the access door latch may fail to engage.

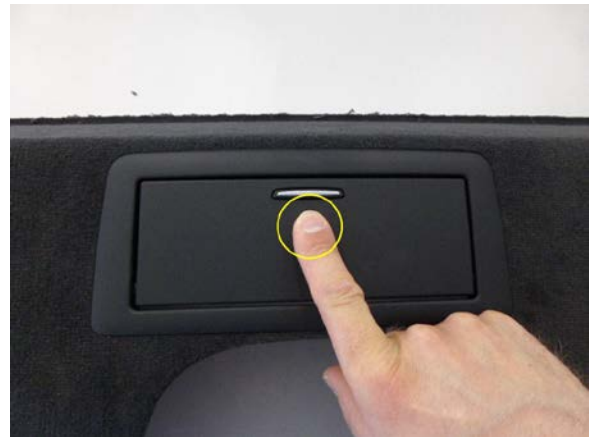
**Figure 2.** Applying force more centrally allows the access door to close more easily and consistently.

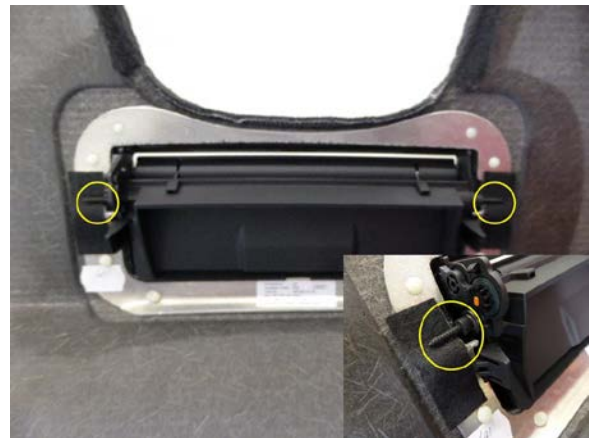
**Figure 3.** Location of the two screws that retain the media access door.

1. Remove the cover for the rear bulkhead
2. Remove the two screws that retain the media access door to the bulkhead cover (Figure 3).
3. When installing the replacement access door, ensure that it is centrally mounted in the opening in the rear bulkhead cover (Figure 4).

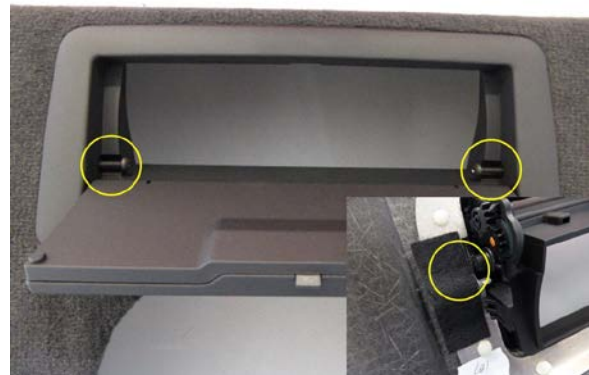
**Figure 4.** Installation of the replacement media access door.
