Technical Service Bulletin

90 Discoloration in image from top view camera

90 15 55 2030193/2 June 9, 2015. Supersedes Technical Service Bulletin Group 90 number 12-31 dated July 16, 2012 for reasons listed below.

Model(s)	Year	VIN Range	Vehicle-Specific Equipment
A6, A7, A8	2011 - 2017	All	Top view camera system

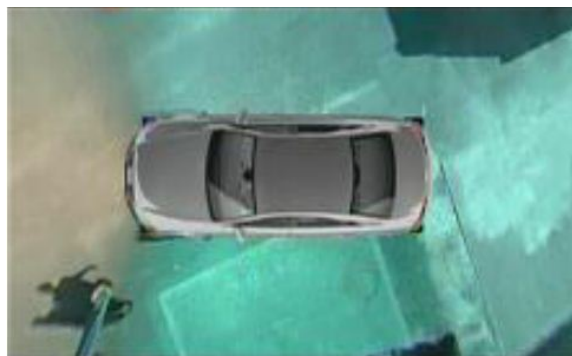
Customer states all or part of the picture generated from the top view camera system has an unnatural hue (Figure 1).

Figure 1. Image of top view with unnatural hue.

In certain lighting conditions, the system responds to vibrant nearby colors (from the vehicle or other objects) by automatically adding a complementary color (Figure 2) to rebalance toward white, which can lead to color deviations. For example, a red object can cause the system to add a green hue. The strength of the added color depends on the brightness of the object and the ambient light.

This is a normal condition. Do not perform any repairs.

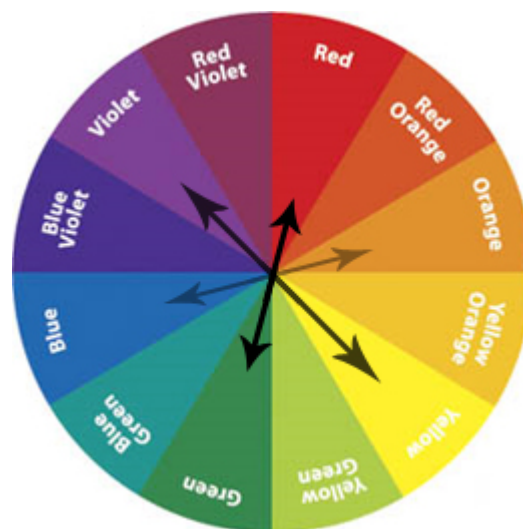
Figure 2. Complementary color wheel.
