Technical Service Bulletin

91 MMI3G+ Audi Connect only reaches 2G service - Telephone module replacement instructions for A4,A5,A5 cab,Q5,Q7,A8

91 15 01 2039476/3 June 30, 2015. Supersedes Technical Service Bulletin Group 91 number 15-86 dated May 15, 2015 for reasons listed below.

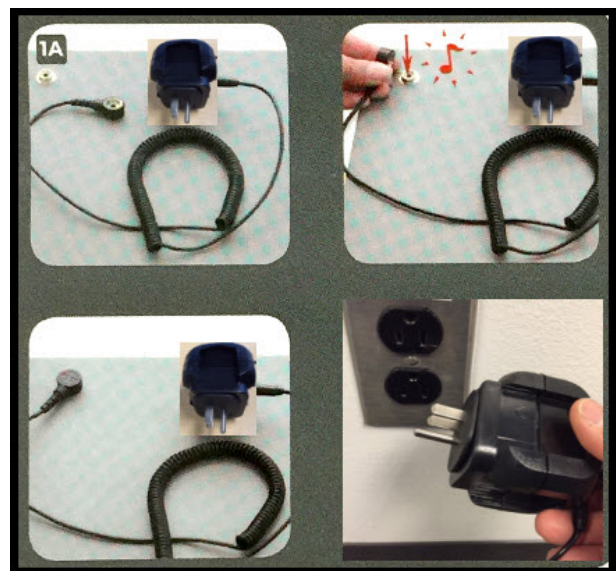
Figure 2. VAS6613 ESD work surface grounding

3. Place the ESD anti-static mat onto the surface. Ensure that all three grounding straps are securely strapped to the ESD mat.
4. Ground the ESD mat by plugging the 110V grounding strap into a wall socket or power strip (Figure 2). If a power strip is used, it must be plugged into a grounded wall outlet. (See attached user instructions for VAS6613 titled “VAS6613 ESD Workspace Guide.pdf”.)

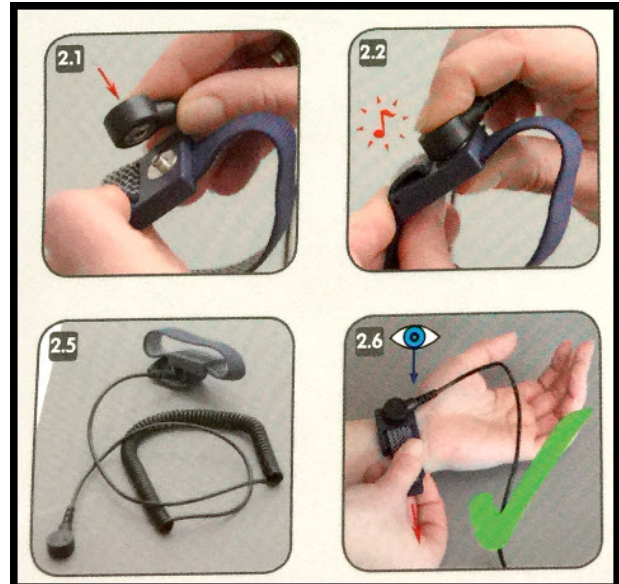
Figure 3. VAS6613 ESD work surface grounding wrist strap.

5. Ground yourself by placing the elastic strap around your wrist. Make sure it is securely touching your skin. It cannot be loose-fitting or over your shirt cuff (Figure 3).

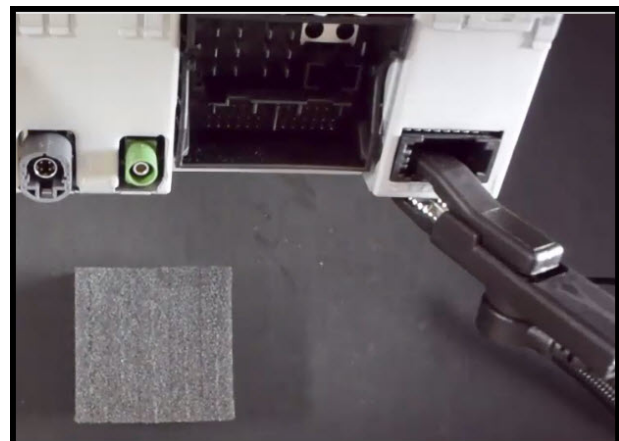
Figure 4. VAS6613 ESD work surface grounding device clip.

6. Ground the MMI main unit by placing an alligator clip on the back, ensuring that it makes contact with the metal housing of the main unit. The most secure location is at the MOST connector (Figure 4).

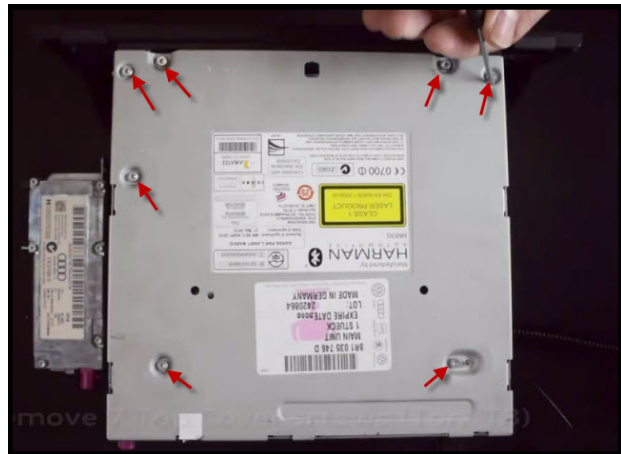
Figure 5. MMI main unit with screw locations for top cover indicated by the red arrows.

7. Remove the seven screws that are holding the MMI top cover in place (Figure 5).

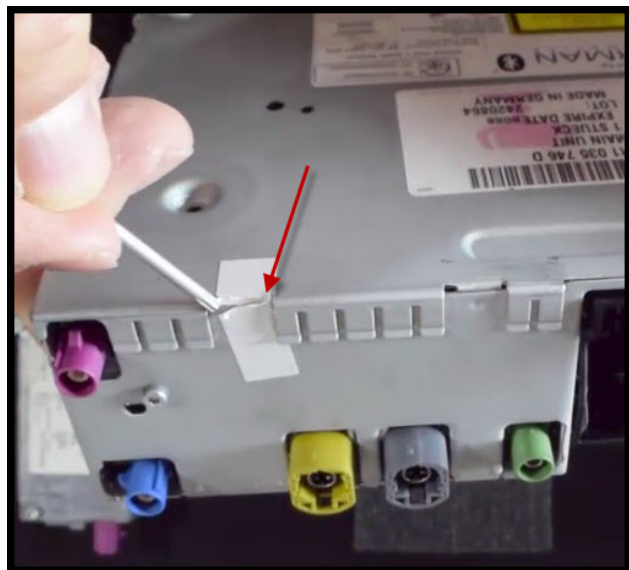
Figure 6. Break white warranty seal.

8. Break the white warranty seal on the back of the main unit (Figure 6).

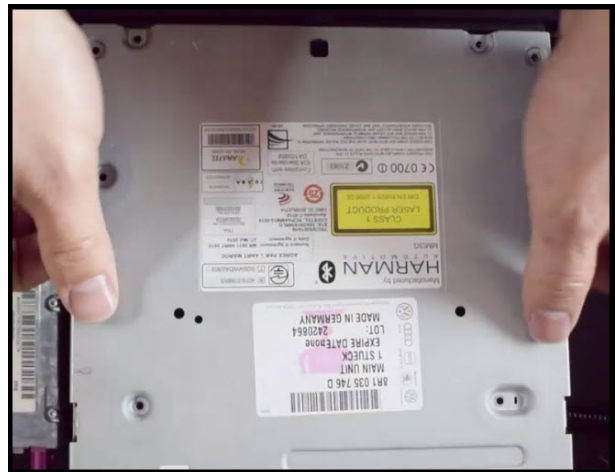
Figure 7. Pry top cover off with fingers.

9. Using a flat head screw driver, your fingers or a plastic wedge trim tool, remove the top cover by prying it from the back of the cover at the location seen in Figure 8. If a flat head screw driver is used then touch the tool to the ESD mat to discharge the tool prior to touching the main unit.

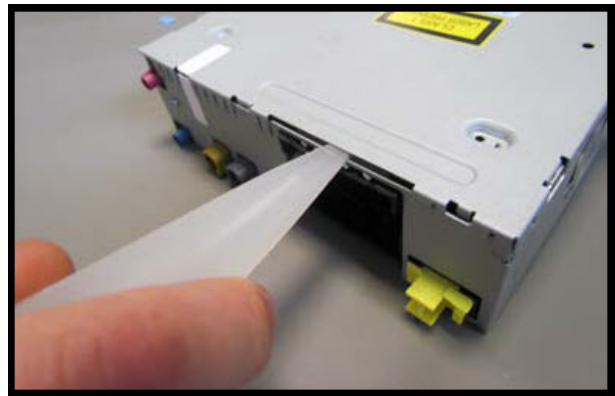
Figure 8. Pry top cover off using plastic trim wedge tool.

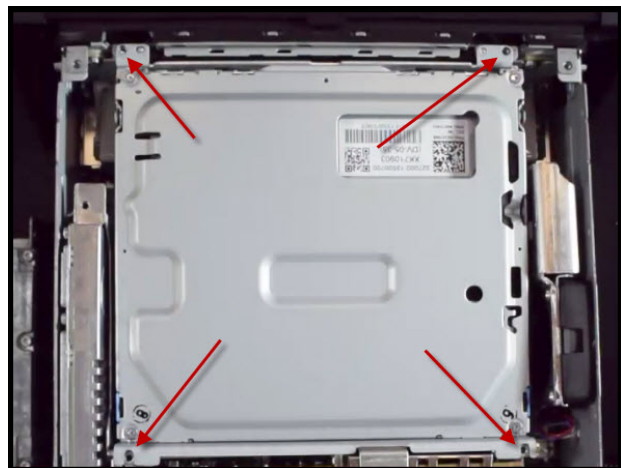
Do not flip the main unit over at this point. The CD drive, which was held in place by the top cover screws, is no longer secured. If it moves significantly, the ribbon cable can detach from the circuit board and disable the CD drive's functionality (Figure 9).

Figure 9. CD drive mounting points are free to move.

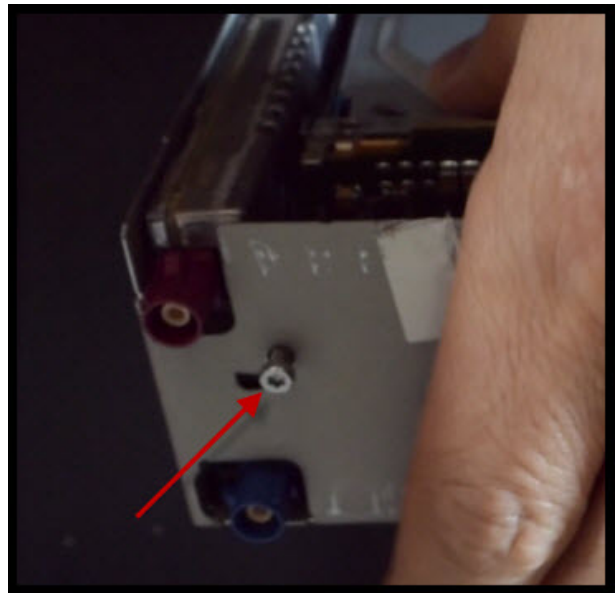
Figure 10. Telephone module retaining screw indicated by the red arrow.

10. On the back of the main unit, remove the retaining screw that holds the telephone module in place (Figure 10).

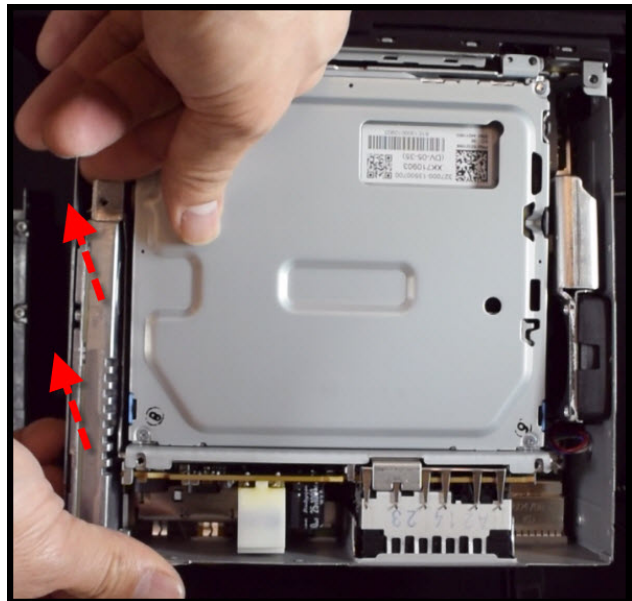
Figure 11. Lift up on both ends of the telephone module as indicated by the red arrows.

11. Carefully lift up the telephone module, using both ends as points of contact when pulling up (Figure 11). The module is held in place with a computer socket-type attachment and will release when enough force is used.

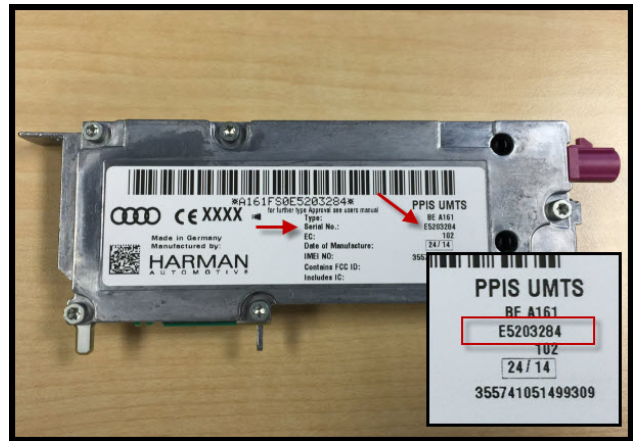
Figure 12. Serial number of the PPIS UMTS telephone module indicated by the red arrows and red box.

12. Before proceeding, write the serial number of the new replacement UMTS telephone module on the rework label (Figure 12).

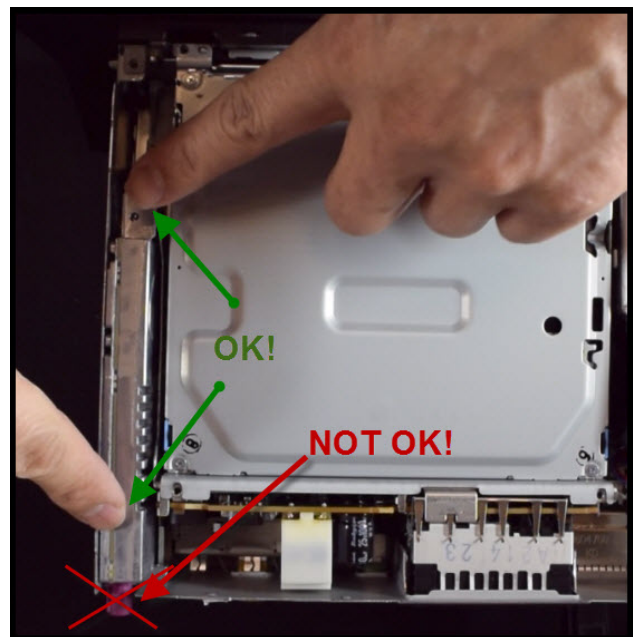
Figure 13. Do not press down using the purple FAKRA connector.

13. Place the new UMTS telephone module into the socket, making sure it is level before snapping it into place. Use both ends of the telephone module when pressing it into place. Do not press down using the purple FAKRA connector (Figure 13).

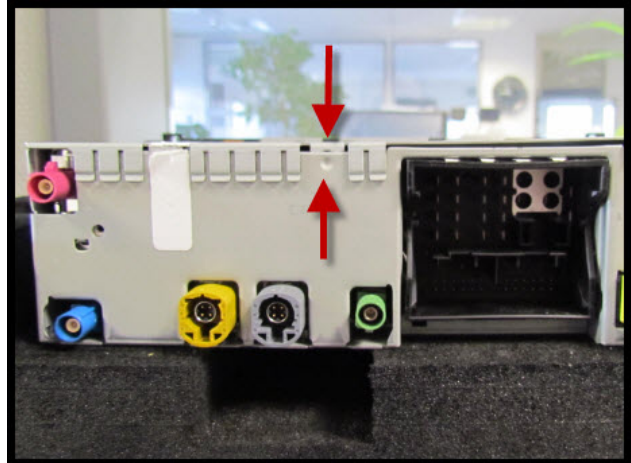
Figure 14. Place the new warranty seal over the location indicated by the red arrows.

17. Place the new warranty seal from the retrofit kit next to the original warranty seal (Figure 14).

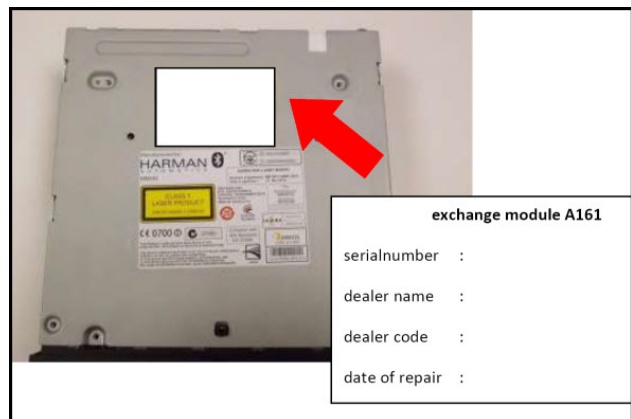
Figure 15. The white area indicates the “suggested” location for the repair label on the top cover of the main unit. Do not cover any existing part number labels.

18. Place the rework label on the top of the main unit cover. Do not cover any part number labels (Figure 15). Fill out all fields on the repair label.

Do not cover the yellow laser warning label. The repair label may need to be placed on sideways due to space limitations.
