**Number: VWR-15-02**

**Subject: Parts Review: Damage vs. Defect Guide**

**Date: Feb. 16, 2015**

### Parts Review: Damage vs. Defect Guide

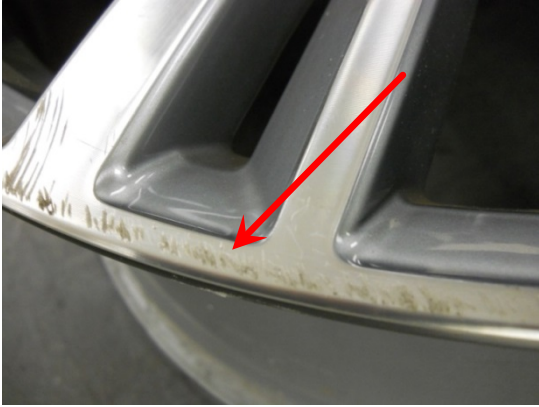
| Wheels | |
|---|---|
| Curb Scuffing | Clear Coat Peeling |

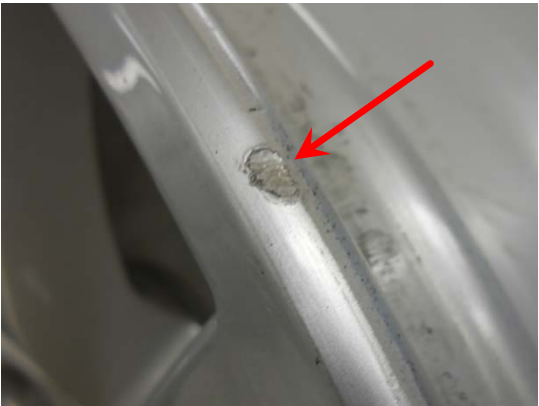
| Wheels | |
|---|---|
| Pothole Damage | Poor Paint Coverage |

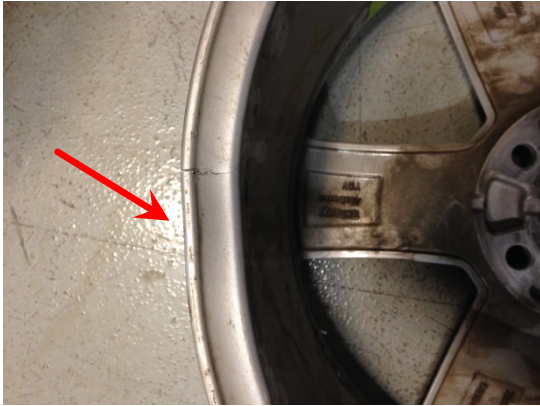
| Wheels | |
|---|---|
| Bent Wheel | Clear Coat Cracking |

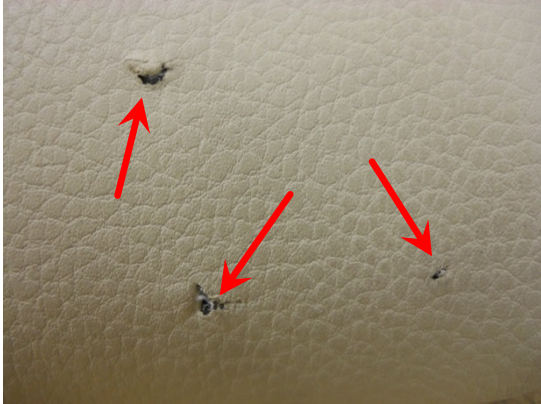
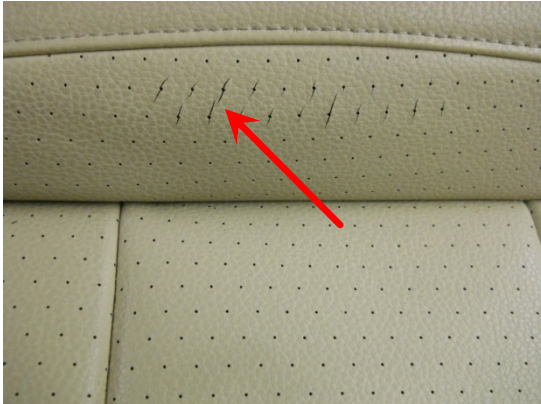
| Seat Covers | |
|---|---|
| Puncture Holes/Cutting | Leather Separation |

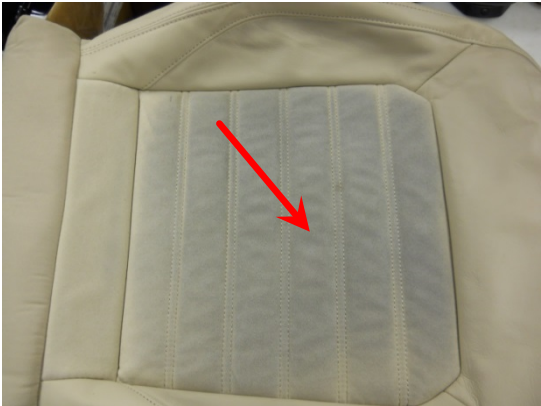
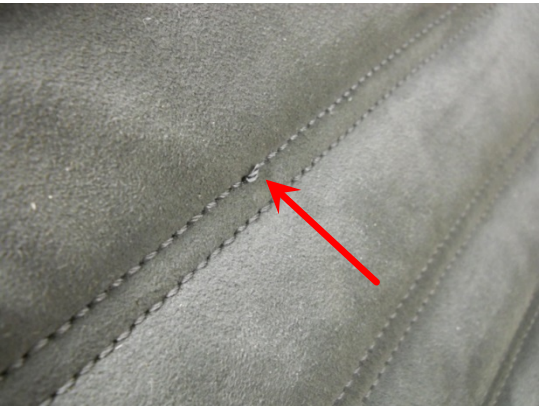
| Seat Covers | |
|---|---|
| Staining | Seam Separation |

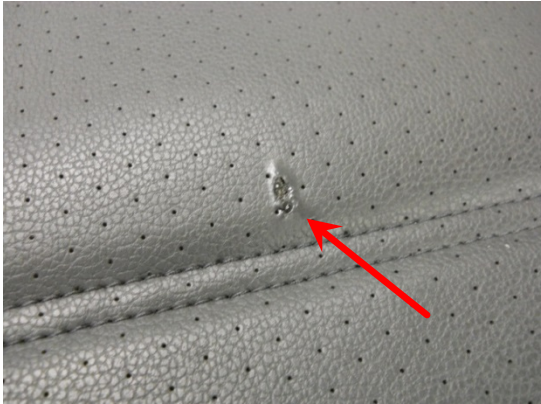
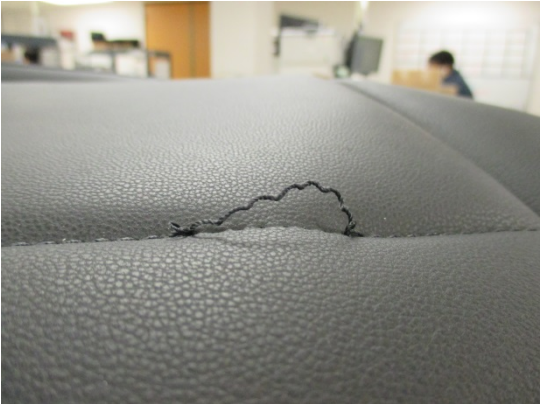
| Seat Covers | |
|---|---|
| Burn Marks | Stitching Separation |

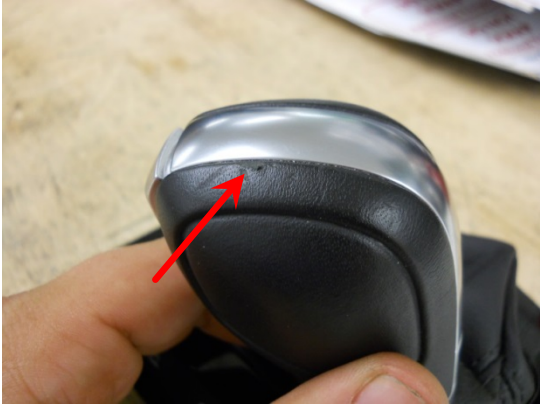
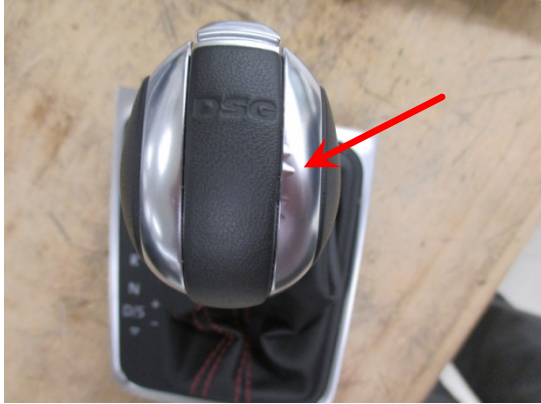
| Shift Knobs/Steering Wheels | |
|---|---|
| Scuffing | Peeling |

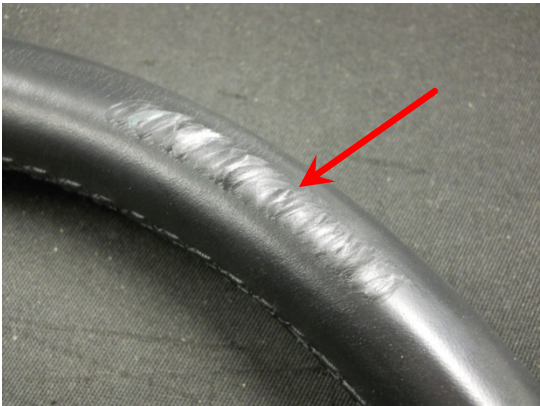
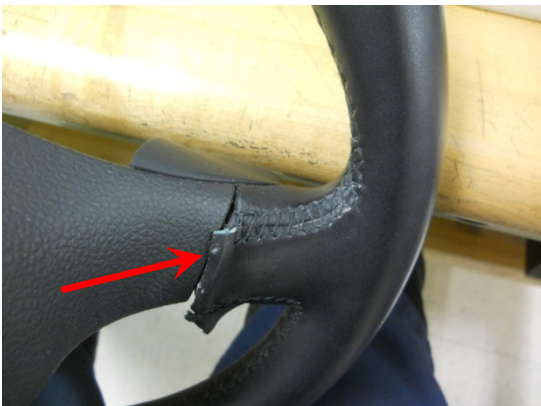
| Shift Knobs/Steering Wheels | |
|---|---|
| Scuffing | Leather Separation |

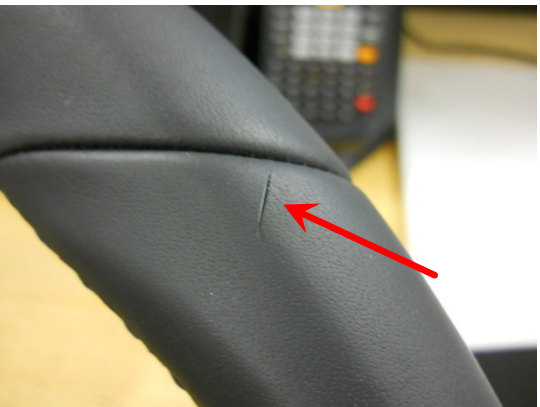
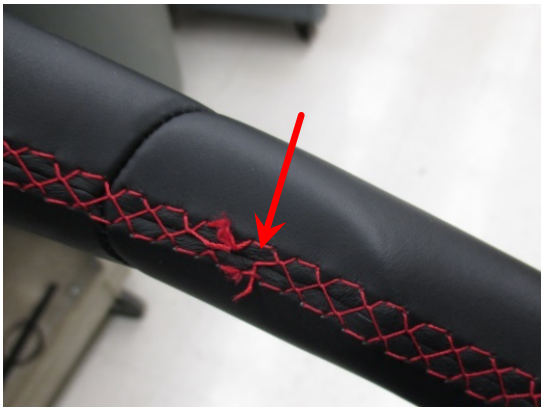
| Shift Knobs/Steering Wheels | |
|---|---|
| Cuts | Seam Separation |

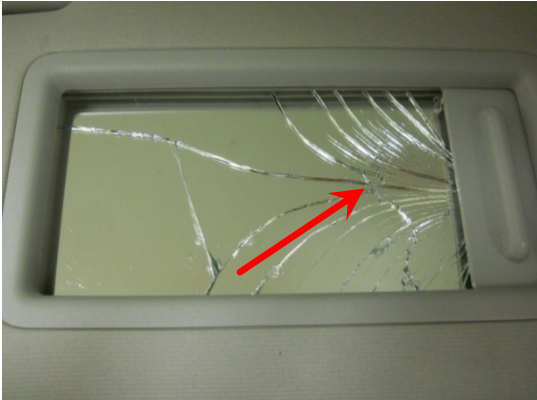
Shattered Glass

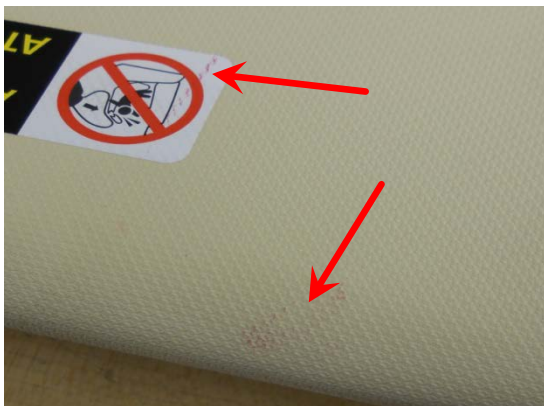
Staining

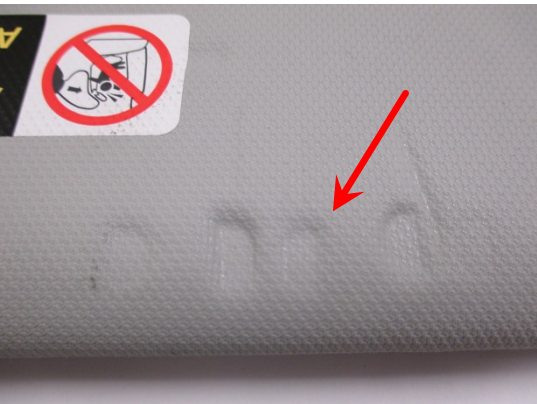
Imprints

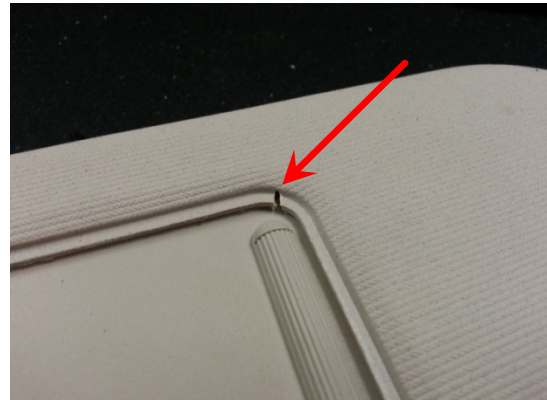
Cracked Trim

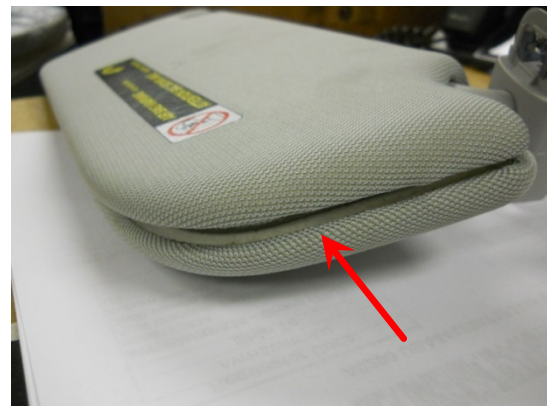
Separation

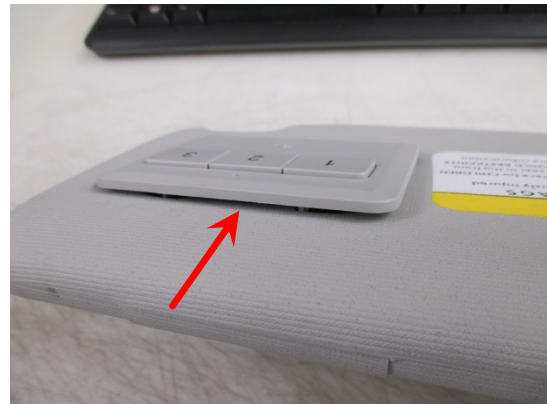
Loose

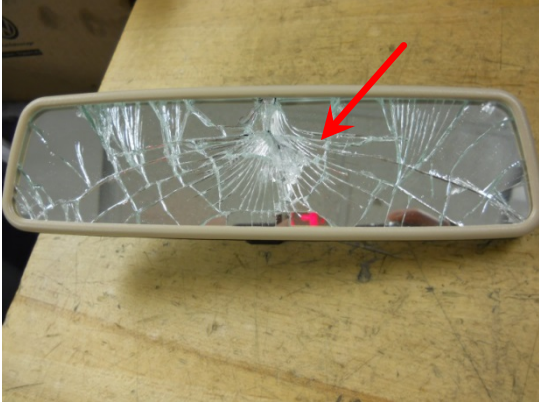
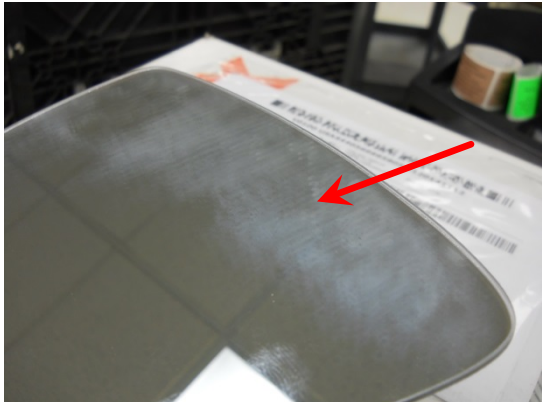
| Mirrors | |
|---|---|
| Shattered Glass | Discolored Glass |

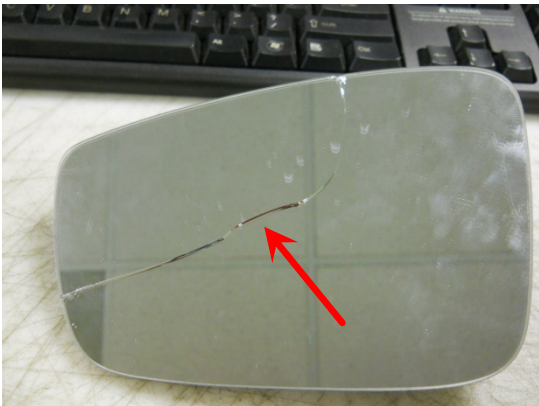
| Mirrors | |
|---|---|
| Cracked | |

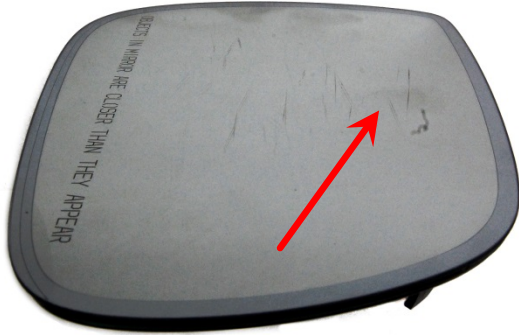
| Mirrors | |
|---|---|
| Scratches | |

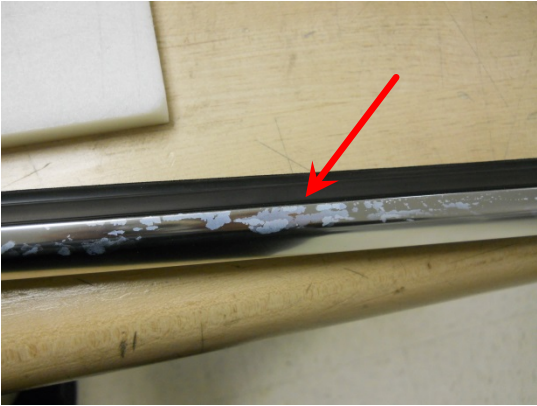
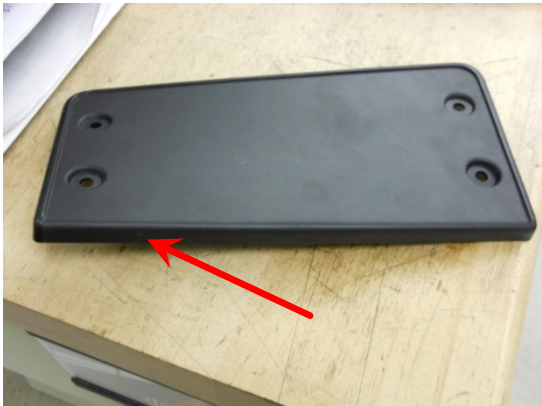
| Trim Exterior | |
|---|---|
| Chemical Reaction | Poor Fit/ Warped |

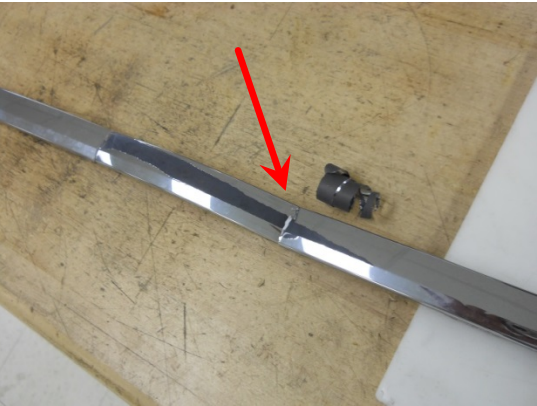
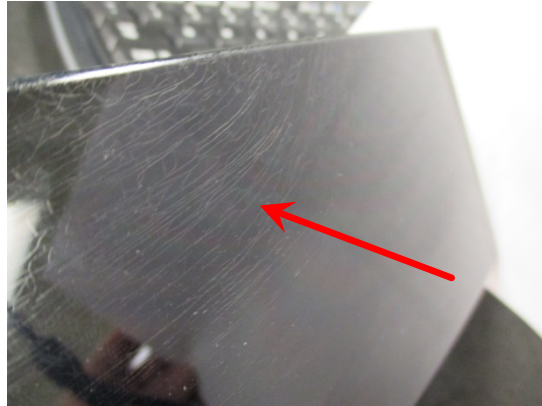
| Trim Exterior | |
|---|---|
| Broken | Cracked Paint |

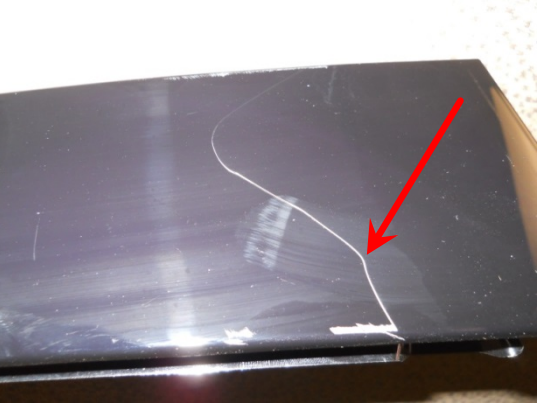
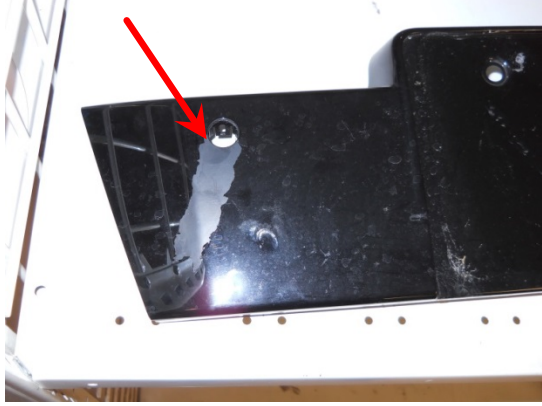
| Trim Exterior | |
|---|---|
| Scratched/Scuffed | Peeling |

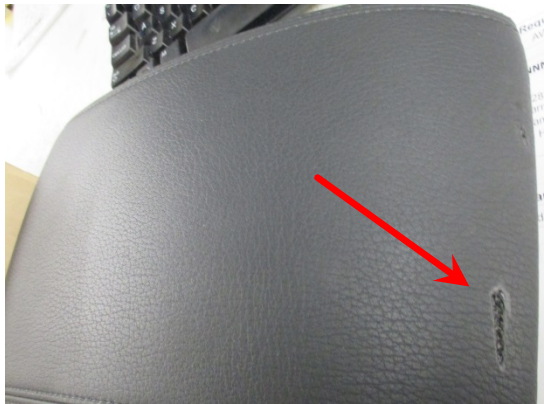
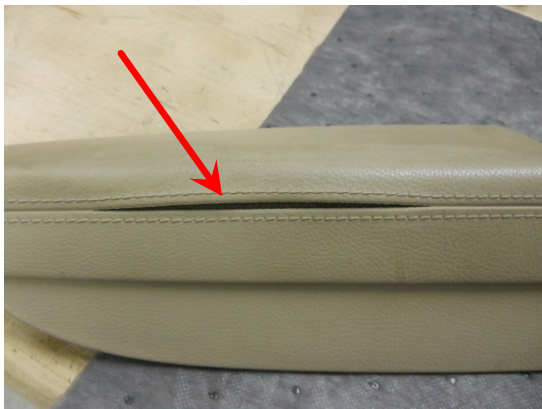
| Trim Interior | |
|---|---|
| <p>A close-up photograph of a grey leather car seat. A red arrow points to a small, dark, irregular mark on the leather surface.</p> <p>Burn Marks</p> | <p>A close-up photograph of a tan leather car seat. A red arrow points to a gap where the stitching has pulled away from the leather.</p> <p>Seam Separation</p> |

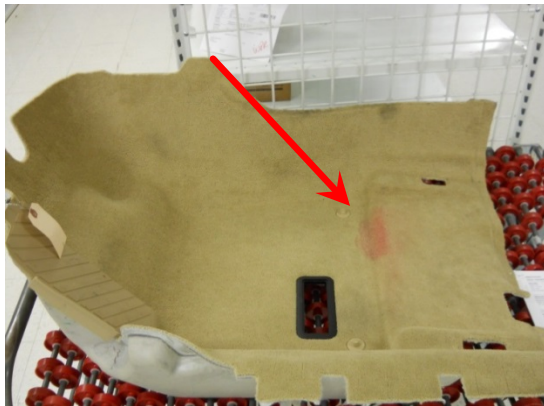
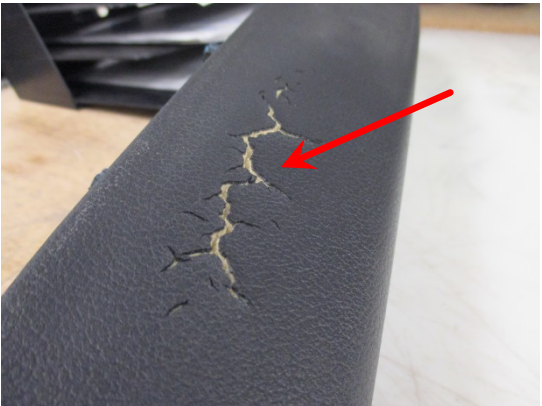
| Trim Interior | |
|---|---|
| <p>A photograph of a tan leather car seat. A red arrow points to a reddish-brown stain on the leather.</p> <p>Stained</p> | <p>A close-up photograph of a dark grey leather car seat. A red arrow points to a jagged, irregular crack in the leather.</p> <p>Weather Cracking</p> |

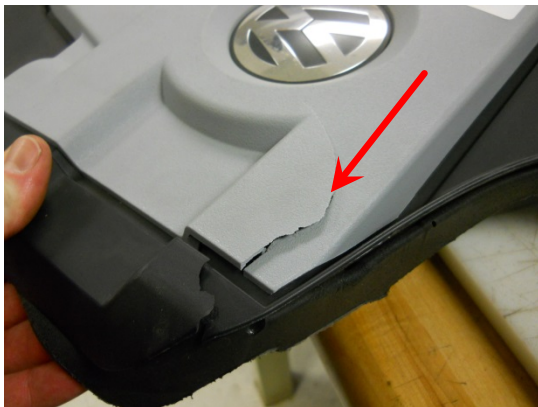
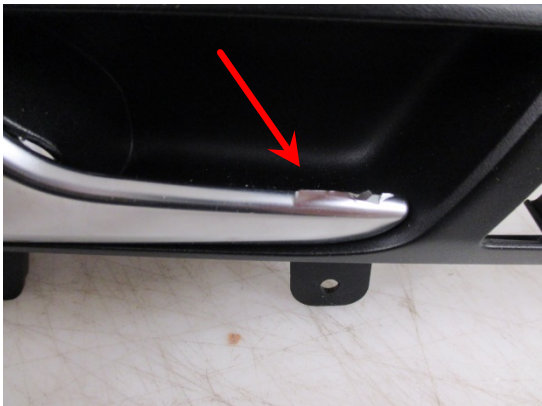
| Trim Interior | |
|---|---|
| <p>A photograph of a grey plastic car trim piece. A red arrow points to a crack in the plastic.</p> <p>Cracked</p> | <p>A photograph of a black plastic car trim piece. A red arrow points to a small area where the plastic is peeling or chipping away.</p> <p>Peeling</p> |

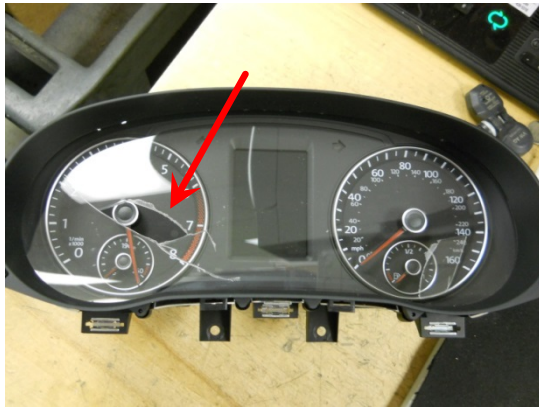
Cracked Glass

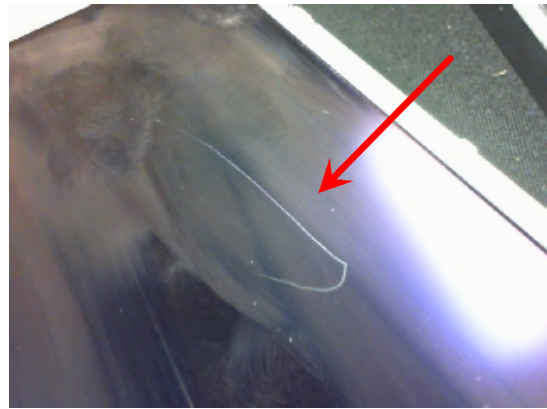
Scratched

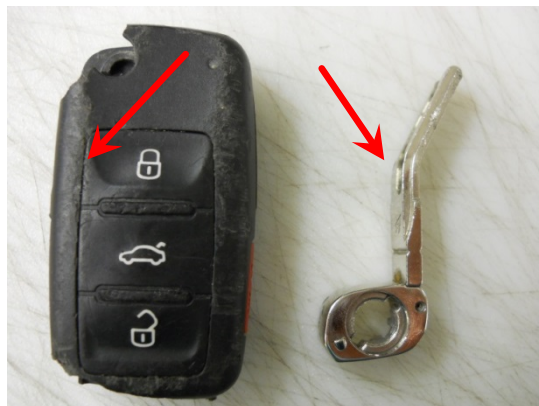
Crushed/Bent

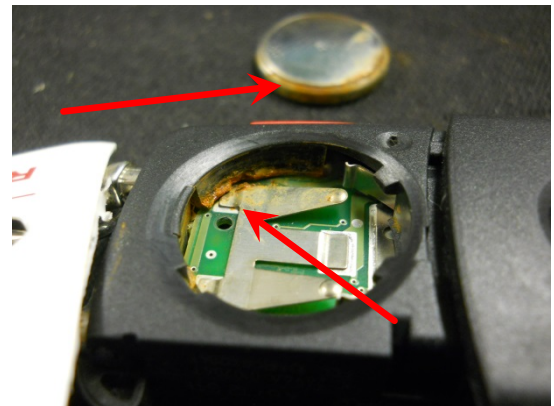
Corrosion

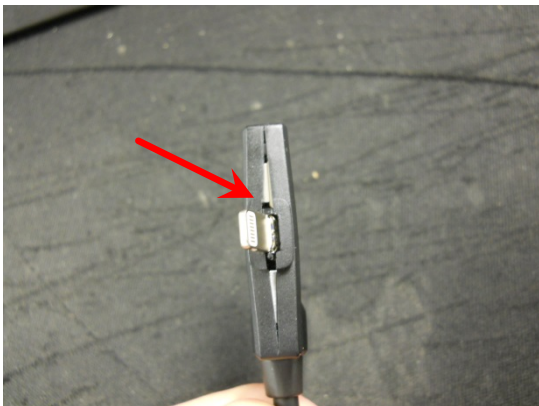
Crushed/Opened

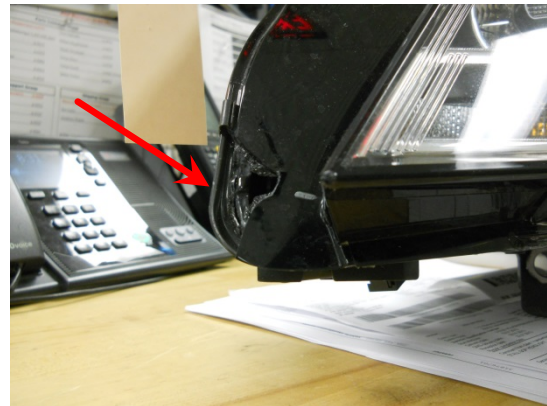
Impacted Lens
