# Technical Bulletin

92 15 01 February 23, 2015 2037322 Supersedes Technical Bulletin V921402 dated May 30, 2014 to include model year 2015 applicability.

Washer Level Sensor

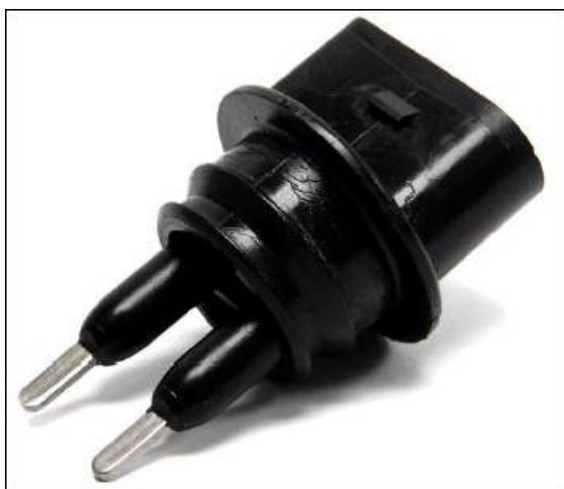
The sensitivity of the washer solvent level sensor (G33) can be affected by the type, concentration, and the presence of additives in the washer solvent currently in the tank. The operation of the level sensor relies on the composition of the solvent to provide an accurate message on the solvent level. Incorrect concentration and the presence of additives can contaminate the sensor and reduce its sensitivity.

Non-approved fluids can cause residues to form on the sensor which causes the washer fluid lamp to remain on when reservoir is full. A picture of the sensor in question (G33) and a picture of the approved cleaner (D-009-401-04) are provided below.

The indicator lamp in the instrument panel for washer fluid remains illuminated and the washer reservoir is full. Validate the washer reservoir is full with the proper washer solvent. Refer to Elsa for proper fluid type and fluid quantities under repair manual, maintenance, fluid capacity table. If the fluid is found to be incorrect, drain the fluid, remove the sensor, and clean with cleaner (D-009-401-04) or equivalent. Reinstall the sensor, top off washer reservoir with proper fluid and validate that the indicator lamp in the instrument panel is no longer illuminated.
