# Tech Tips

TT 96-15-02

Date: February 27, 2015

## 2013-2015 Tiguan-Alarm Horn Tone Weak or Abnormal When Locking

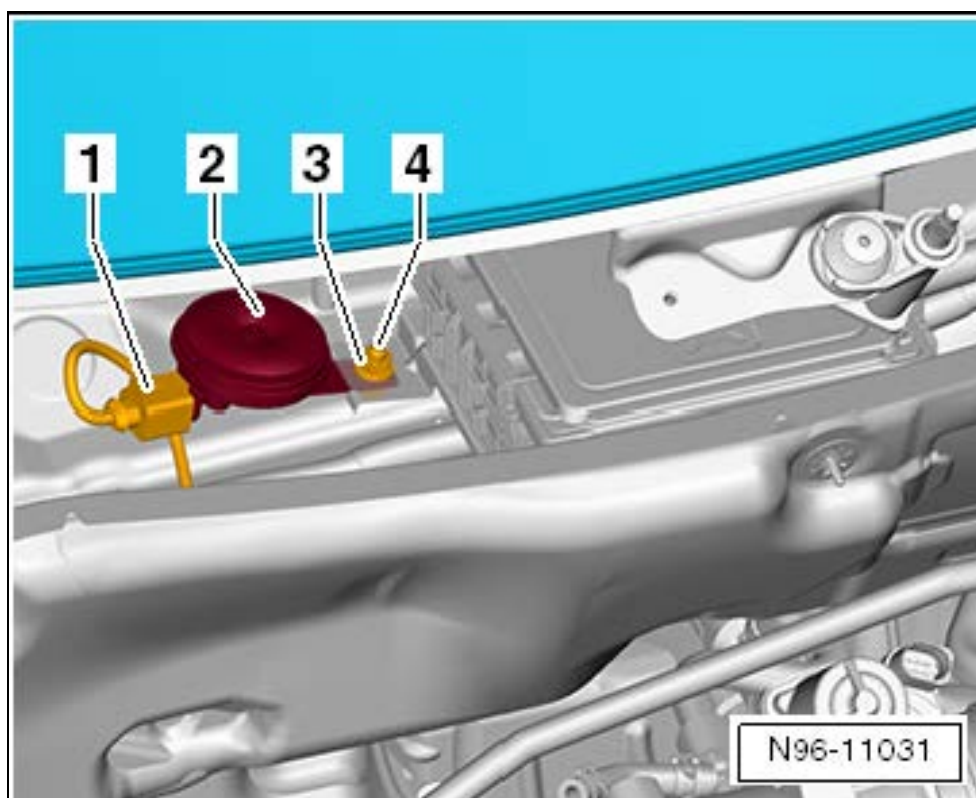
Before replacing the alarm horn (part number 5C0951115) for a weak, muffled, or abnormal tone condition, ensure the nut that secures the alarm horn bracket to the vehicle body (number 3 in the illustration below) is properly torqued. According to the Elsa Repair Manual, the specified torque for the securing nut is 20 Nm.
