Technical Bulletin

26 15 01 January 21, 2015 2039436

Ad Blue Warning and or MIL ON - Ad Blue Leakage at Reductant Injector

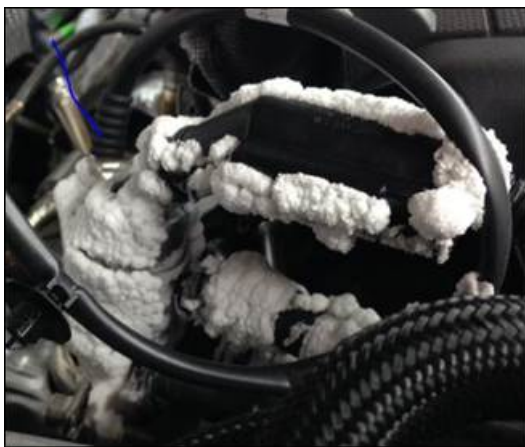
Welding process issues of the reductant line connector to the supply line may cause Ad Blue leakage at the reductant injector.

Inspect the connection of the reductant supply line connector at the reductant injector in the engine compartment. If white crystalized (dried) Ad Blue is found at the reductant injector (see Figure 1 & 2), it will be necessary to replace the reductant supply line.

Thoroughly clean the area of the reductant supply line connection with water to remove the crystalized Ad Blue. Replace the reductant supply line.

It is not necessary to replace the reductant injector.
