Tech Tips

TT **94-14-01**

2011-2013 Routan Turn Signals Will Not Activate after TIPM Replacement

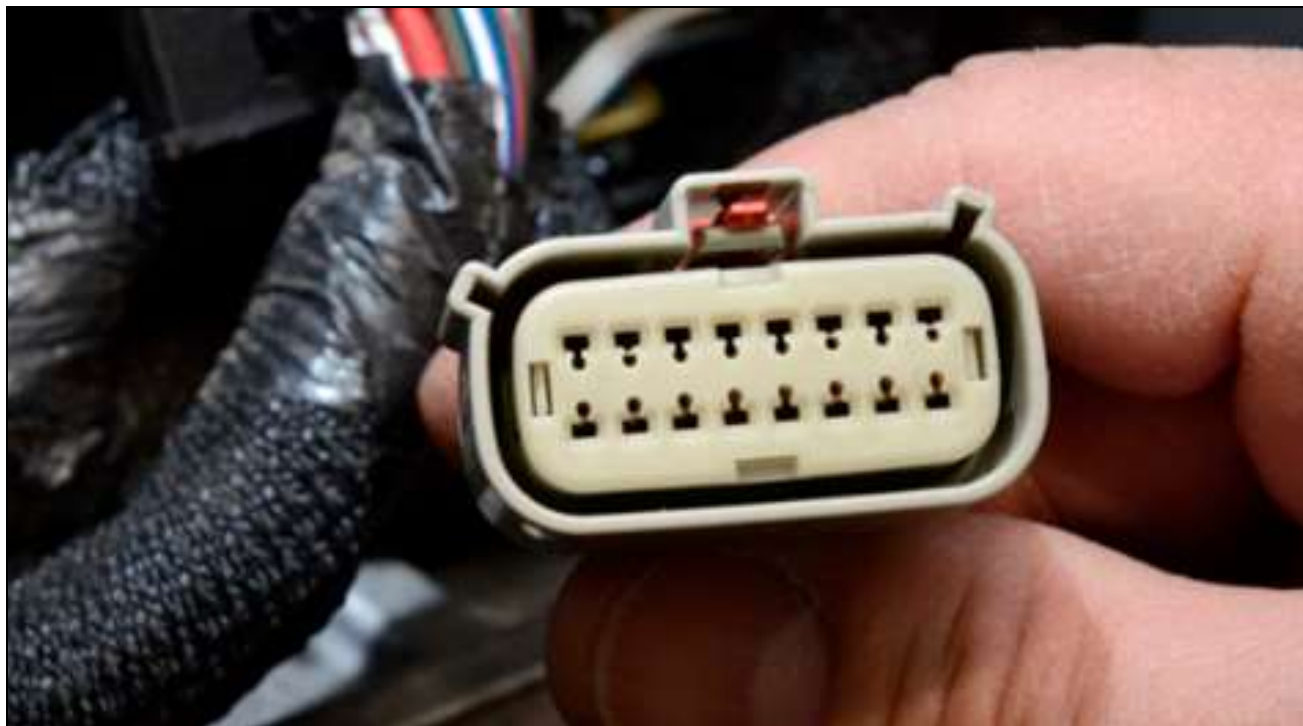
Figure 1

2. With the TIPM removed from the vehicle locate Gray 16 way the TIPM C4 connector on the vehicles wiring harness (Figure 1).

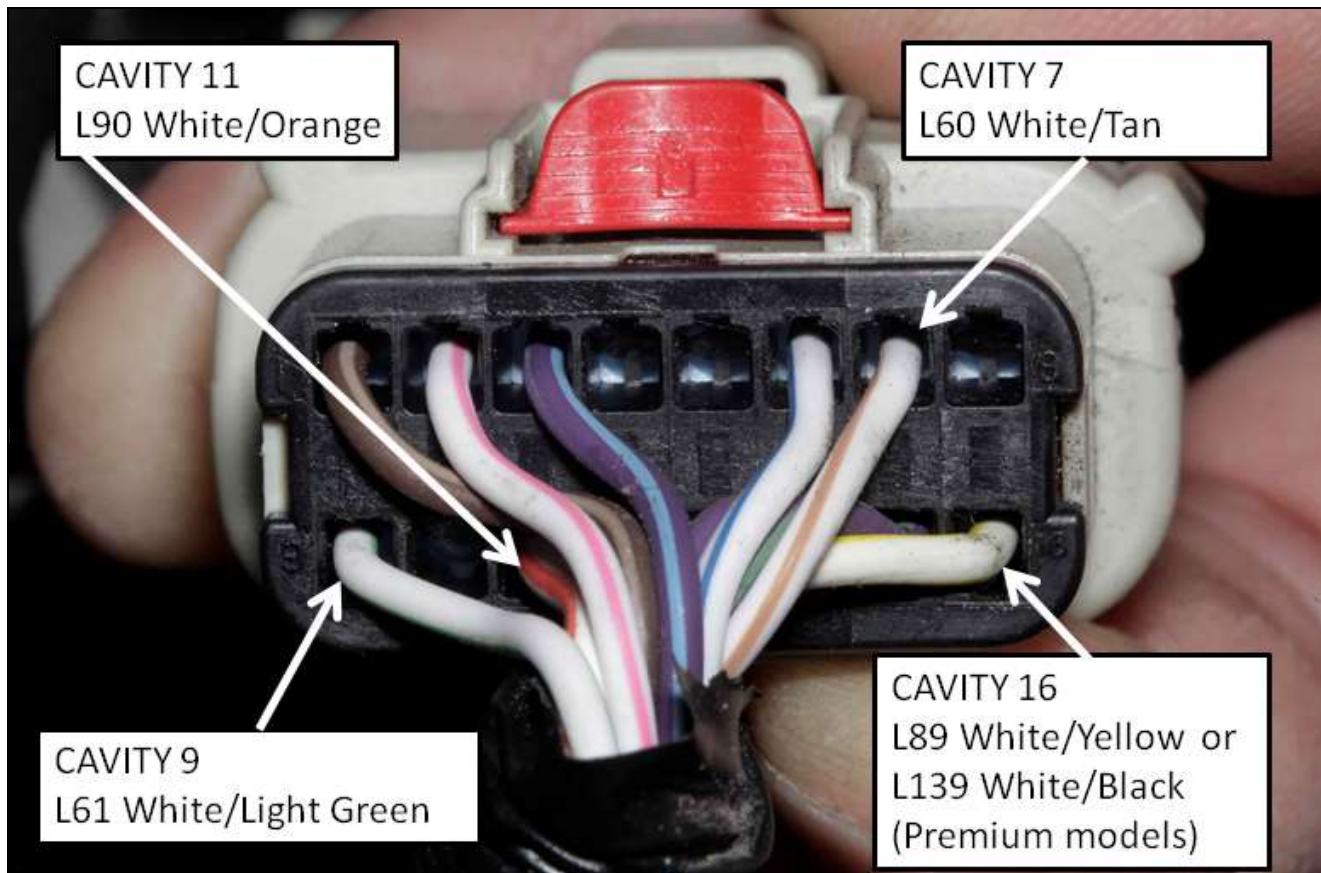
Figure 2

3. Identify cavity 7 of the C4 connector. If the wire in cavity 7 is White with Tan proceed to the next step (Figure 2).
4. Identify cavity 9 of the C4 connector. If the wire in cavity 9 is White with Light Green proceed to the next step.
5. Identify cavity 11 of the C4 connector. If the wire in cavity 11 is White with Orange or there is no wire present continue to the next step.
6. Identify cavity 16 of the C4 connector. If the wire in cavity 16 is White with Yellow or White with Black or there is no wire present proceed to the next step.
