Technical Bulletin

87 15 02 March 5, 2015 **2037255** Supersedes Technical Bulletin V871406 dated June 19, 2014 to update air distribution box production date.

Whistle Noise from Center Vent Area; Blower Set On 3 or 4 with Full Heat Selected

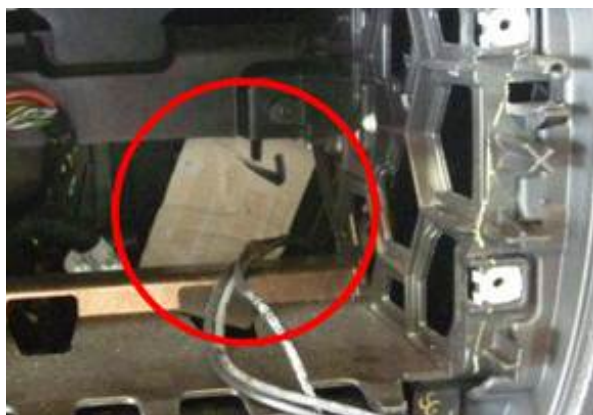
Figure 1

- Remove the radio, see Repair Group 91 in Elsa.
- The label on the air distribution unit is located on the front of the distribution unit assembly (Figure 1).
- Check the production date of the air distribution unit (Figure 2).

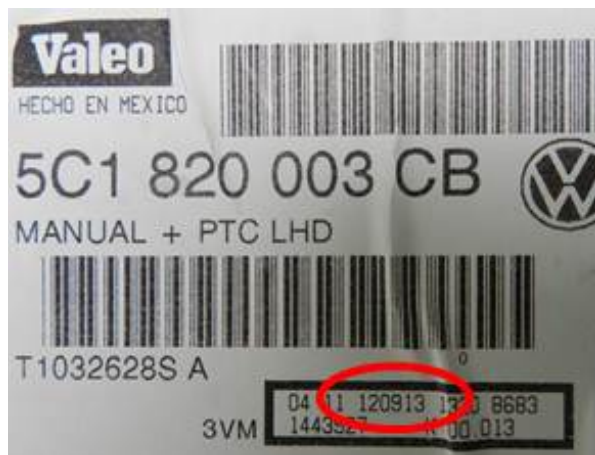
Figure 2

The production date is Day/Month/Year (120913 = Sep 12th 2013) (Figure 2).

All air distribution units built before 9/30/2013 will require both the left and the right temperature flap levers.

Air distribution boxes built between **October 1st 2013 and **March 20th 2014** will require only the right (Black) temperature flap lever.**

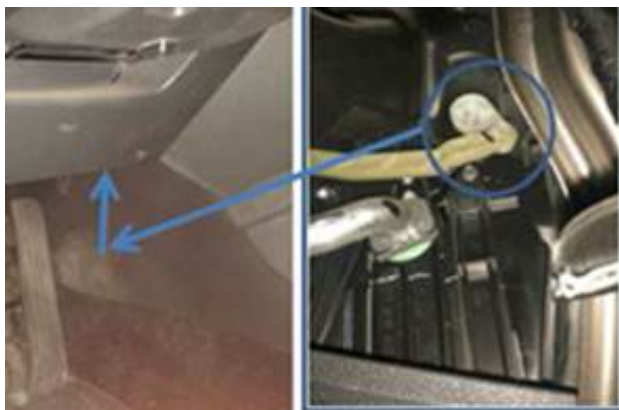
Figure 3

- Locate the left temperature flap lever (White) on the distribution housing (Figure 3).
