Technical Bulletin

64 15 01 March 2, 2015 2039887

Rear Door Glass Inoperative

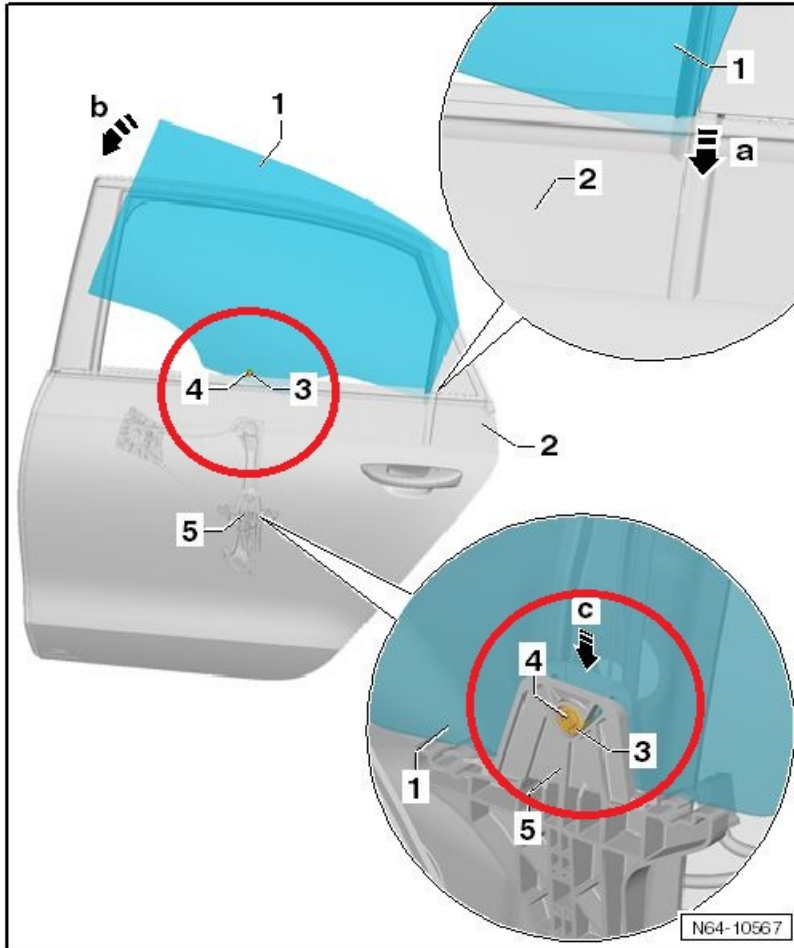
Figure 1

The spreader plug with expanding pin for securing the door glass to the window regulator can wander loose from the glass (see Fig.1 No 3 / 4). If this occurs, the door glass will no longer be secured to the window regulator.

Replace the spreader plug with expanding pin for securing the rear door window.

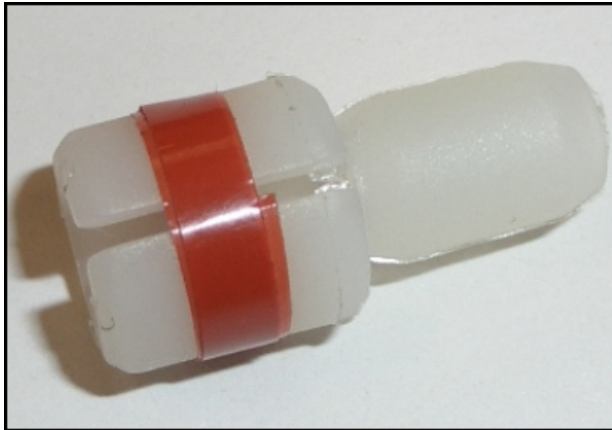
Figure 2 (Adhesive strip shown in red for clarity)

- Remove the rear door trim panel, see Repair Manual Group 70 in Elsa.
- Remove the inner glass shaft seal, see Repair Manual Group 64 Glass, Window Regulators in Elsa.
- Remove the outer glass shaft seal, see Repair Manual Group 64 Glass, Window Regulators in Elsa.
- Remove the rear door glass, see Repair Manual Group 64 Glass, Window Regulators in Elsa.
- Inspect the hole for the spreader plug in the glass for damage. (If there is damage to the hole in the glass, the glass must be replaced during this repair.)
- Using the foil tape (part number AKL.433.014.01) or vinyl tape obtained locally, cut a 55 mm long and 6 mm wide strip.
- Wrap the strip around the center of a new spreader plug (see Fig. 2).

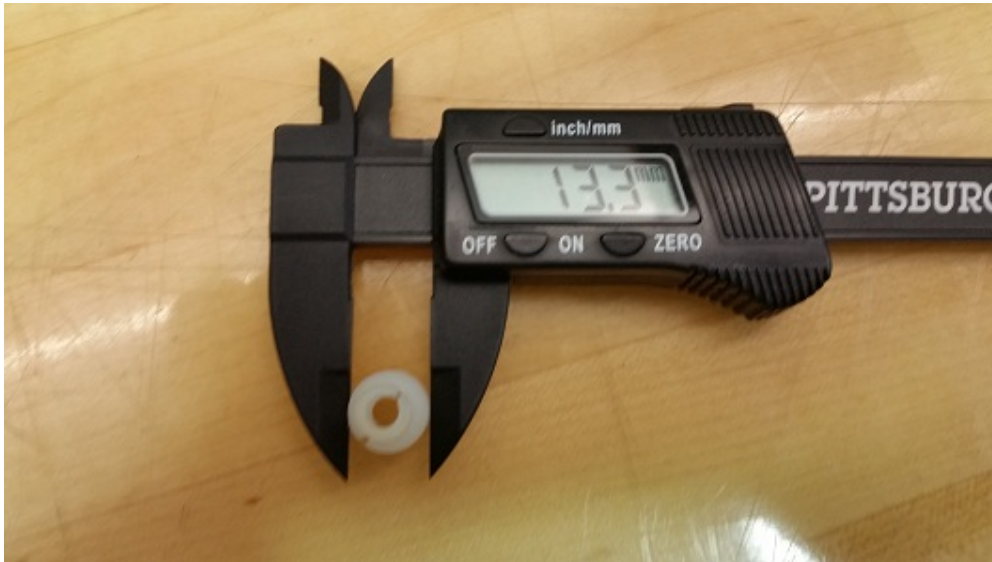
Figure 3 (Acceptable diameter after adding adhesive strip)

- Measure the diameter of the new plug with the adhesive strip. The diameter must be approximately 13.4 mm (see Fig. 3).
