NUMBER: 23-001-16

Center Console Lid Binding

This bulletin involves adding a rubber bumper to the console lid.

2015 - 2016	(DS)	Ram 1500 Pickup
2015 - 2016	(DJ)	Ram 2500 Pickup

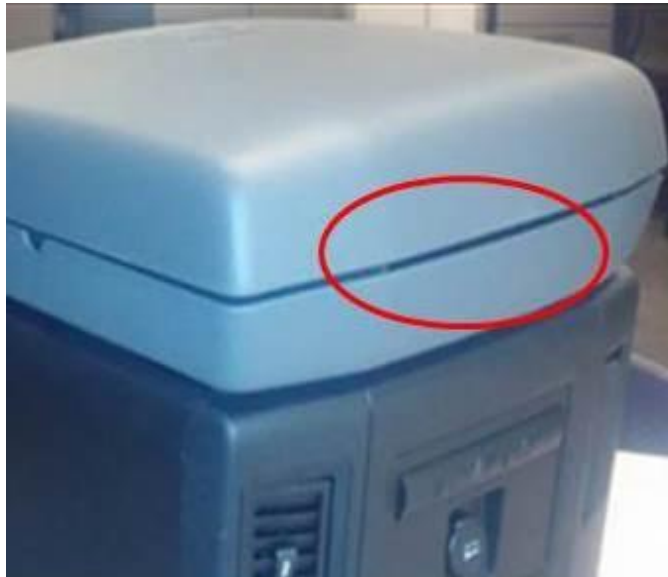
Fig. 1 Check Lid For Rubbing

1. Locate the center console inside the vehicle.
2. Slowly open the upper lid of the center console while checking the gap between the bottom of the upper lid and the top of the lower lid for rubbing together as shown in (Fig. 1).
