UPDATE Technical Bulletin

December 8, 2015

91N8 UPDATE – Radio Antenna Wiring (NLVW)

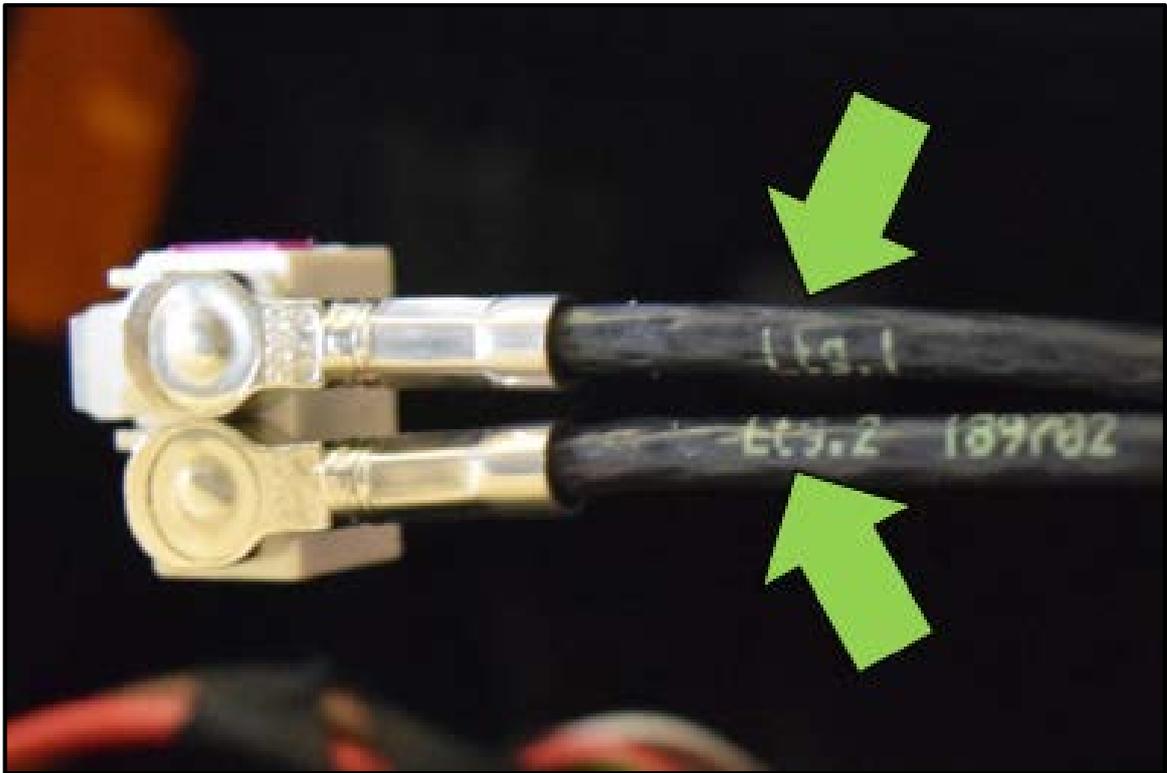
During production, the coaxial cable antenna connections were switched in the connector at the radio by the antenna cable supplier. Reversing these antenna cables in the connector will correct the AM reception concern.

- Inspect the coaxial cable markings as shown <arrows>.
- With the connector positioned as pictured, the cable labeled “Ltg.1” should be in the top position, and the cable labeled “Ltg. 2” should be in the bottom position.
- If necessary, remove and reverse the coaxial cables in the radio connector.

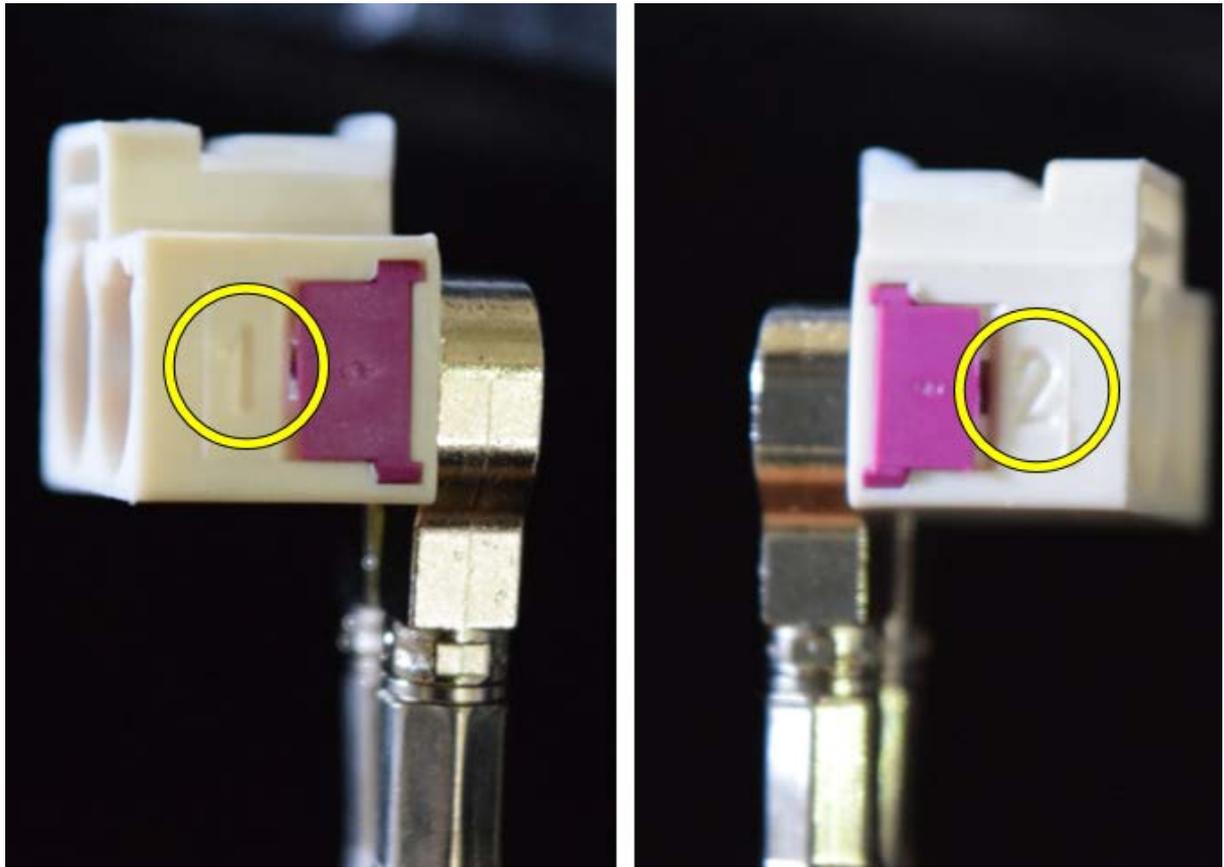
The pin locations marked on the coaxial cable connector DO NOT correspond to the labels on the cables themselves. The cable labeled "Ltg.1" is inserted into slot "2" and vice versa.

- Reinstall the radio.
- Test AM radio operation to ensure the repair was successful.
- Reinstall the radio trim bezel.
- Clear all DTCs.
