UPDATE Technical Bulletin

December 17, 2015

69L7 UPDATE – Airbag Control Module Software Update (NVLW)

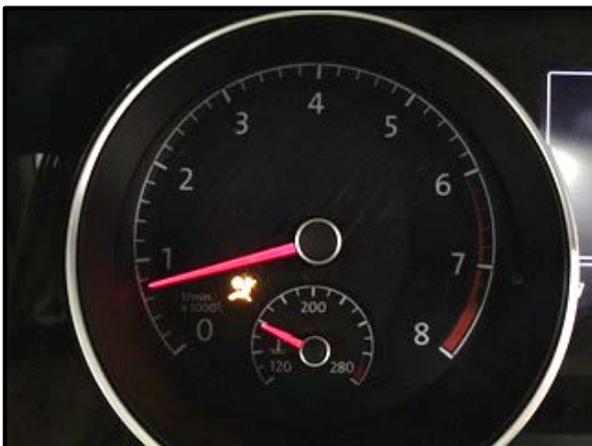
- With the ignition switched ON, check the current status of the airbag warning light.
- If the airbag warning light is OFF, **Proceed to Section C – Update Airbag Control Module Software.**
- If the airbag warning light is illuminated <as shown>, connect the VAS 6150C (or equivalent) to the vehicle and perform a Guided Fault Finding (GFF) scan.
- If the airbag system faults include “B200000”, replace the airbag control module. Then, proceed to **Section D – PODS system basic settings.**
