# Technical Bulletin

Model(s)	Year	Eng. Code	Trans. Code	VIN Range From	VIN Range To
Passat	2014-2015	All	All	A3_EC000000	A3_FC054650

70 15 01 April 10, 2015 2040091

### Instrument Panel Creaking Noise

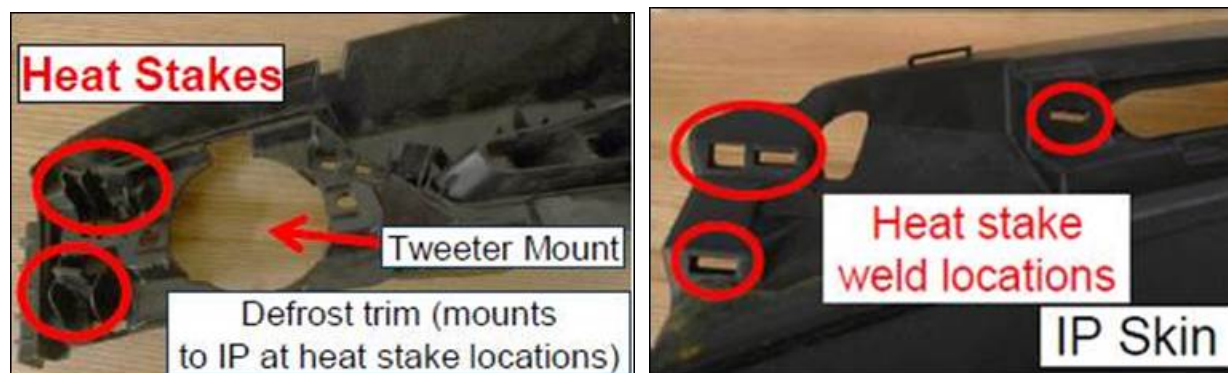
Figure 1

Plastic weld between the dash and defrost trim (Heat Stake) under the right front tweeter is broken causing a creaking noise when turning or on bumpy roads.

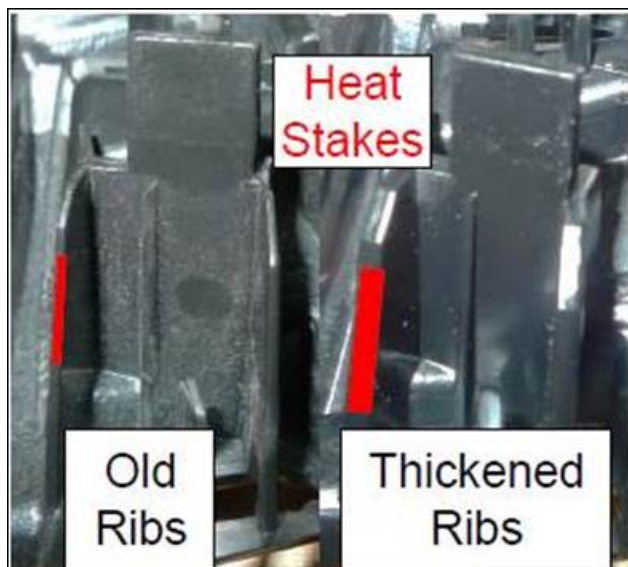
Figure 2

Strengthened rib around the Heat stake to prevent damage (figure 2).

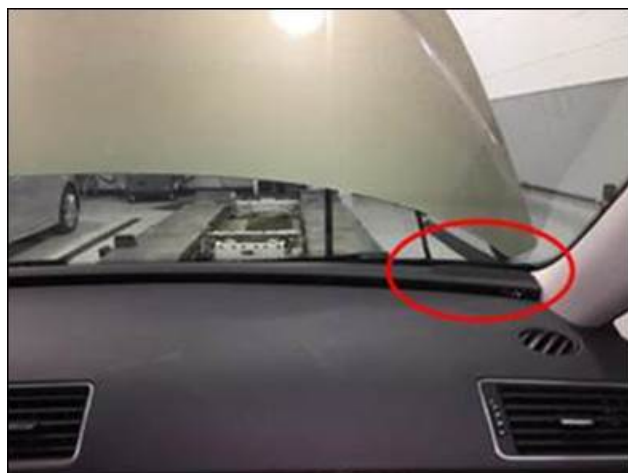
Figure 3

1. Test drive car to reproduce the noise.
2. If noise is duplicated verify the noise is coming from the passenger front tweeter area (Figure 3).
