Technical Bulletin

64 15 02 April 20, 2015 2039887 Supersedes Technical Bulletin V641501 dated March 2, 2015 to update service number and causal part information in warranty table.

Rear Door Glass Inoperative

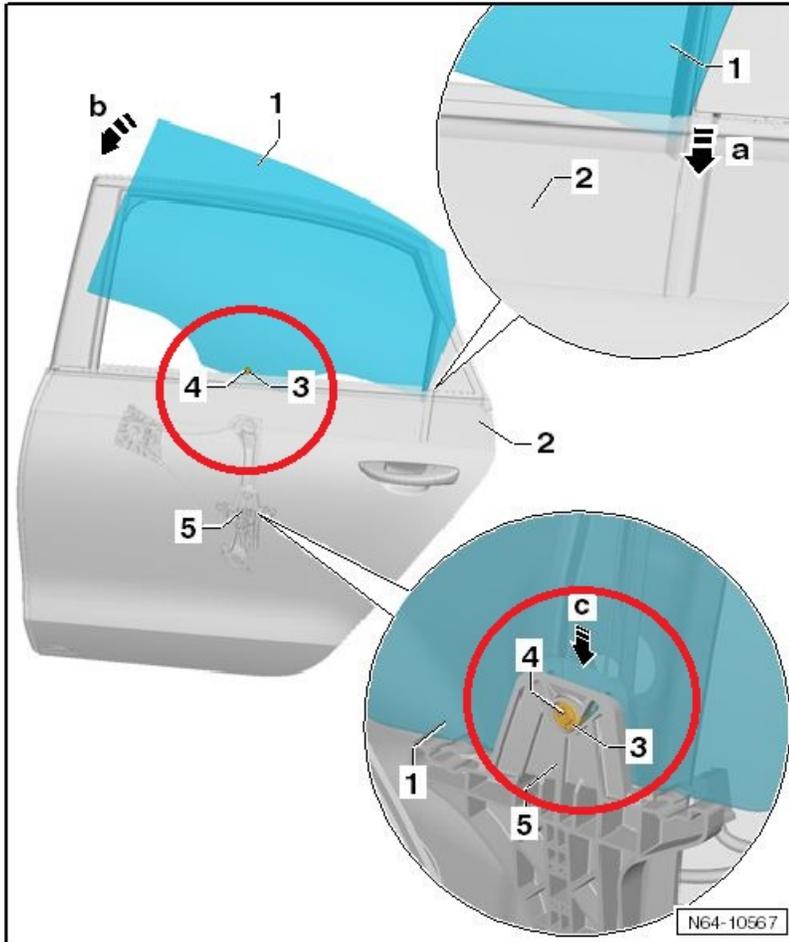
Figure 1

The spreader plug with expanding pin for securing the door glass to the window regulator can wander loose from the glass (see Fig.1 No 3 / 4). If this occurs, the door glass will no longer be secured to the window regulator.

Replace the spreader plug with expanding pin for securing the rear door window.

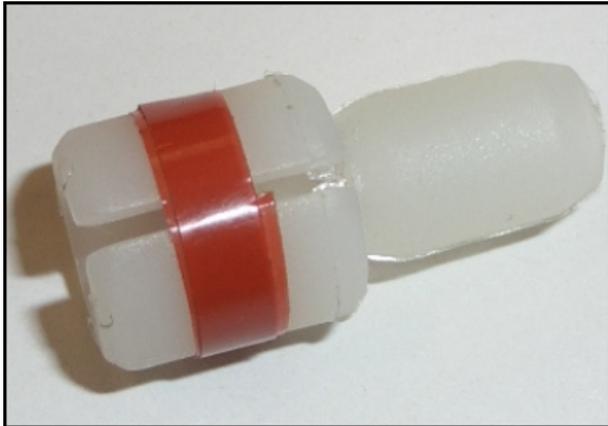
Figure 2 (Adhesive strip shown in red for clarity)

- Remove the rear door trim panel, see Repair Manual Group 70 in Elsa.
- Remove the inner glass shaft seal, see Repair Manual Group 64 Glass, Window Regulators in Elsa.
- Remove the outer glass shaft seal, see Repair Manual Group 64 Glass, Window Regulators in Elsa.
- Remove the rear door glass, see Repair Manual Group 64 Glass, Window Regulators in Elsa.
- Inspect the hole for the spreader plug in the glass for damage. (If there is damage to the hole in the glass, the glass must be replaced during this repair.)
- Using the foil tape (part number AKL.433.014.01) or vinyl tape obtained locally, cut a 55 mm long and 6 mm wide strip.
- Wrap the strip around the center of a new spreader plug (see Fig. 2).

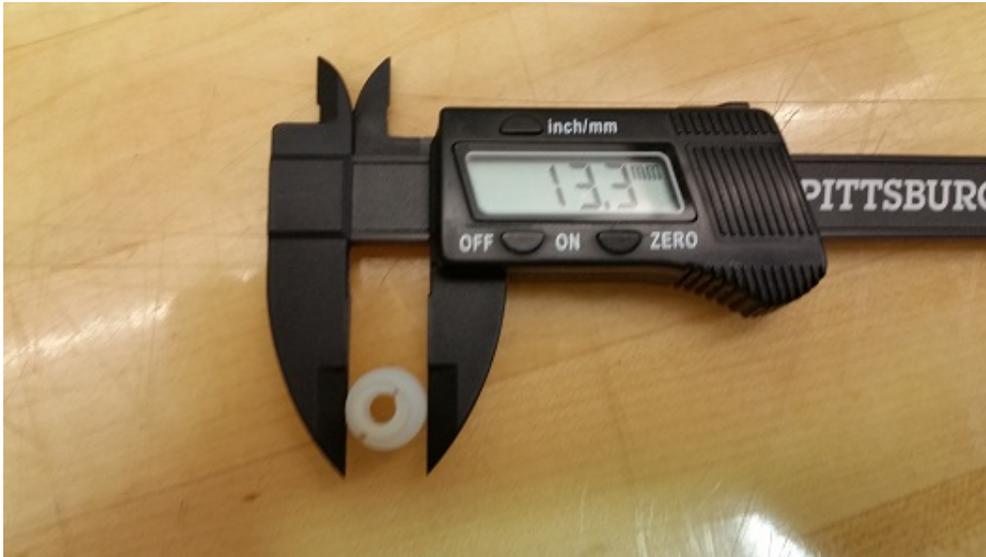
Figure 3 (Acceptable diameter after adding adhesive strip)

- Measure the diameter of the new plug with the adhesive strip. The diameter must be approximately 13.4 mm (see Fig. 3).
