Technical Bulletin

21 15 04 April 29, 2015 2026771 Supersedes T. B. V211501 dated January 15, 2015 to remove engine cover labor operation contained in diesel particulate filter labor operation.

Engine Lacks Performance, Engine Warning Light ON, DTCs P2563, P2564, P0299 or P20D8 Stored in ECM Fault Memory

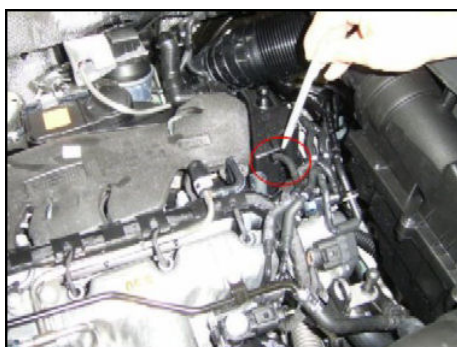
Figure 1

Hose not inserted into the vacuum container.

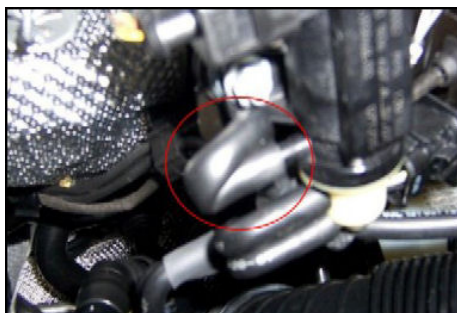
Figure 2

Vacuum hose at the solenoid valve, or in the pipe system, is kinked.

- Re-position hoses to avoid pinching. It is not necessary to replace the hoses.

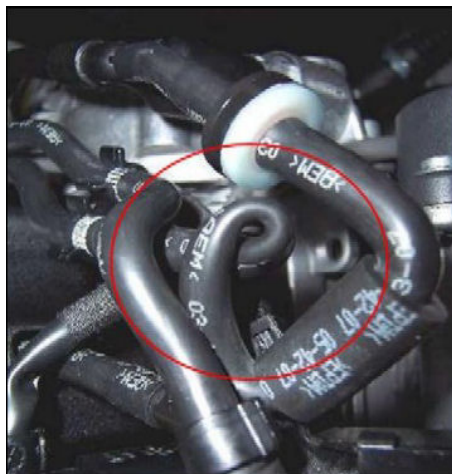
Figure 3

Vacuum hose at the solenoid valve, or in the pipe system, is twisted.

- Re-position hoses to avoid pinching. It is not necessary to replace the hoses.

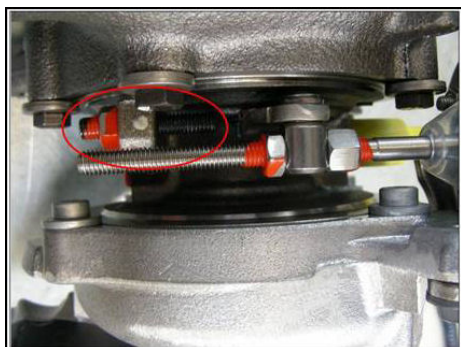
Figure 4

- Inspect the turbocharger stud with clamp nut (min. flow adjustment screw) (Figure 4).

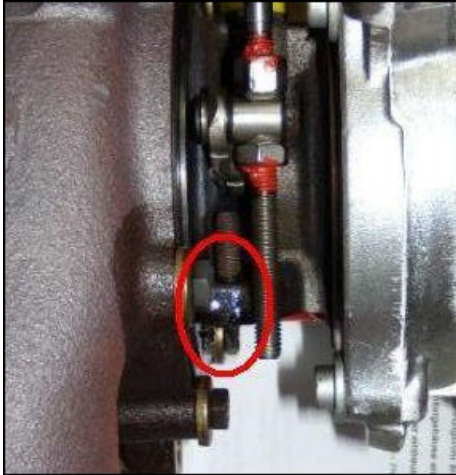
Figure 5

- Inspect the turbo charger to see whether the stud with clamp nut is broken (Figure 5).

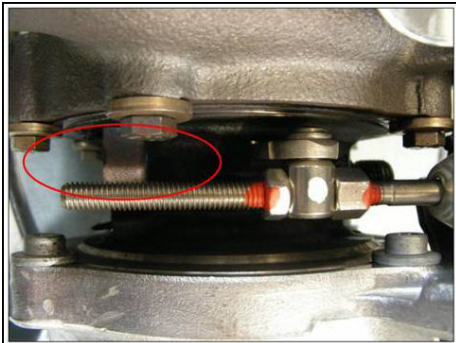
Figure 6

- Inspect the turbo charger to see whether the stud with clamp nut is missing (Figure 6).
- If the stud or clamp nut are missing, replace turbocharger.

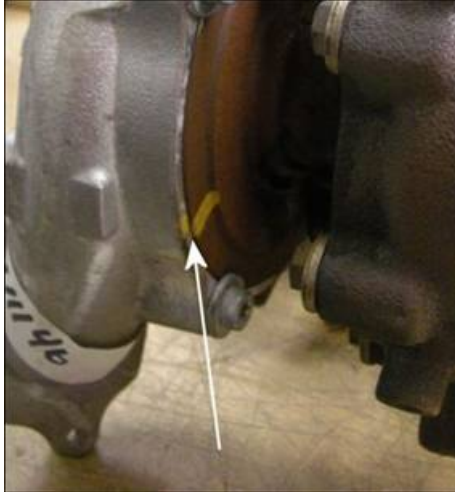
Figure 7

- Carefully inspect the turbocharger housing around the entire housing assembly for an alignment mark (Figure 7). If the alignment mark is misaligned, this indicates that the housing has rotated.
- If misaligned, replace turbocharger.

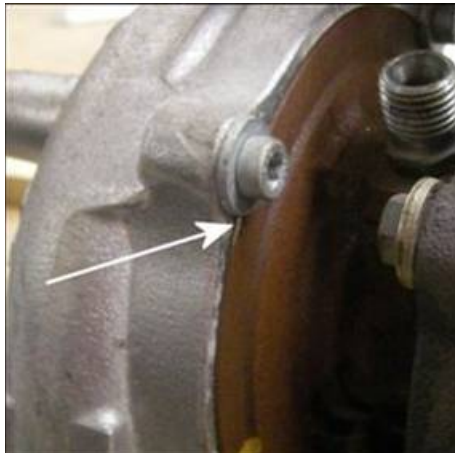
Figure 8

- Carefully inspect the turbocharger housing around the retaining bolts for witness marks (Figure 8), indicating that the housing has rotated.
- If witness marks are present from washers, replace turbocharger.

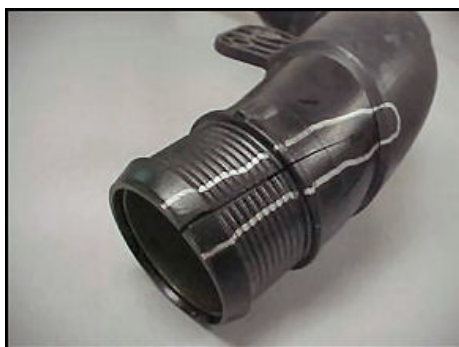
Figure 9

- Inspect the plastic boost pipe that runs from the intake side of the turbocharger to the intercooler for cracks or leaks (Figures 9 and 10).

These cracks can be difficult to see. It may be necessary to pressure test the charge air system according to the repair manual under Engine > Engine Mechanical, Fuel Injection and Glow Plug > 21 turbo charger, G charger =>Diagnosis and Testing => Charge Air System, Checking for Leaks.

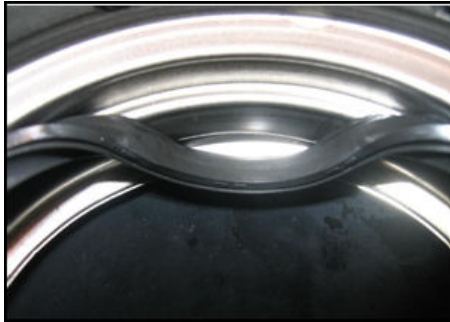
Figure 11

- Inspect the boost pressure hose connections to the intercooler for leaks.
- Ensure that the seals are in the proper position and not damaged (Figure 11).
- Damaged or missing seals should be replaced. The seals are available separately, it is not necessary to replace the entire hose.
