Tech Tips

TT 21-10-02

All 2008-2015 Vehicles with 2.0 TSI Engine (CCTA, CBFA) –
Fault Codes P0299, P0234, or P0236

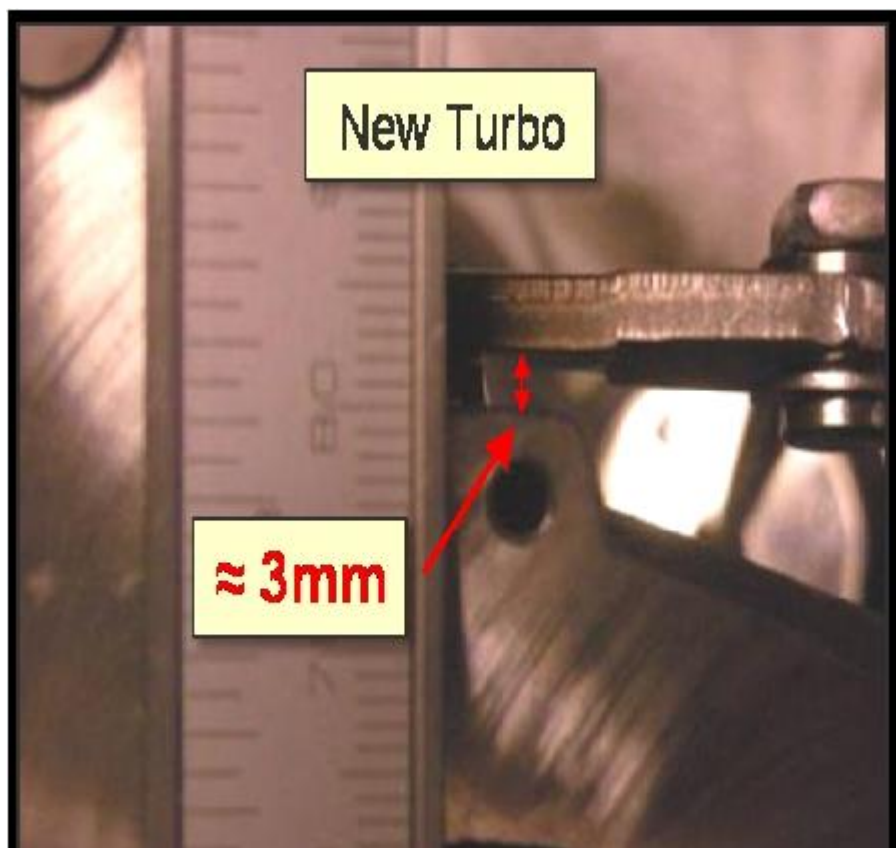
Check that the roll pin located in the turbocharger exhaust housing hasn't backed out, allowing the wastegate valve and lever to drop into the housing (see attached pictures). The wastegate lever can become seized in the open or closed position, causing either an underboost or overboost condition. This condition can be intermittent as well making it hard to duplicate the fault. Inspect the wastegate lever for approx. 3mm of clearance between the bottom of the lever and the turbocharger housing. If there is no gap then the turbo must be replaced.
