Technical Bulletin

87 15 09 July 8, 2015 2038368 Supersedes Technical Bulletin V871412 dated December 8, 2014 to include Golf SportWagen applicability.

Air Conditioning Does Not Cool and or Compressor is Noisy

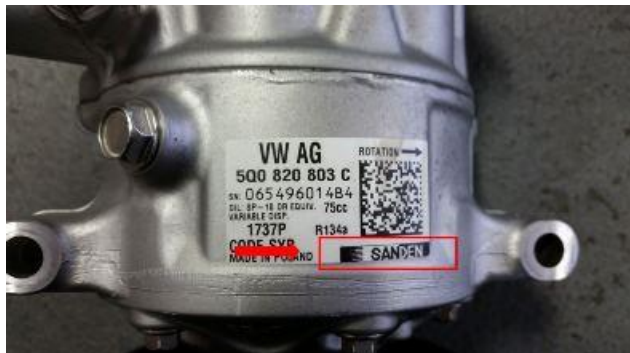
Figure 1: Sanden compressor identification tag.

The originally installed compressor on the MY 2015 Golf/GTI is manufactured by Sanden (Figure 1). The replacement compressor is manufactured by Denso (Figure 2).

All MY2015 GTI/Golf, SportWagen have Sanden factory compressors. The compressor should be replaced with Denso 5Q0820803F.

It is necessary to flush the system to clean the refrigerant circuit of Sanden PAG. Failure to do so can cause damage to the new compressor.

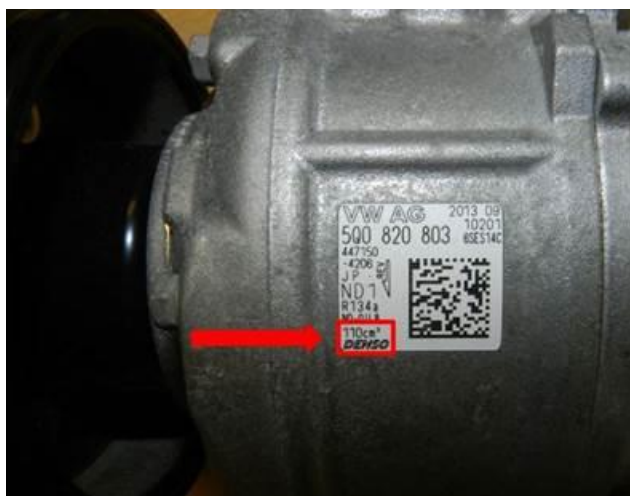
Figure 2: Denso compressor identification tag.

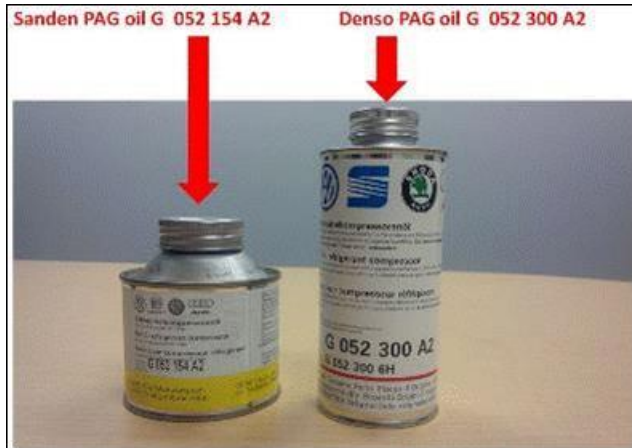
Figure 3: Compressor manufacturer specific PAG oils.

The replacement compressor will come with the specified type of PAG oil for the compressor (Figure 3).

The compressor comes with a full charge of oil for the entire refrigerant circuit. However The amount of PAG oil supplied with the replacement compressor may not be the exact amount required to replenish the refrigerant circuit. Drain and measure the PAG oil in the replacement compressor to determine the required amount. If the amount needs to be adjusted, do so using the correct type of PAG oil specified in ETKA. Refer to Elsa for the correct oil capacity for the compressor being installed.
