Technical Bulletin

Model(s)	Year	Eng. Code	Trans. Code	VIN Range From	VIN Range To
Phaeton	2004 –2006	All	All	All	All

57 15 02 July 20, 2015 2039003 Supersedes Technical Bulletin V571407 dated December 18, 2014 to update service number.

Corrosion on Front Doors (Multiple Locations)

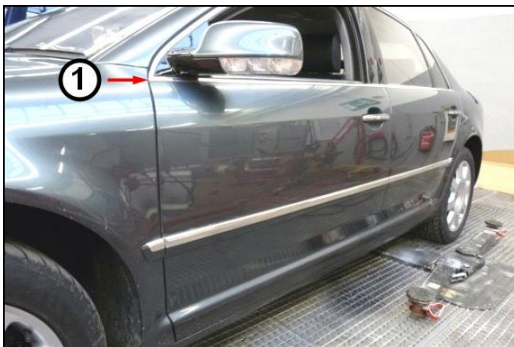
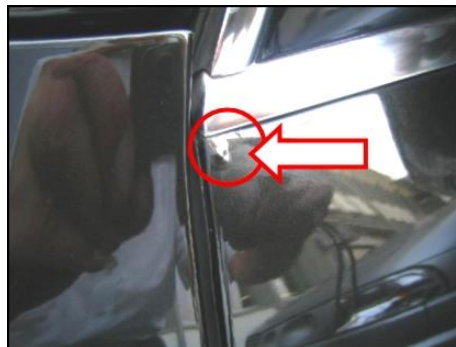
Figure 1 – Upper window channel strip

Figure 1.1

Alignments in production can lead to hairline cracks in the top coat and paint damage (edges on holes) on the already painted door. Humidity then penetrates paint and causes blistering and/or white corrosion.

- Inspect the inner edge area of the doors for cracks, particularly the fine seam sealing.
- Completely remove the corrosion in the damaged area.
- Apply a VOC compliant epoxy primer as an anti-corrosion treatment and primer to both sides of the door (locally sourced).
- Seal the edges/metal sheathings with adhesive (part number: AKD 476 KD505) before painting.
- Repaint door according to Volkswagen guidelines

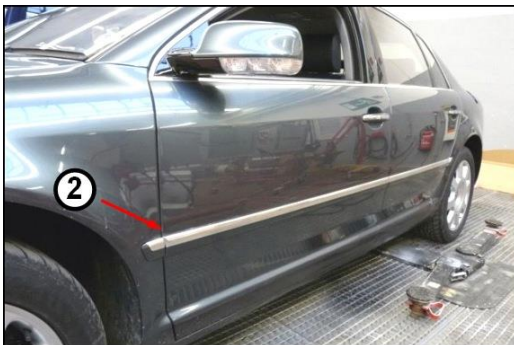
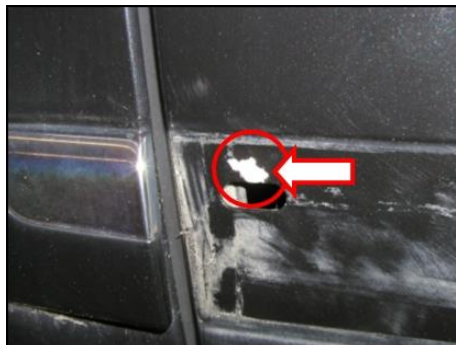
Figure 2 – Central protective strip

Figure 2.1

- Before installing the side protective strip, attach from the outside, and only on the front and rear holes/elongated hole (Figure 7 and 8, red arrows), a trim protective foil (part number: AKL 448 030 05) or similar as additional anti-chafing protection.

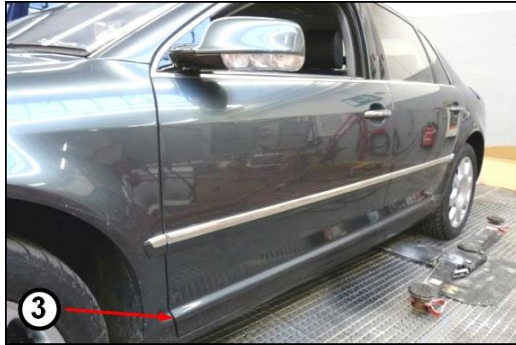
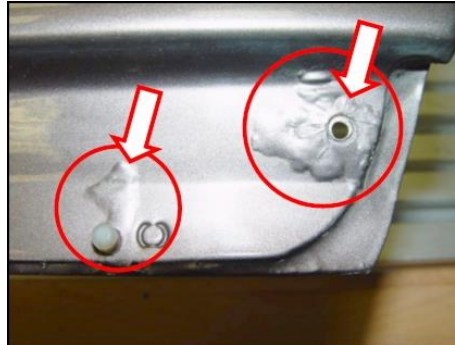
Figure 3 – Lower protective strip

Figure 3.1

- Before installing the lower protective strip, attach on every front and rear hole (Figure 10, red arrows) from outside, a trim protective foil (part number: AKL 448 030 05) as additional anti-chafing protection.

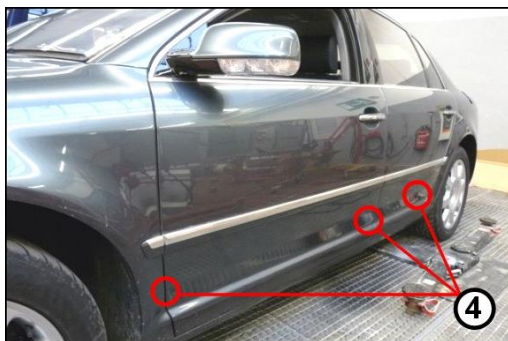
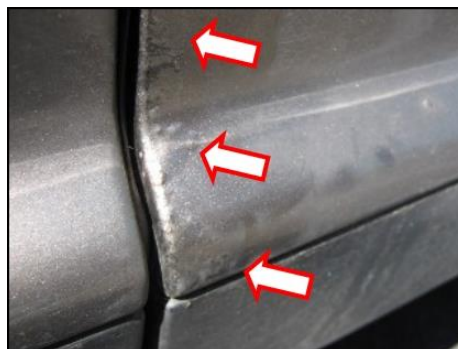
Figure 4 – Surface/edge corrosion

Figure 4.1

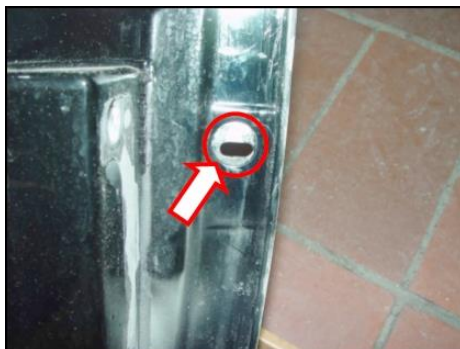
Figure 5

Holes and edges in the flange area.

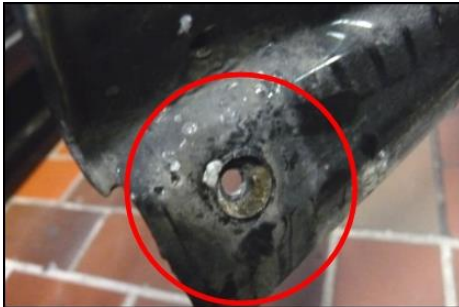
Figure 6 (front door, lower left)
