# Tech Tips

TT 96-14-05

Date: August 22, 2014

## 2015 Golf, GTI – Immobilizer Key / Key Remote Adaptation Test Plan

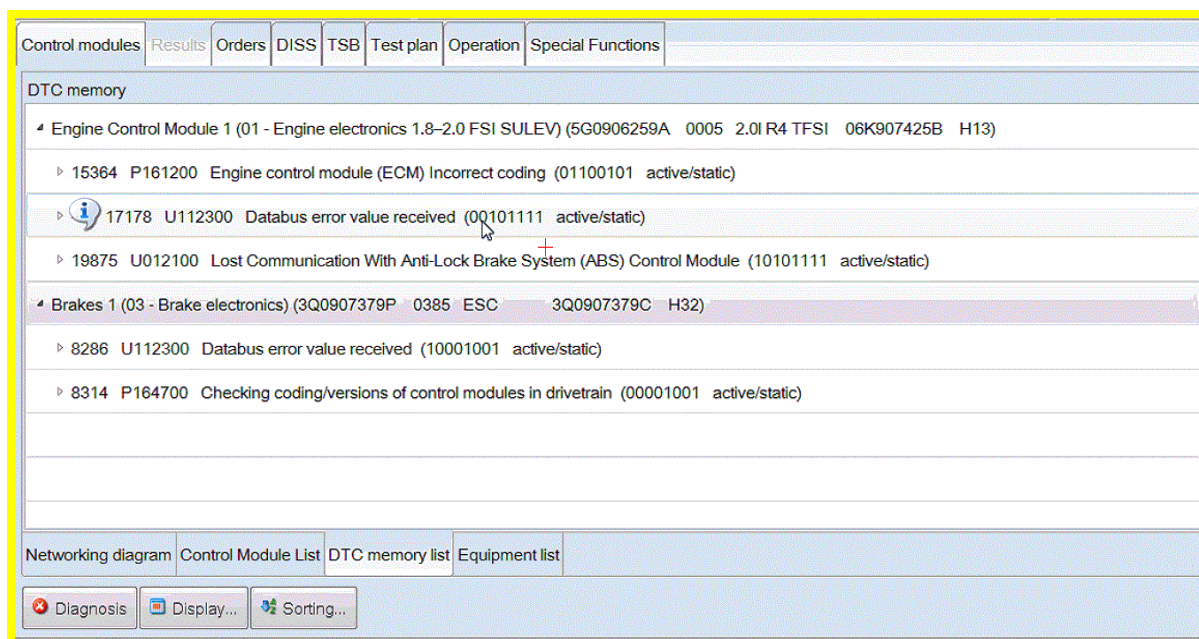
Vehicle doesn't start and or warning lights on after immobilizer / key adaptation. Check for faults related to modules that may no longer be coded.

If a control module is no longer coded, the test plan for immobilizer / key adaptation has failed. If the scan tool being used is up to date, please submit feedback for the failed test plan using the Help tab and Support button in the right column of the scan tool.

It will be necessary to recode all modules that are no longer coded. Code modules online under the special functions tab, "Code online control module". Modules may include, but not limited to ECM, ABS, TCM.

Clear all related faults, recheck operation of the vehicle.
