Service Bulletin

SUBJECT: Service Update for Inventory and Customer Vehicles
Engine Block Porosity
Expires with Base Warranty

MODELS: 2015 Buick Enclave
2015 Chevrolet Traverse
2015 GMC Acadia
Equipped with HFV6 Engine (RPO LLT)

Subject: 15532 – Service Update Bulletin
Engine Block Porosity

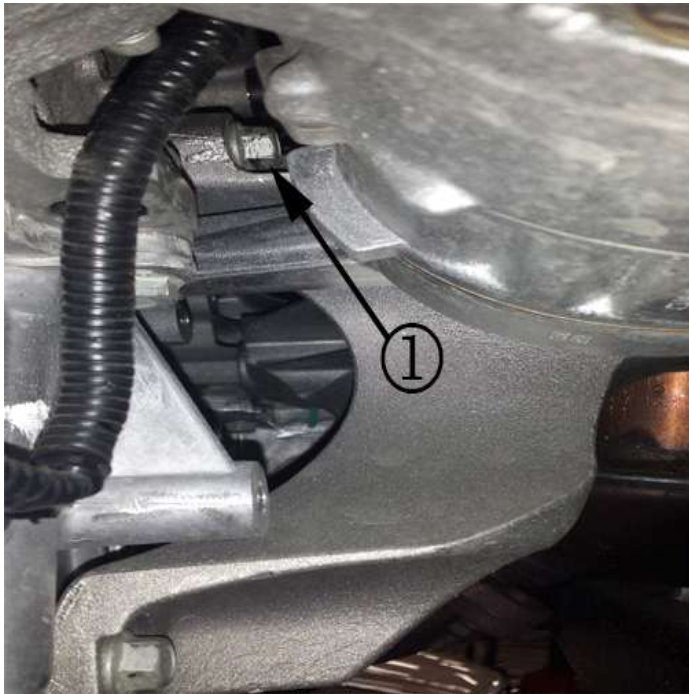
4258509

This bulletin provides a service procedure to correct a potential oil leak on certain 2015 model year Buick Enclave, Chevrolet Traverse and GMC Acadia vehicles equipped with a HFV6 engine (RPO LLT). The potential leak is from the oil pan crank case at an engine mount hole location, which is not under engine oil system pressure. To correct this condition, dealers will remove the mounting bolt, clean the bolt and hole, apply thread sealant and reinstall the bolt.

2. Remove the passenger side upper mounting bolt (1) from the engine mounting bracket (2) as shown in the pictures above.
3. Clean out the bolt hole with brake cleaner. Allow the brake cleaner to completely dry.
4. Apply a thin layer of Teflon pipe sealant to the first 1/3 of the threads of the bolt and tighten to 58 Nm (43 lb ft).
5. Lower the vehicle. Refer to *Lifting and Jacking the Vehicle* in SI.
